Faith Meadow Baseline Stream Habitat Condition Inventory and Assessment

West Fork Carson River, Alpine County, California

Prepared by Sabra Purdy, Trout Unlimited, 2018

Report Commissioned by American Rivers from a Grant from the National Fish and Wildlife Foundation

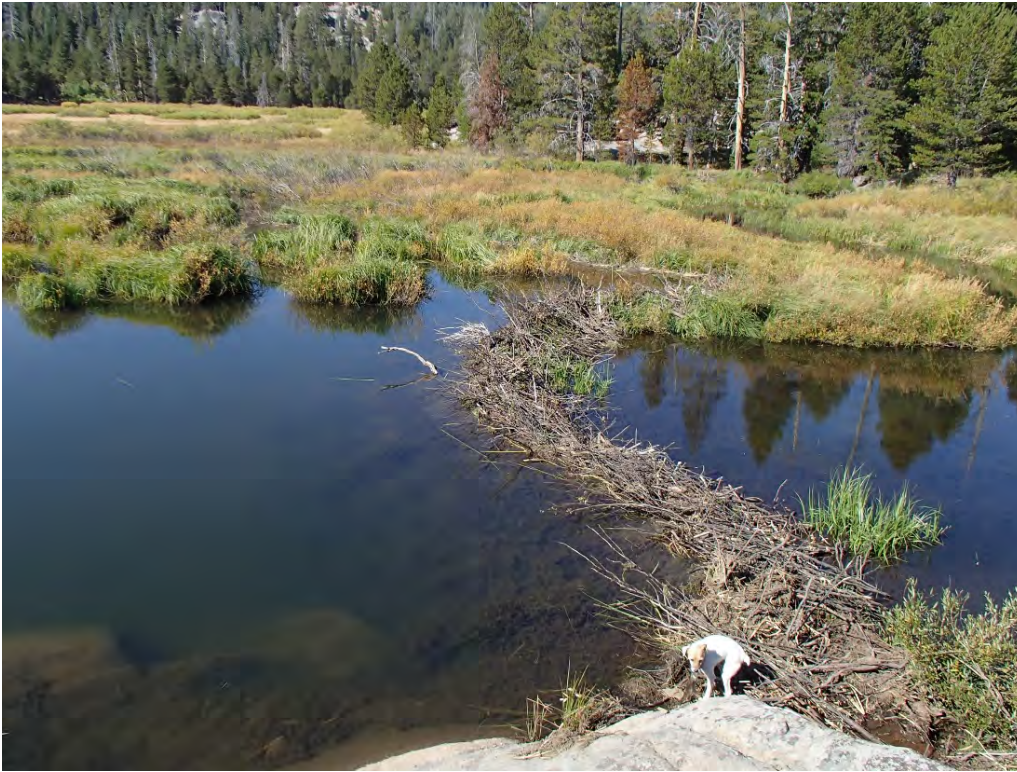
Figure 9. Beaver Dam at the base of FM1. This dam backs water up for hundreds of meters and created a large area of inundation laterally that resulted in a tremendous vegetation response. This dam did not survive the winter of 2016/2017 resulting in a much narrower area of inundation and lower water surface elevation exposing much of the previously inundated floodplain and channel. FM1, SDBV1.

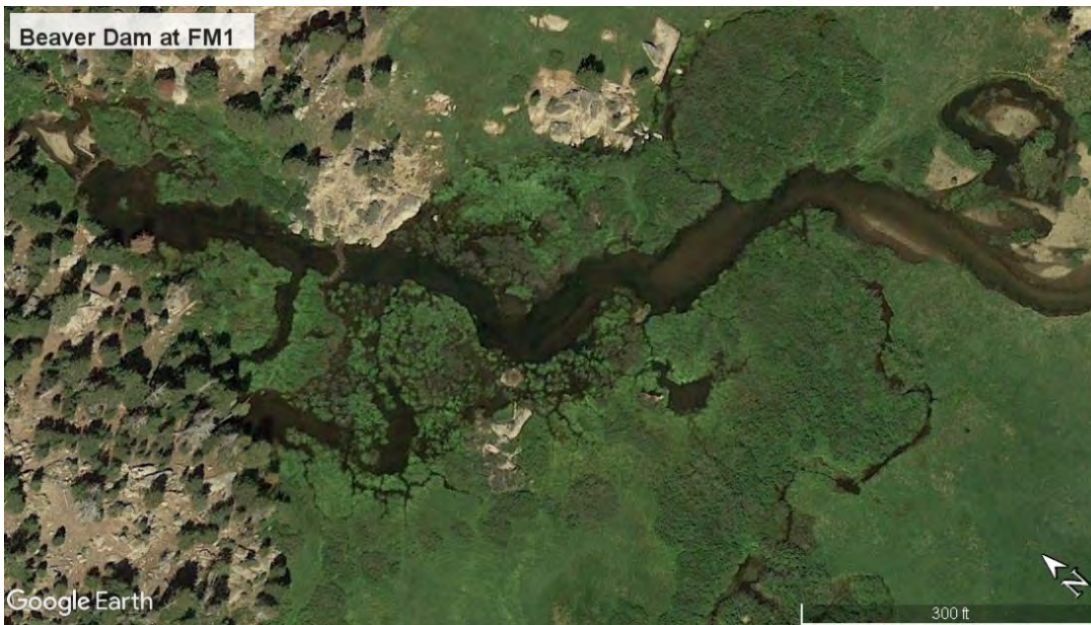
Figure 10. Aerial view of FM1, channel unit SDBV1. Note the intact beaver dam near the rocky outcropping adjacent to the channel in the left part of the photo. Note the complex backwater habitat and inundated area on the left side of the channel and the influence of the beaver dam on the tributary on the bottom right part of the photo. Note the lush herbaceous vegetation and willows and inundated oxbow/backwater habitats on the right bank. There is a second beaver dam ~75 m downstream as well. Both washed out in the 2017 floods.

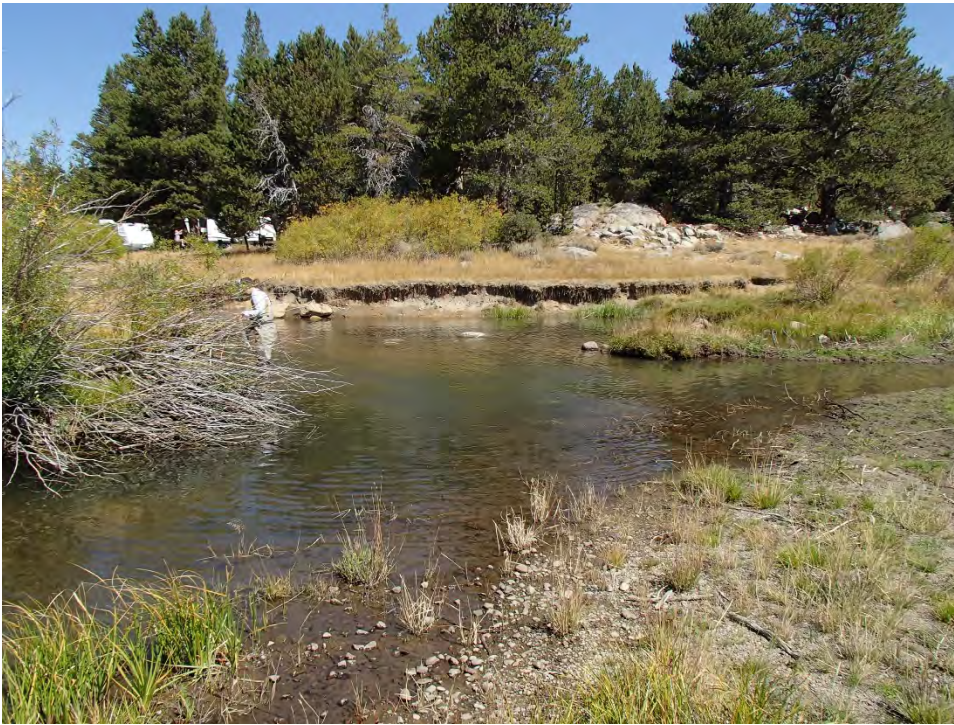
Figure 11. Just upstream of the inundated area from SDBV1 the stream channel becomes entrenched with unstable cutbanks and fresh sediment deposition on the point bars. This location also has a lateral moraine on the right bank (the boulders in the upper right corner of the photo). FM1, SSMC3.

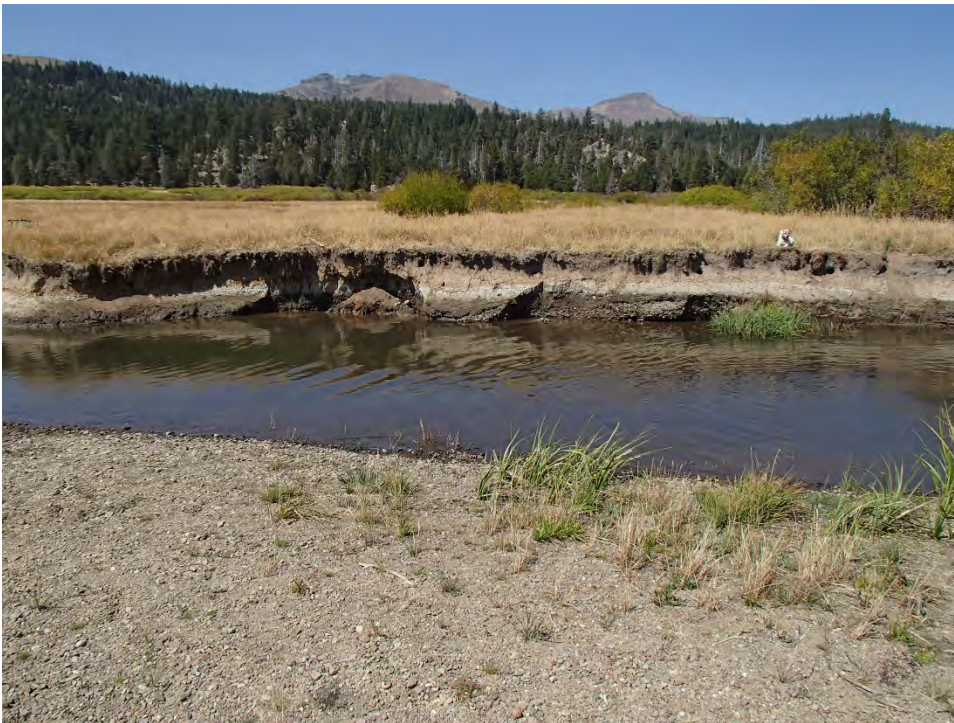
Figure 12. Area of instability and disconnection from the floodplain. Inset floodplain development is occurring, but small substrates are highly mobile. This section rarely overtops its banks and vegetation on the terrace has shifted to mesic/xeric grasses rather than hydric sedges. FM1, SSLS4.

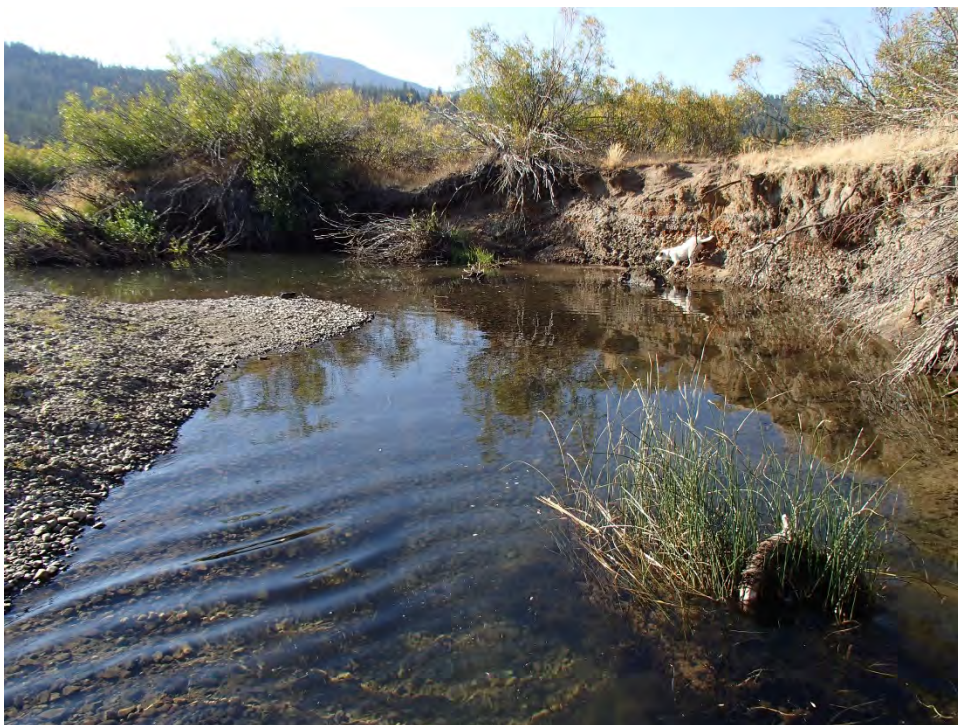
Figure 13. Area of incision and bank instability. Note the chunk of sod that has fractured off the bank. There is a beaver dam remnant immediately downstream that contributed to bank erosion when it end-cut. FM1, SSL8.

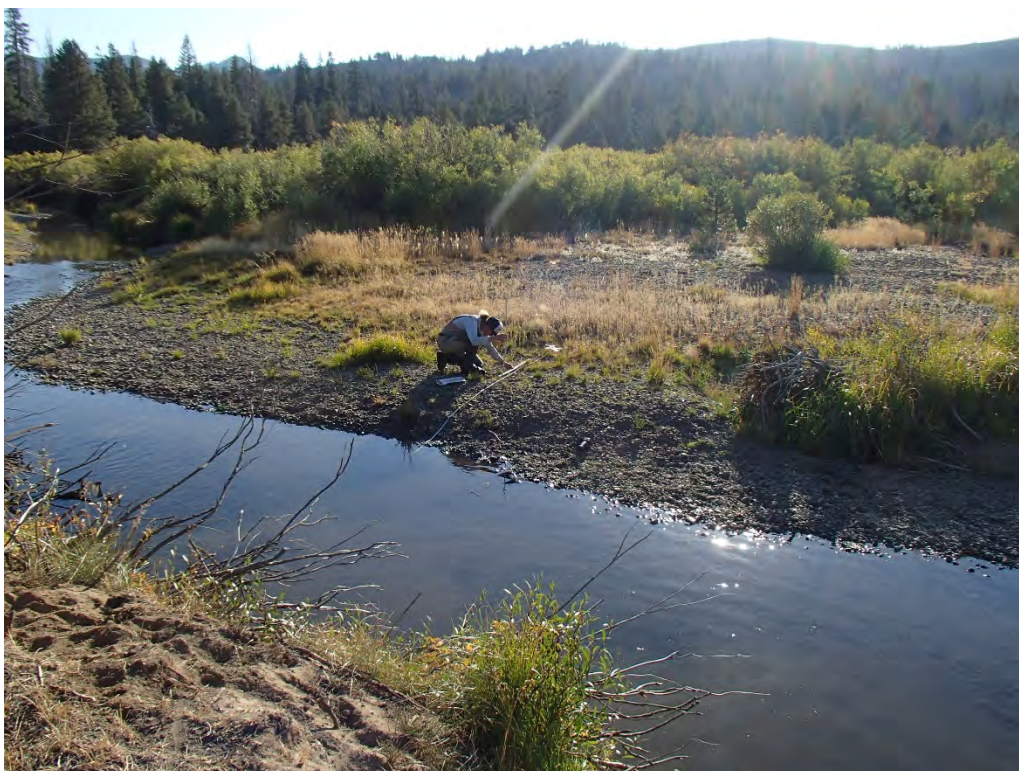
Figure 14. A typical point bar with sparse herbaceous vegetation above bankfull but healthy willow colonization occurring. Note the eroding remnant of a beaver-stabilized bank on the right edge of the photo. FM1, SSL9.

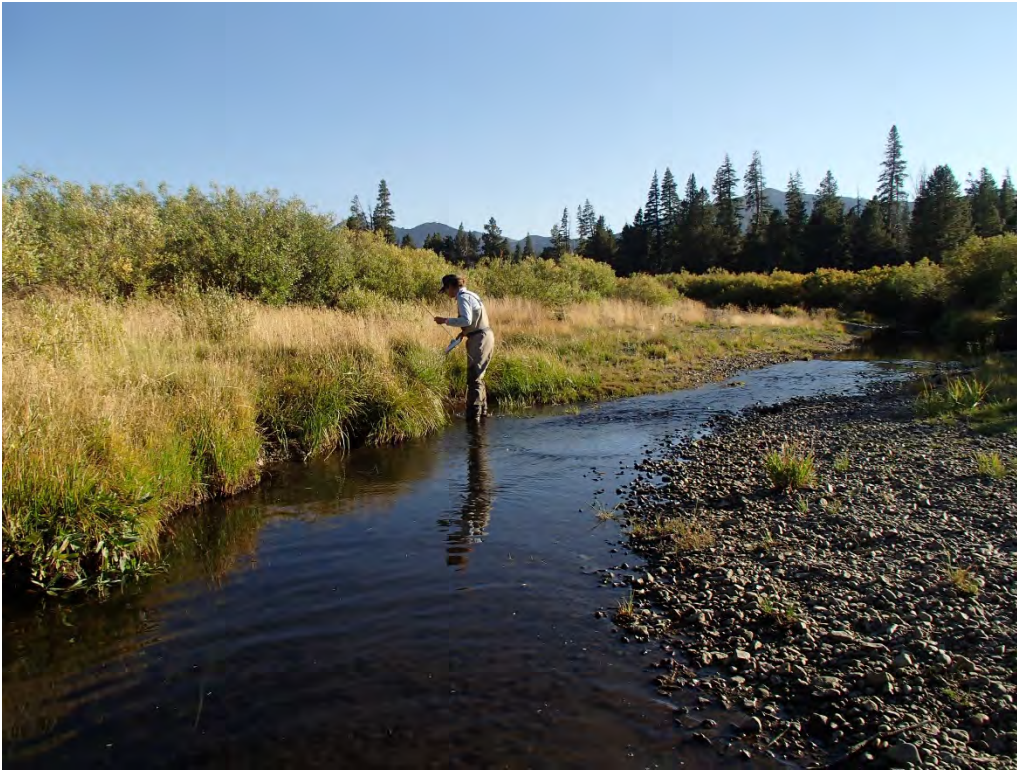
Figure 15. Though entrenched, this section of the streambank has been stabilized by a downstream beaver dam that has since been washed out. Note the tell-tale “pillow-shape” of the banks with excellent herbaceous vegetation recruitment, stability and developing undercut banks. These types of banks are common in places where beaver dams have been able to persist for a long enough duration to support this kind of vegetation colonization and reduction of erosion. FM1, SSLS9.

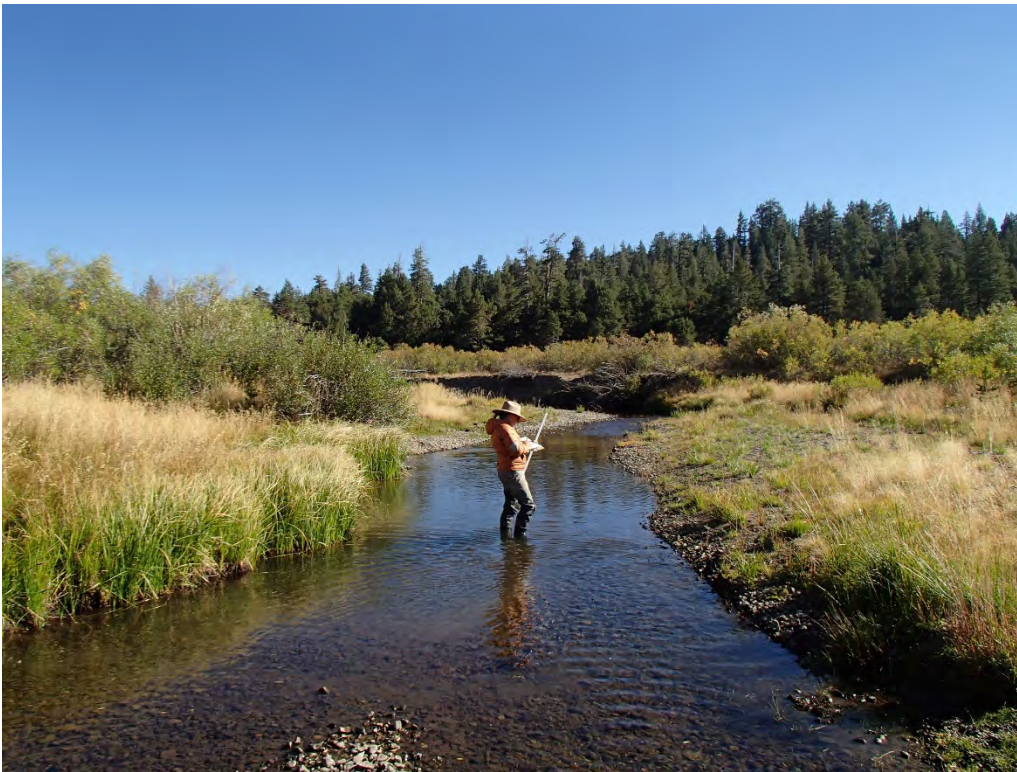
Figure 16. Another area where a now-gone beaver dam has improved the conditions of the stream channel. Here, the accreted sediments have resulted in an emergent marsh type habitat on the left side of the photo (river right) where dense sedges (*Carex* spp.) inhabit the inundated zone below bankfull protecting the entrenched but no longer eroding bank behind it. Upstream however, the cutbank and terrace continue to erode and floodplain access is restricted. FM2, SSLS10.

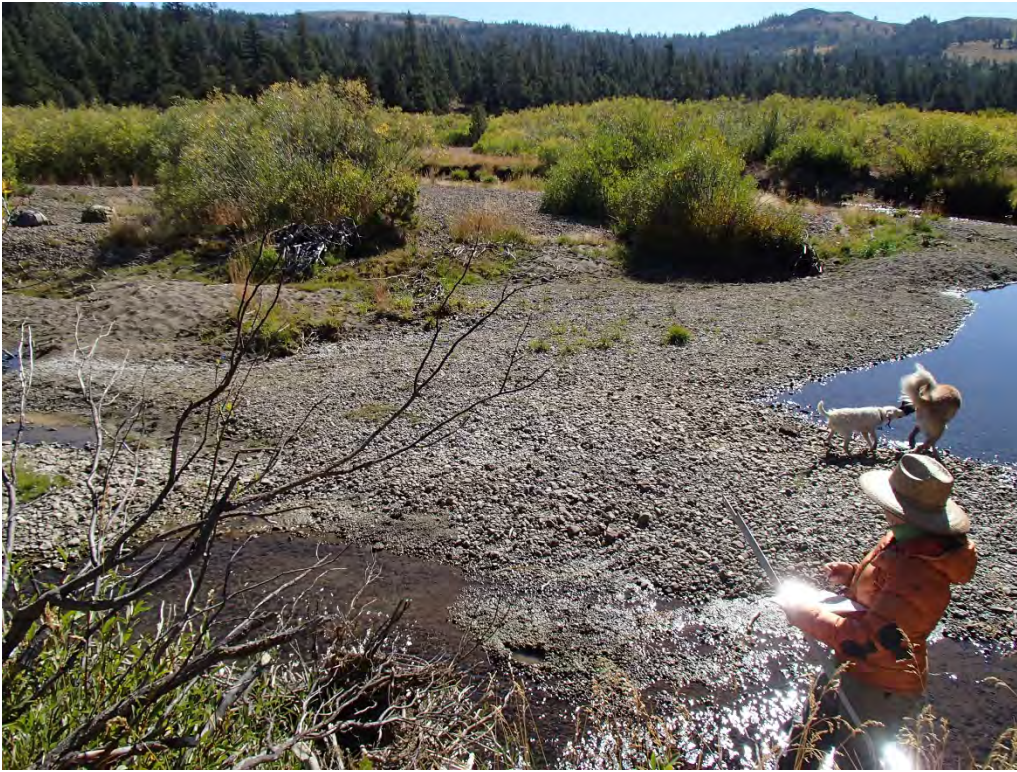
Figure 17. Visible remnants of a former beaver dam on the channel margin are all that remain (lower left of photo) of a beaver dam, but the accumulated sediments remain in the channel leading to the formation of a riffle crest. Note the point bar with willows, but very little understory vegetation on the exposed gravel. FM2, FTRF7.

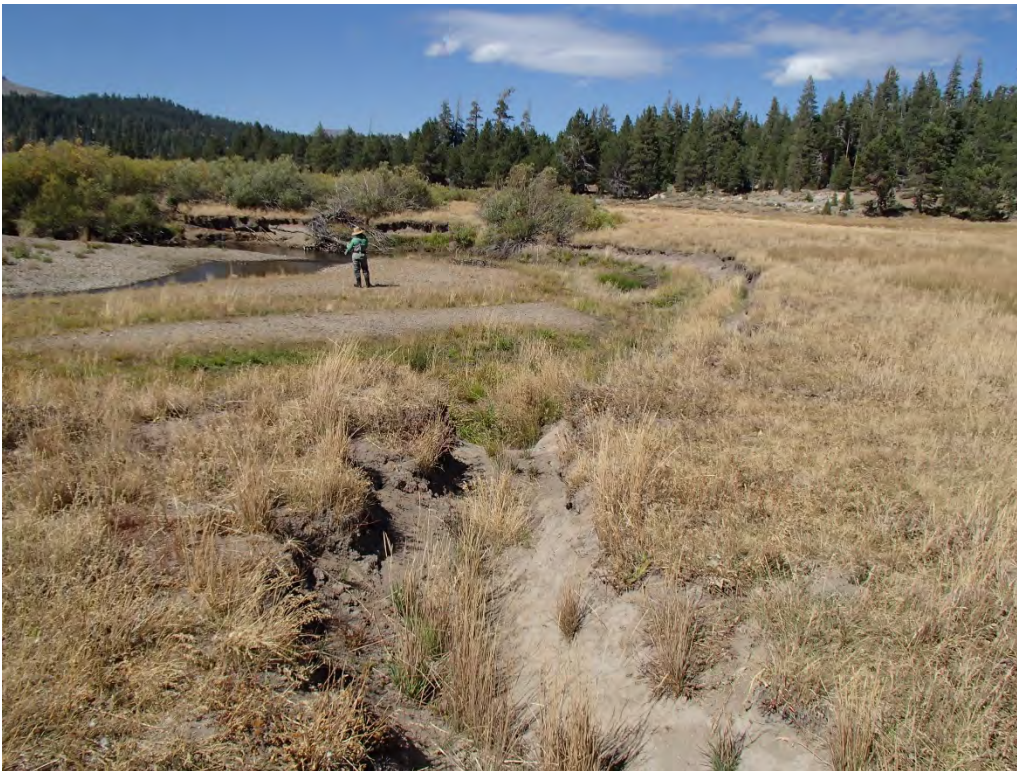
Figure 18. A former cutbank still shows scars from the bad old days when it was actively eroding. The new gravel bar that protects it and allowed it to stabilize appears to be sediments that accreted behind an old beaver dam (now just a remnant). However, the historic floodplain is still largely disconnected from the stream and the difference in elevation is creating a headcut that is moving into the meadow. Note the dry vegetation and soil. FM2. Near SLS16.

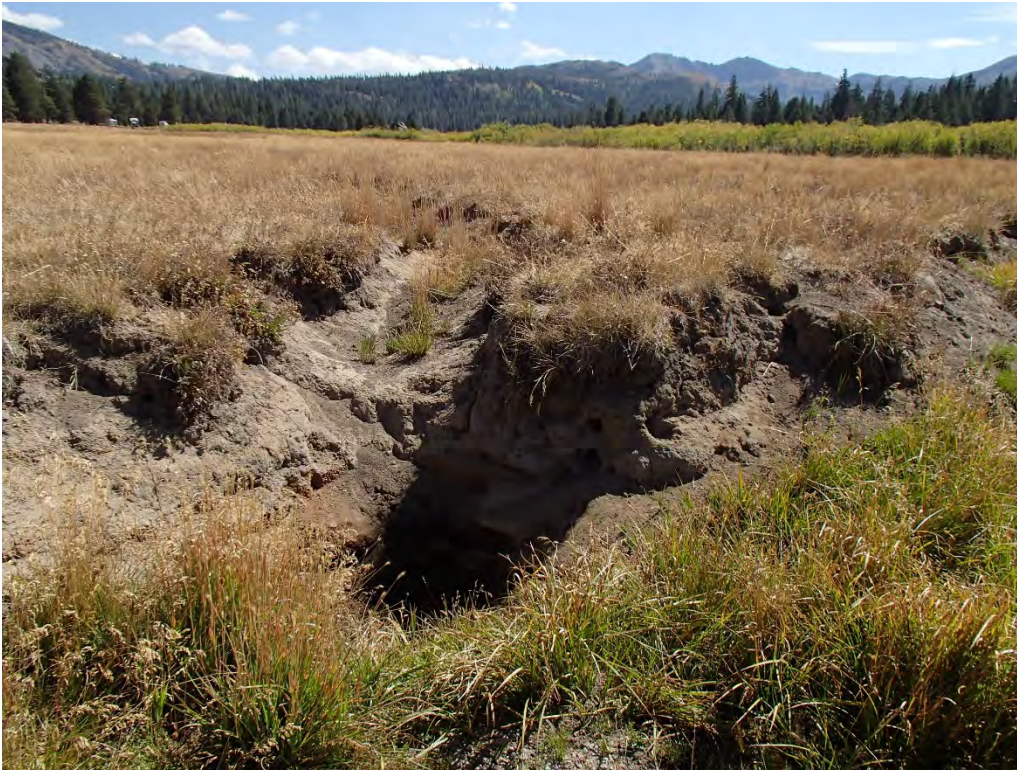
Figure 19. Inset floodplain formation is occurring along an old cutbank but an active headcut is working into the historic floodplain. Note the greener, more hydric-type vegetation at the base of the old cutbank with the dry vegetation and crumbling sod on the terrace. FM2. Near SLS16.

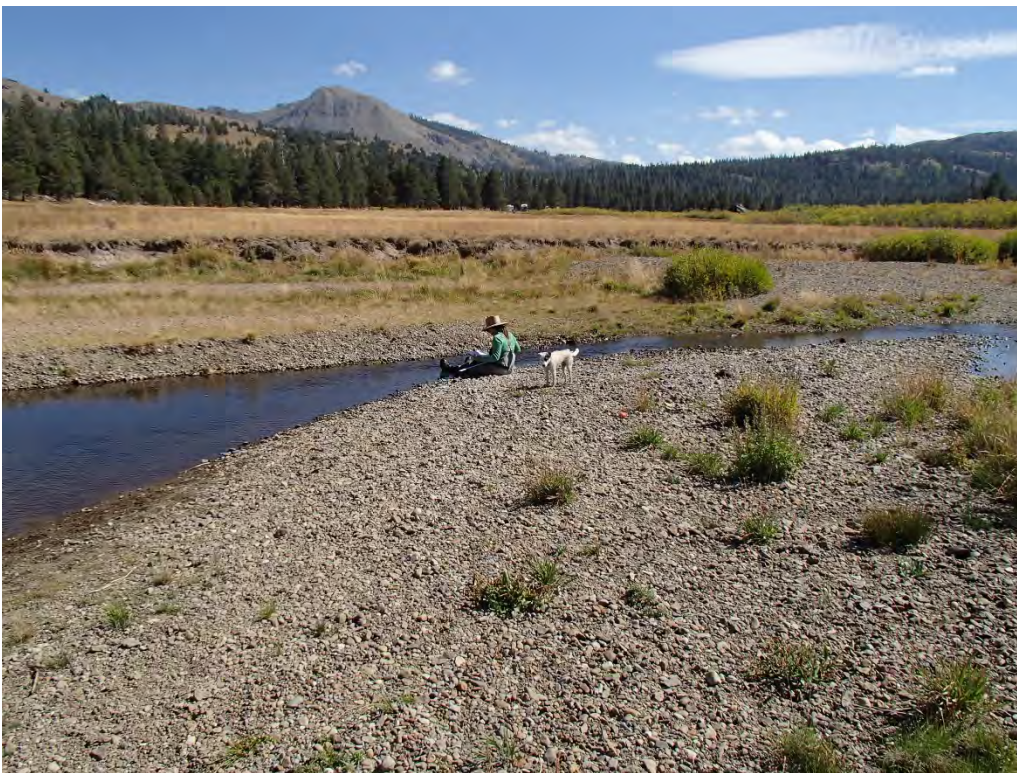
Figure 20. Gravel bar formation in the inset floodplain. This is a sign of some recovery. However, the historic floodplain remains disconnected from the stream. FM2, FTRF11.

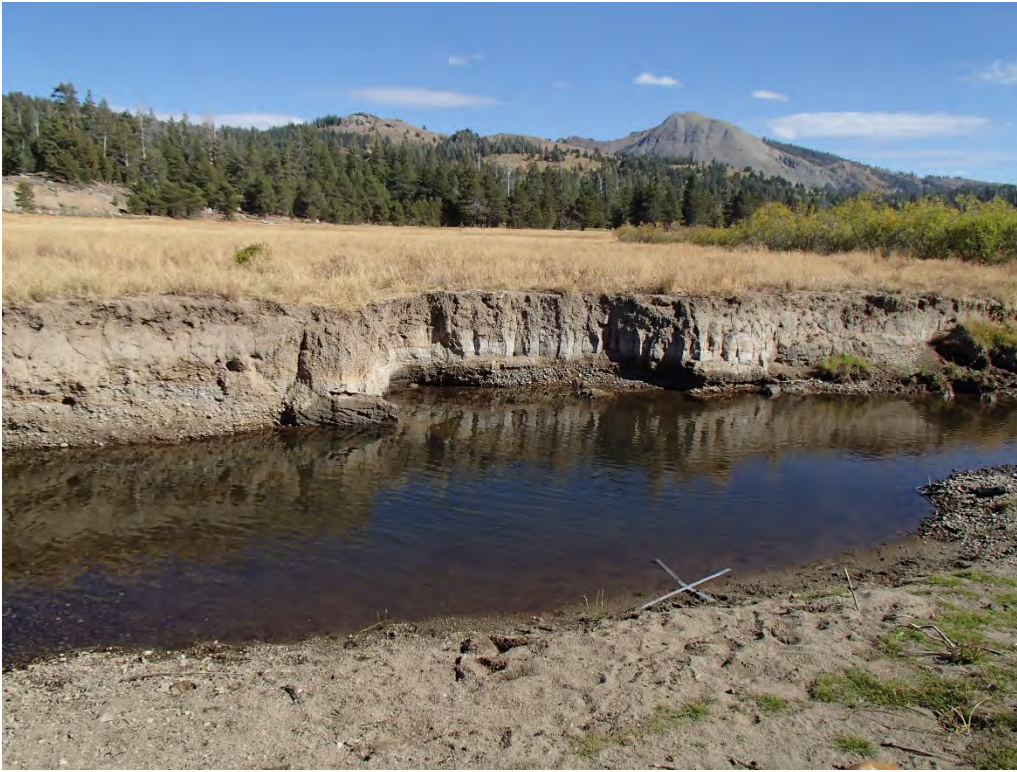
Figure 21. Actively eroding banks occur in many areas of Faith Valley with a disconnected floodplain and ongoing bank fracturing, channel widening, and sediment losses. FM2. SSL518.

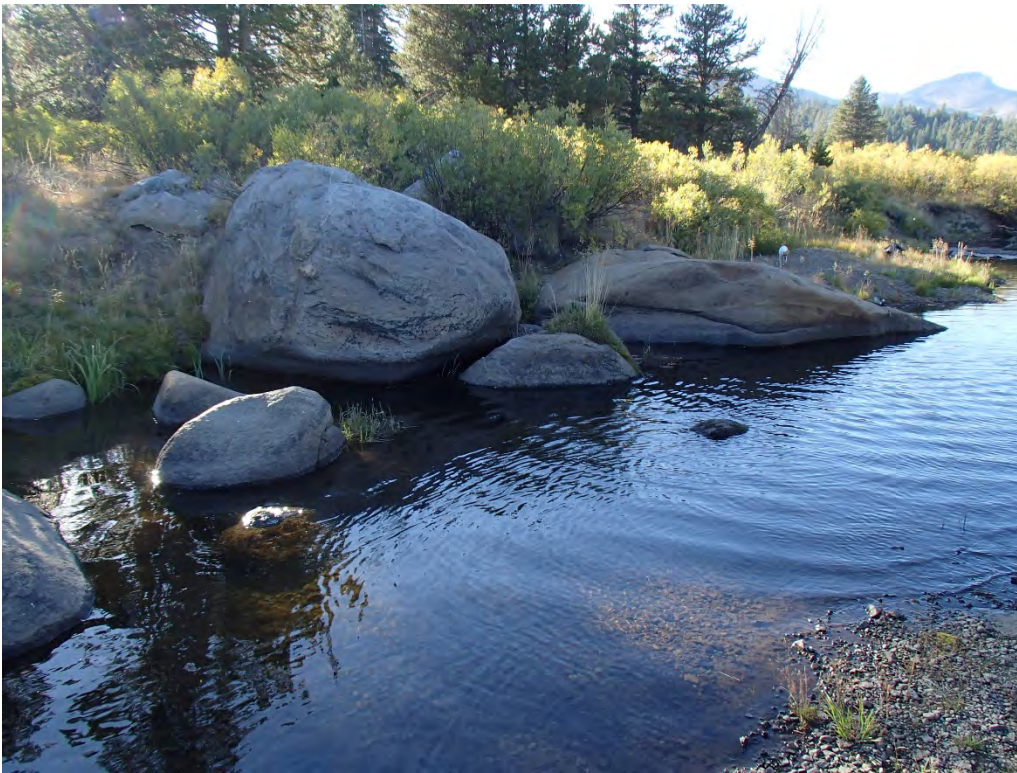
Figure 22. When the stream channel approaches a moraine, large boulders are often found in the channel and conifers come into the riparian zone. FM2. SSMC22.

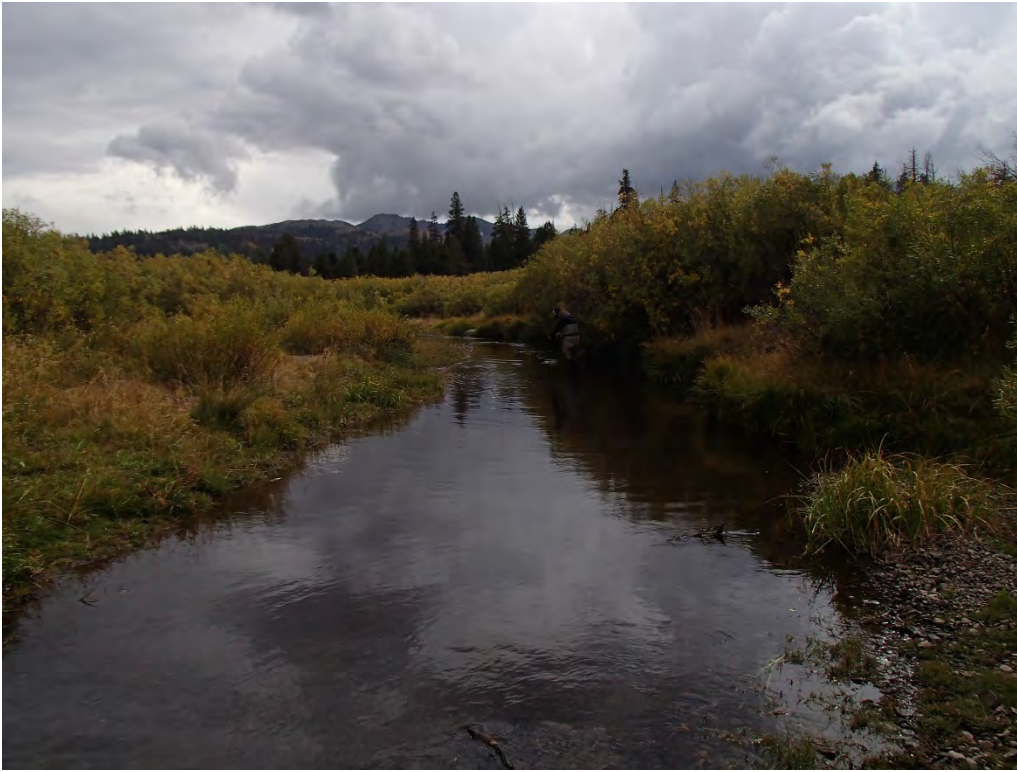
Figure 23. A tiny remnant of beaver dam (bottom right of photo) is all that remains, but the stabilizing effect on the stream banks and recruitment of vegetation remain after it has blown out. The longer these structures persist, the more resilient the habitat becomes. FM3, FTRF18.

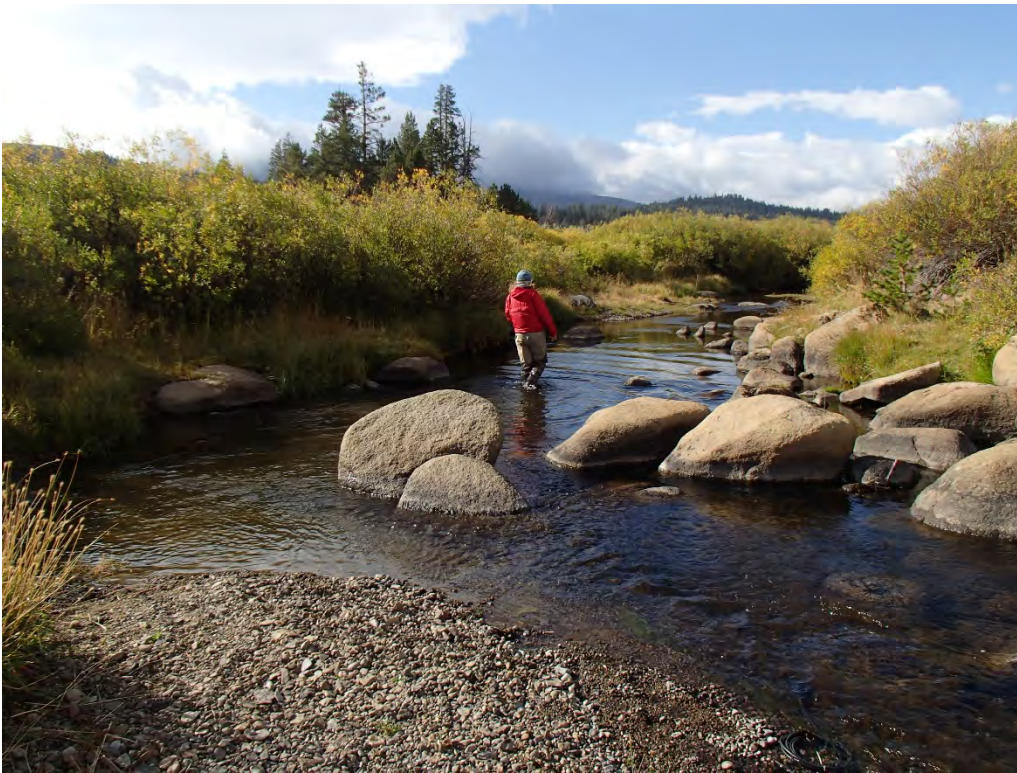
Figure 24. More glacial-origin boulders in the stream near a moraine. These boulders can also help stabilize the channel in some locations. FM3, SSMC27.

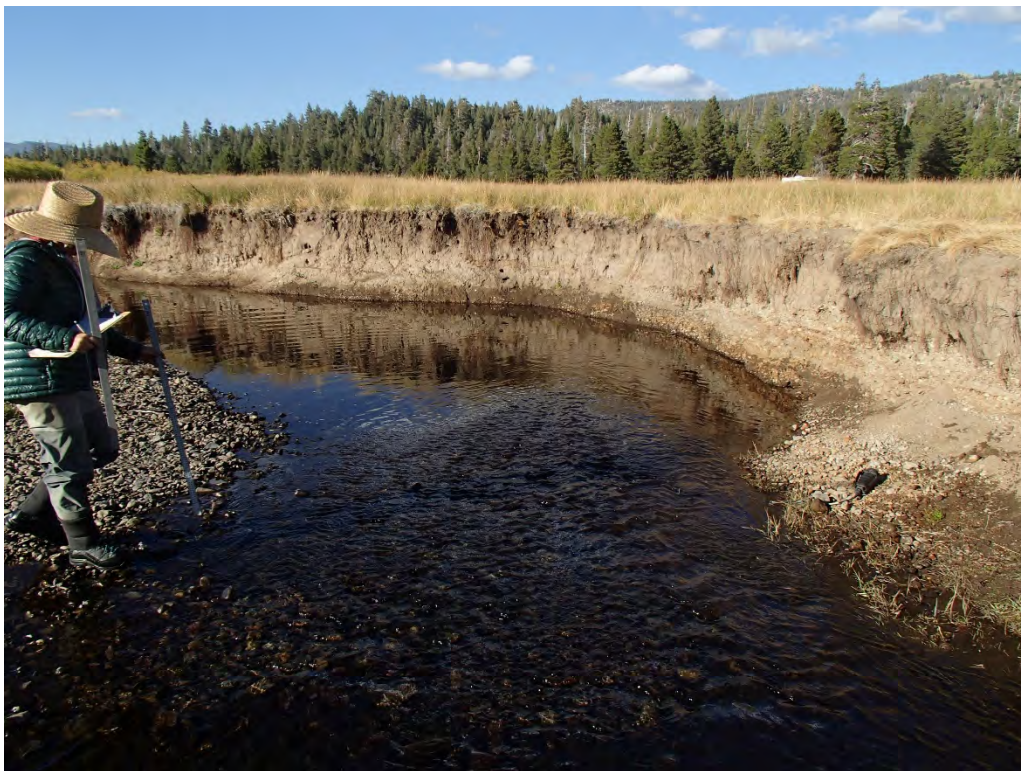
Figure 25. More eroding cutbanks with a disconnected floodplain. FM4, FTRF34.

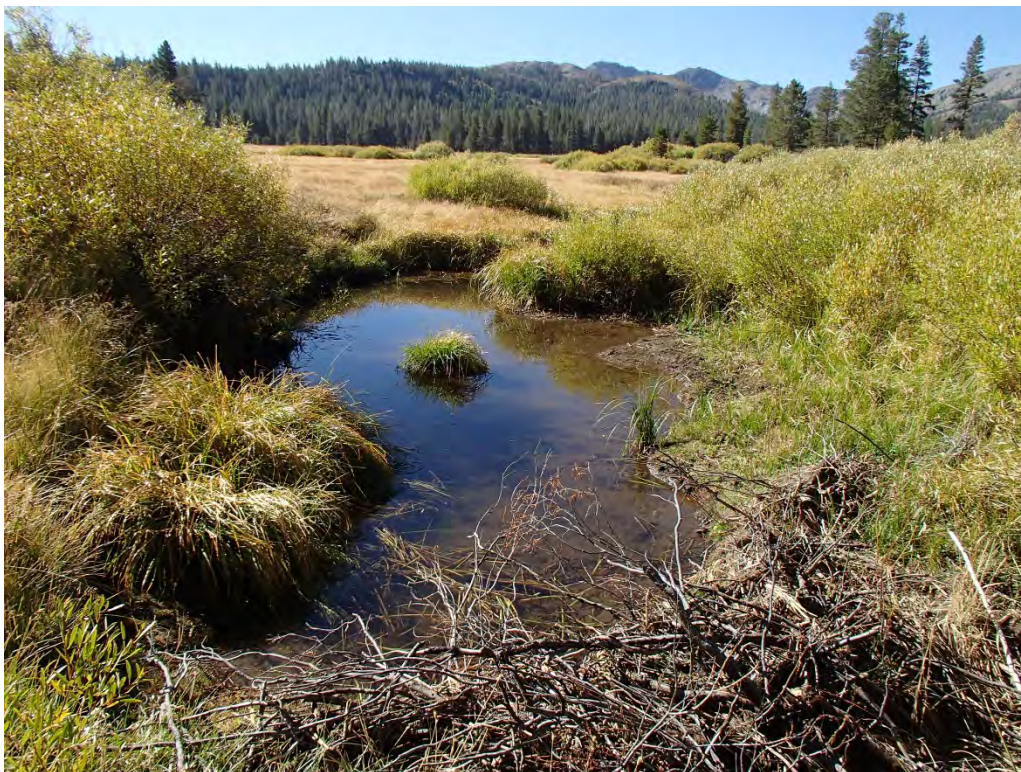
Figure 26. A small beaver dam on a tributary backs water up, encourages wet-meadow vegetation and accretes sediment. The floodplain near the top of the photo is more accessible than in many areas of Faith Valley and has dense sedge and active willow colonization. FM5. TRIB2.

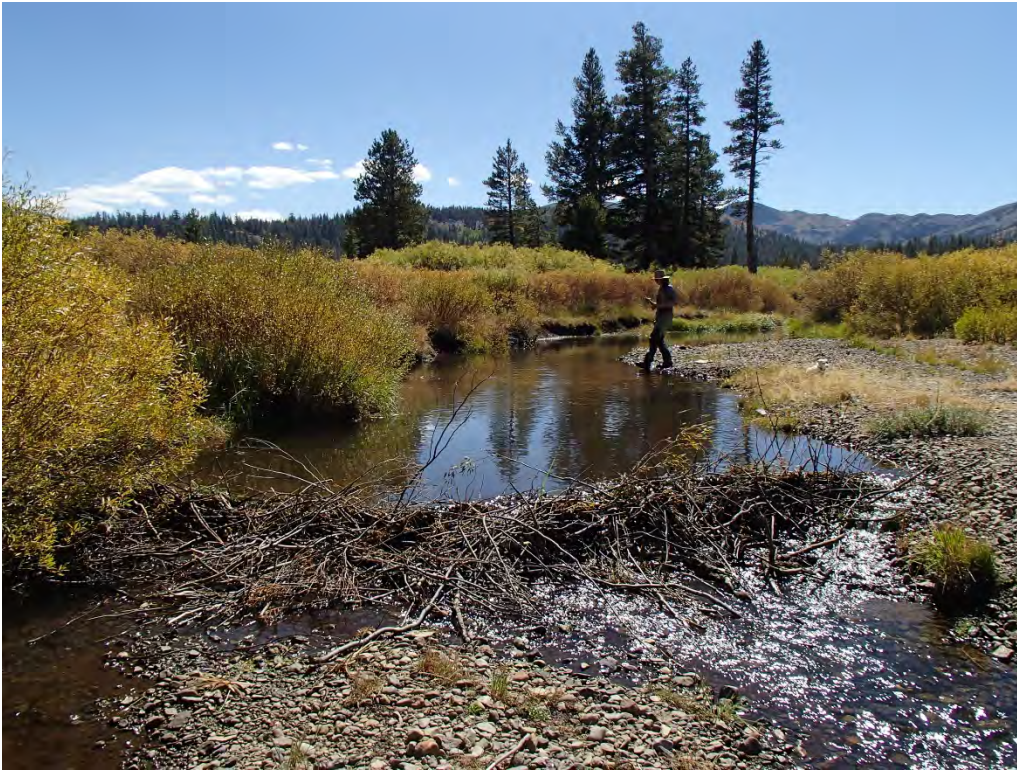
Figure 27. A small beaver dam on a side channel. There are many remnants of old dams in this area which have helped with reconnecting the floodplain and encouraging vegetation growth in this section. FM5, SIDES2.

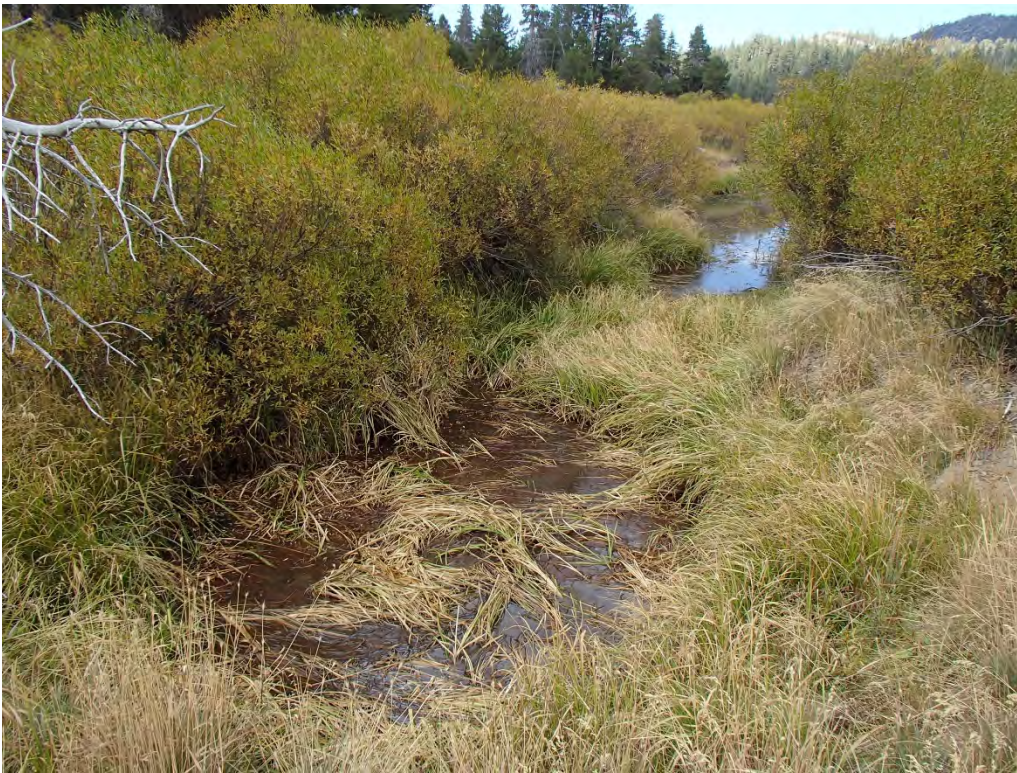
Figure 28. This side channel formed from a beaver larger beaver dam (partially intact) upstream. Beaver dams often increase channel complexity once the stream accesses the floodplain and a multi-thread channel is formed. FM5, SIDES3.

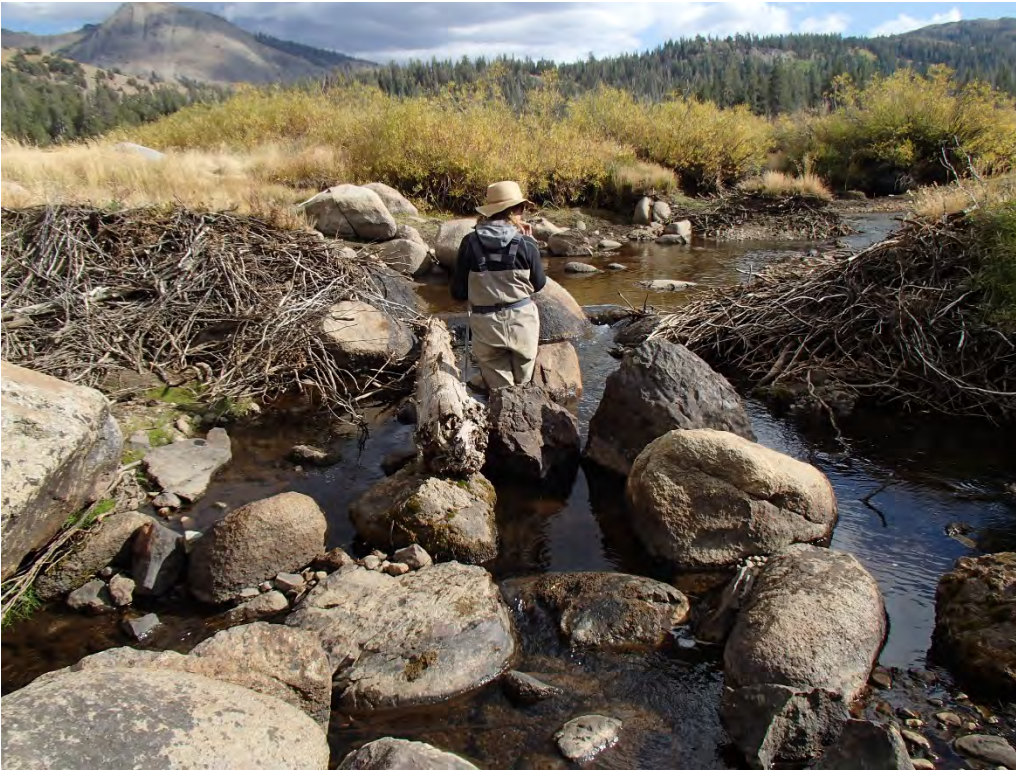
Figure 29. The center of this beaver dam failed but the sides along the stream banks remain intact. Though the water table is lowered again, the bank protecting benefits of the beaver dam still persist at this unit. FM5, FNRN48.

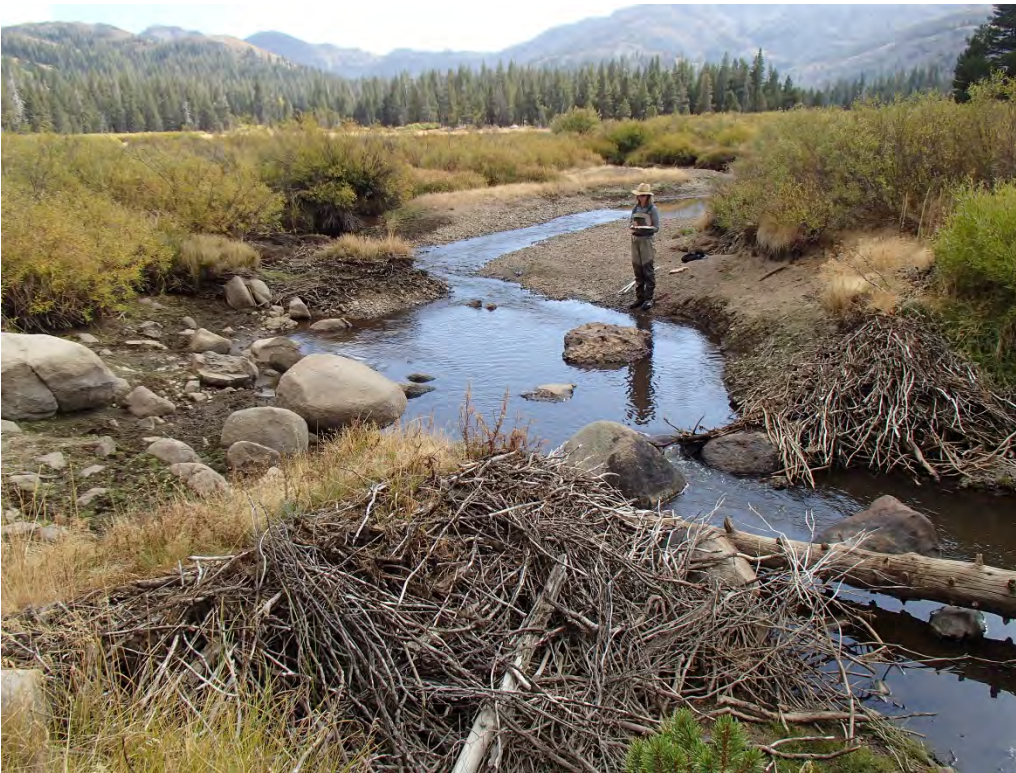
Figure 30. At this partially blown beaver dam, the habitat has shifted from dam pool to scour pool. Note the evidence of the former area of inundation and the bankfull indicator when the dam was intact. The water table has dropped and headcuts occur where tributaries enter the stream. FM5, SSMC48.

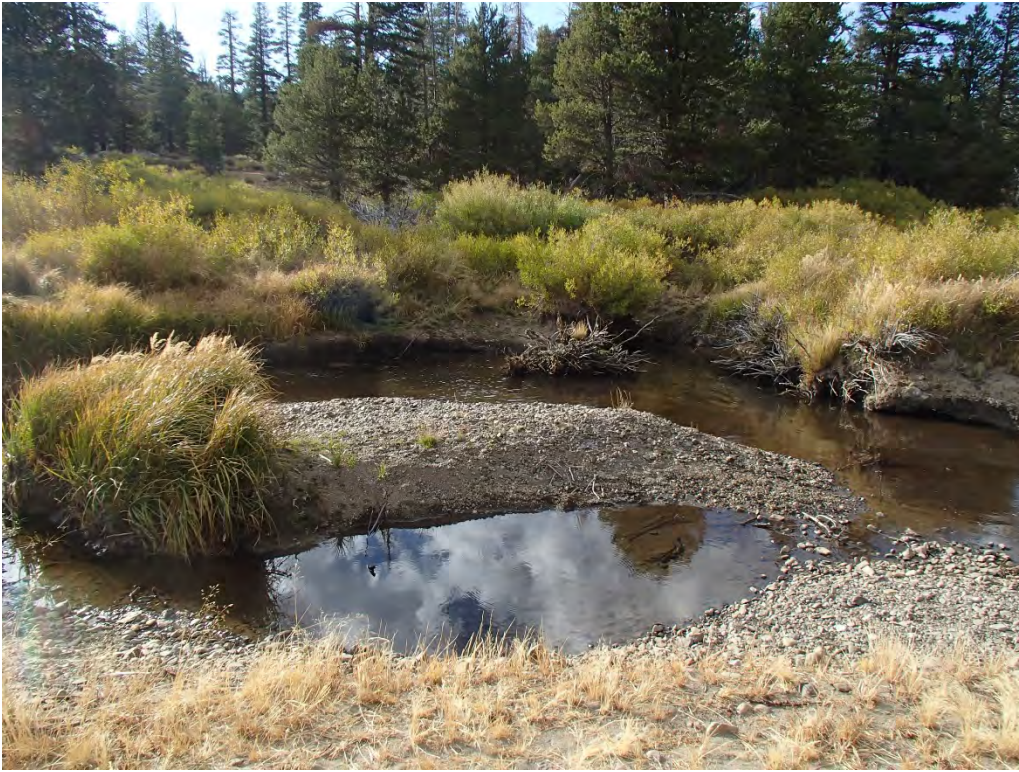
Figure 31. After the downstream beaver dam failed, more stream channel and bare sediments are exposed and the stream channel becomes re-entrenched. FM6, SSLS49.

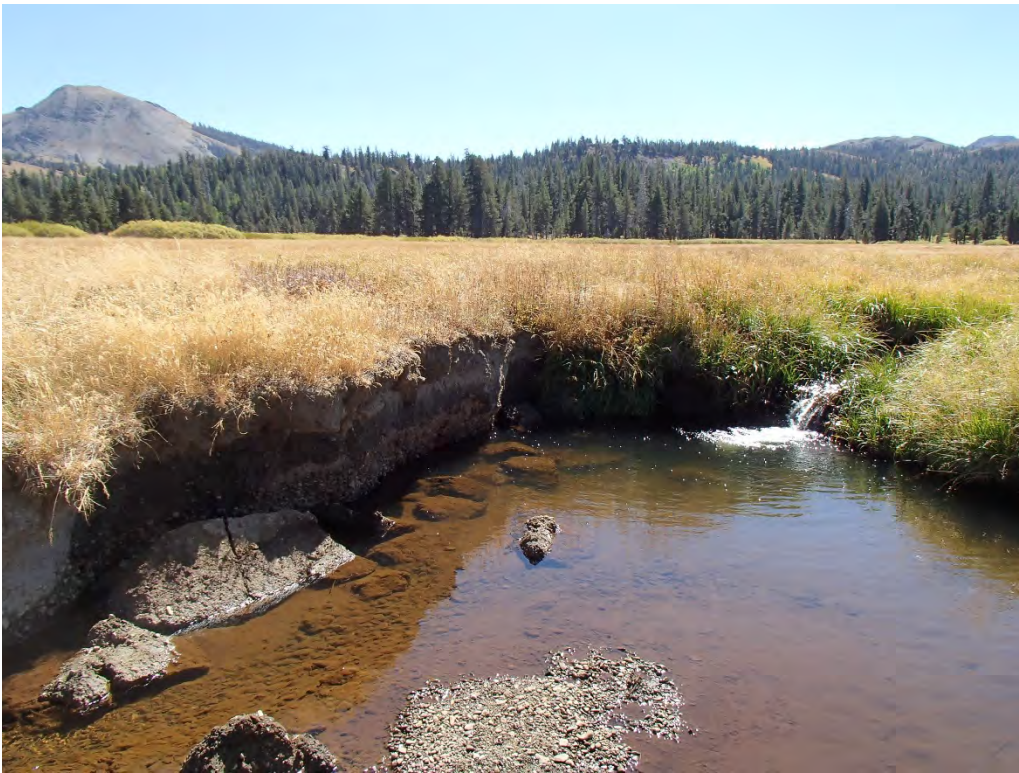
Figure 32. A headcut moves up a side channel after the downstream beaver dam failed. This side channel was formed by the large beaver dam above with a multiple-thread channel coming down. FM6, SIDEF2.

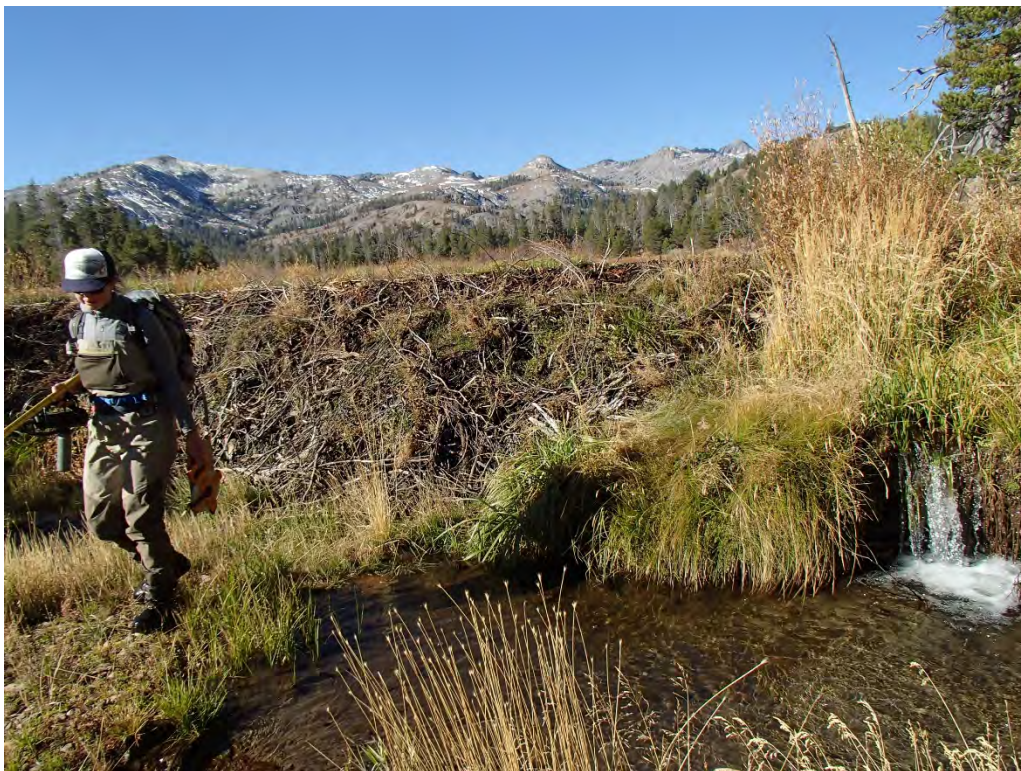
Figure 33. This enormous, channel spanning beaver dam has exerted a huge amount of influence on the stream and floodplain in this section of Faith Valley Meadow. FM7, SDBV55.

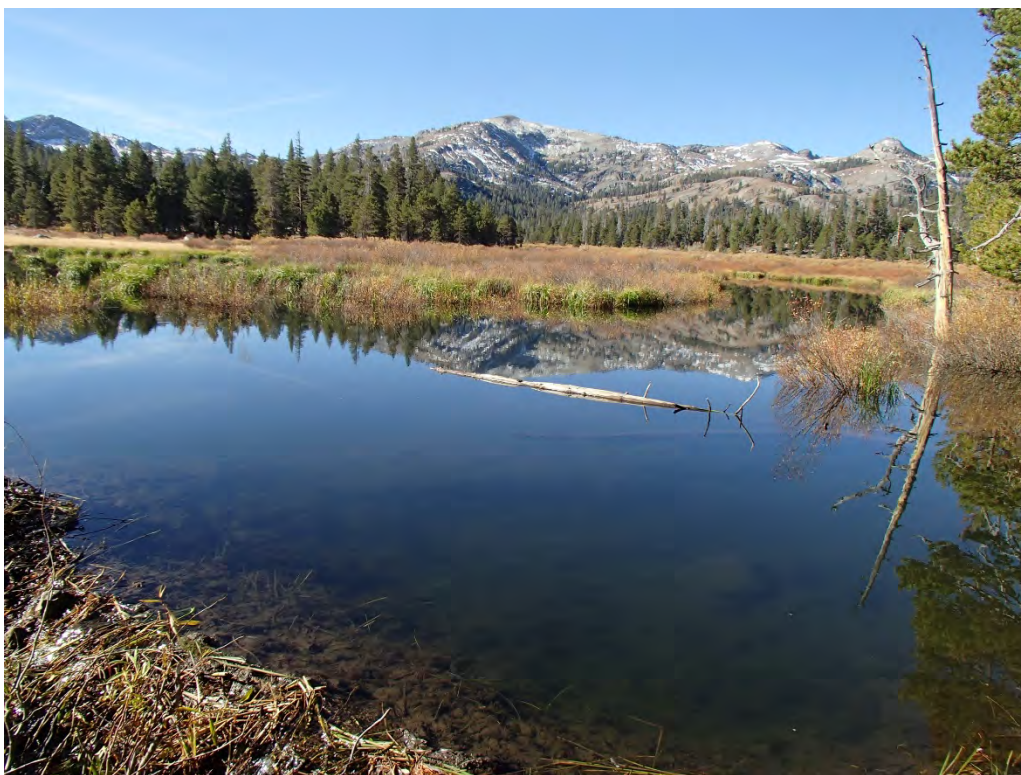
Figure 34. A peek into the large dam pool at FM7, SDBV55. Note the emergent sedge marsh and dead conifers.

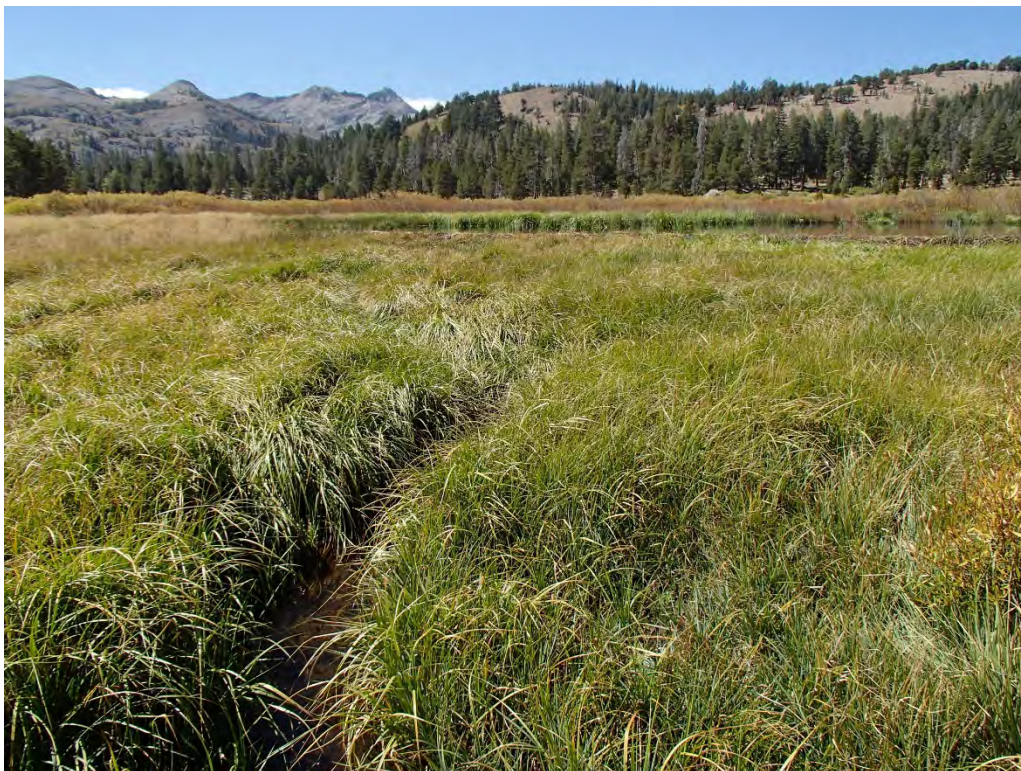
Figure 35. The large beaver dam at SDBV55 has created an area of inundation of ~16,000 square meters. The vegetation response to saturated soils is very positive. This type of habitat is excellent rearing habitat for juvenile fishes, has tremendous primary and secondary production, and is contributing to ground water recharge. It also provides velocity refuge for all fishes during high flow events. This dam failed in winter 2017. FM7, SDBV55.
