Faith Meadow Baseline Stream Habitat Condition Inventory and Assessment

West Fork Carson River, Alpine County, California

Prepared by Sabra Purdy, Trout Unlimited, 2018

Report Commissioned by American Rivers from a Grant from the National Fish and Wildlife Foundation

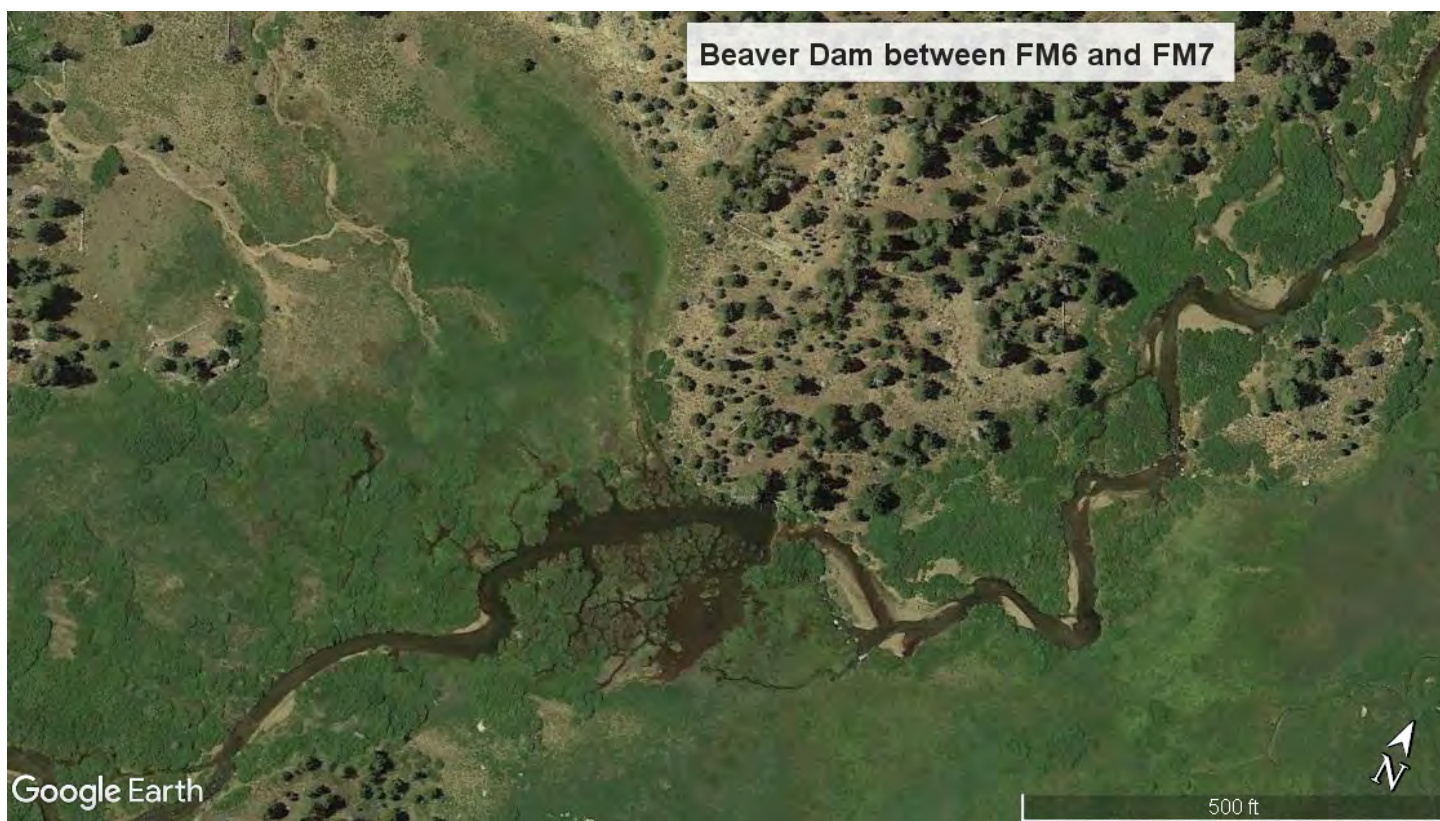
Figure 36. Aerial imagery of the large beaver dam that divides FM6 and FM7. The area of inundation is quite large, continuing on the northwest side all the way to the tan colored moraine area.

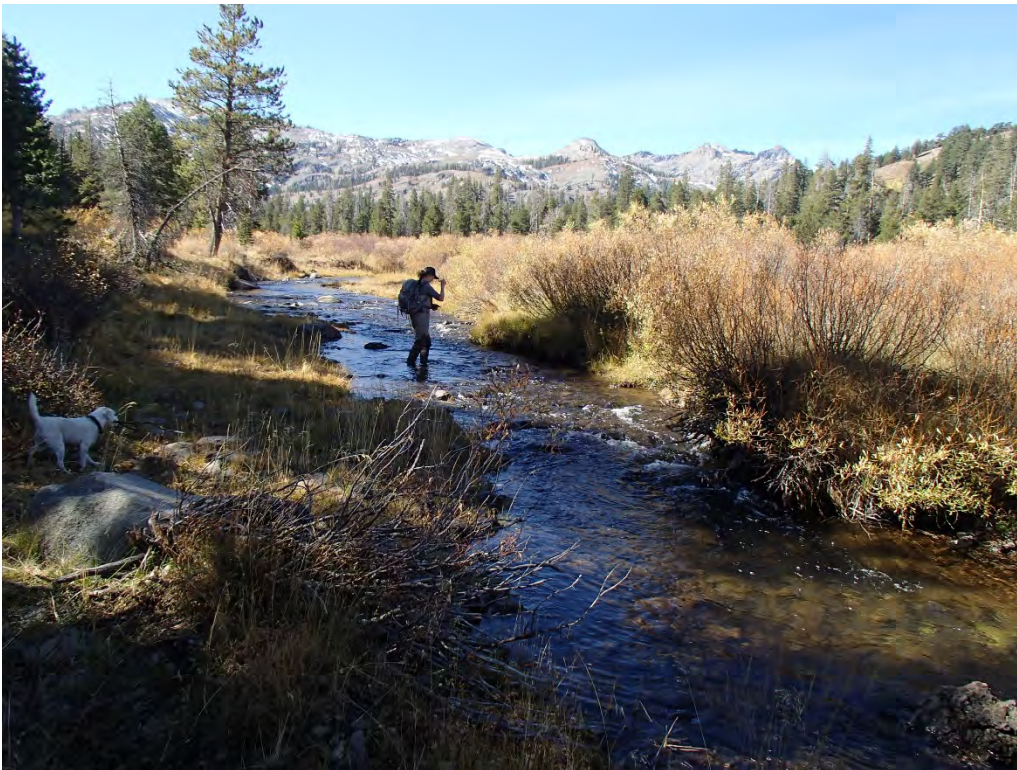
Figure 38. Upstream of SDBV55, the character of the stream changes noticeably. Note the larger substrate size, decreased height between bankfull and the floodplain, and very healthy riparian willow forests. Larger-sized substrate is less vulnerable to erosion than smaller substrate. Additionally, meadows typically become incised and eroded from downstream to upstream (headcutting), thus the upstream reaches are often less entrenched than the downstream reaches. FM7, FTRF54.

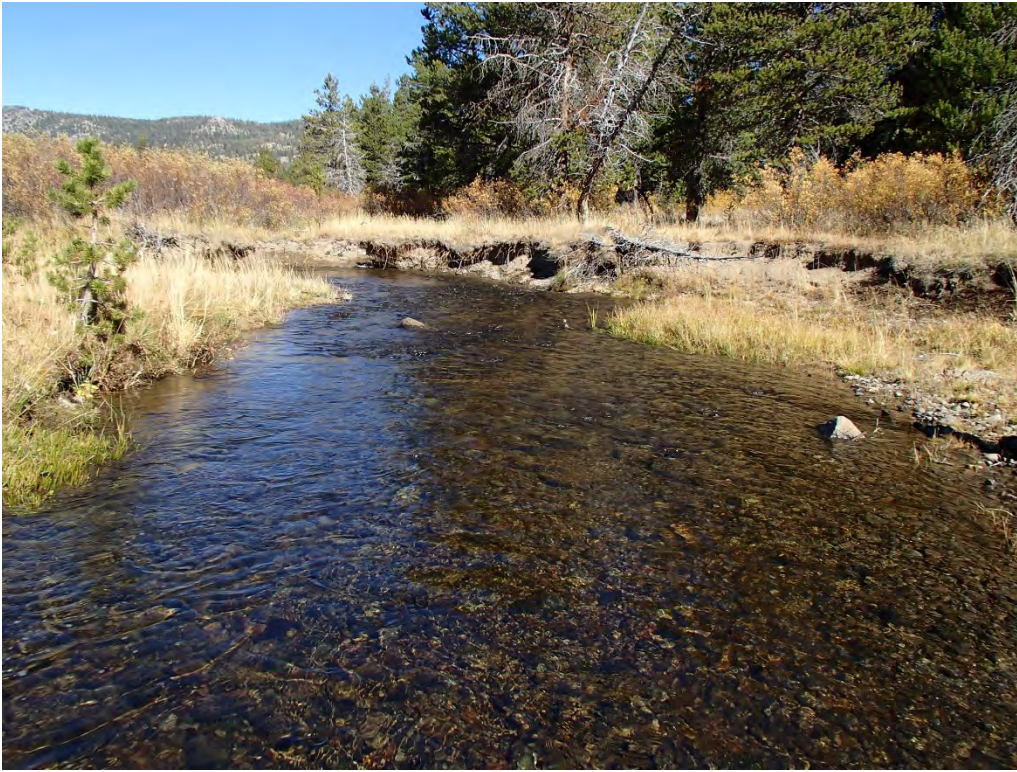
Figure 39. While erosion is generally less in FM7 than in the other reaches, the stream still shows legacy impacts (likely from grazing) and has inset floodplain development. Conifers here show the location of the nearby moraine. FM7, FTRF58.

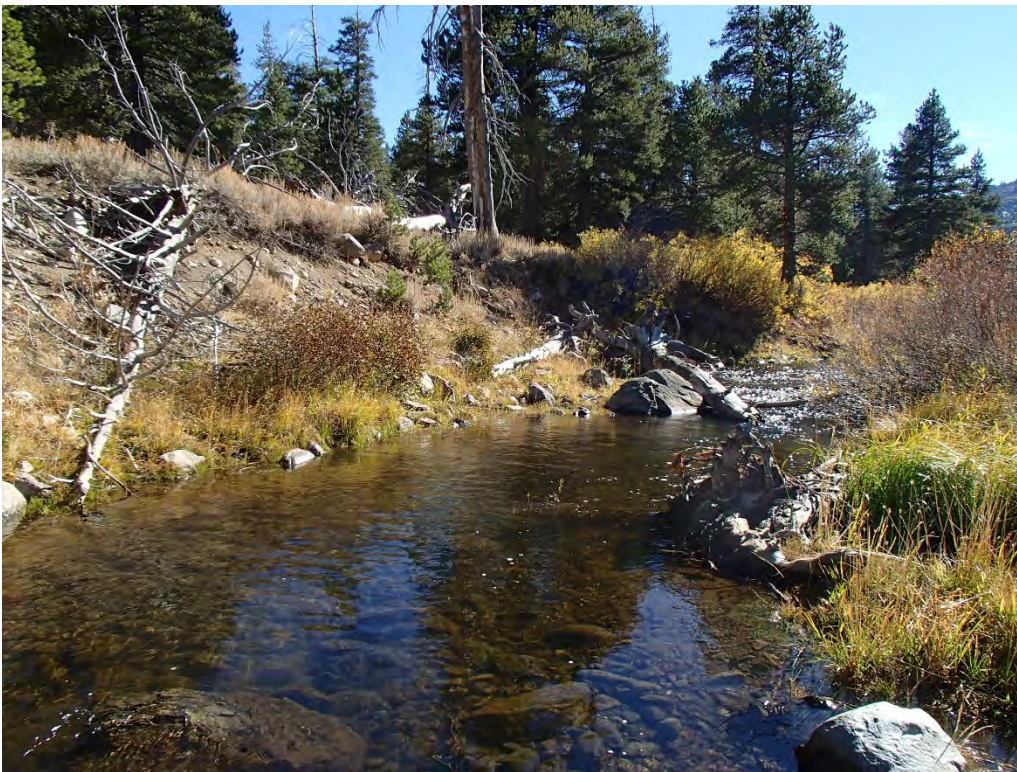
Figure 40. In some locations, the stream actually cuts into the moraine creating a taller cutbank and potentially creating more erosion than in other areas. This is not an indication of increased impact, it is simply part the geomorphological process near moraines. Note the larger glacial boulders in the stream as well. The stream does not appear to be actively eroding the right bank here (see the willow and sedge colonization) but this zone is vulnerable to erosion in high flow events. FM7, SSMC63.

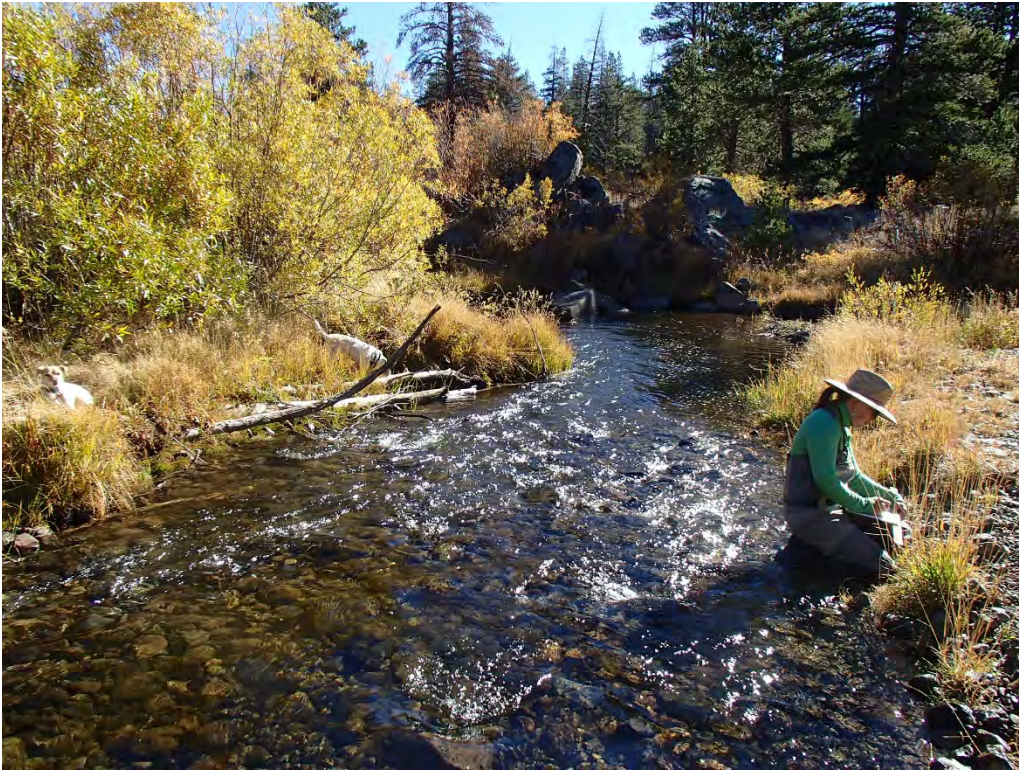
Figure 41. The riparian zone becomes more forested, and less meadow-like in upper FM7. Note the substrate dominated by cobble rather than gravel. FM7, FTRF64.

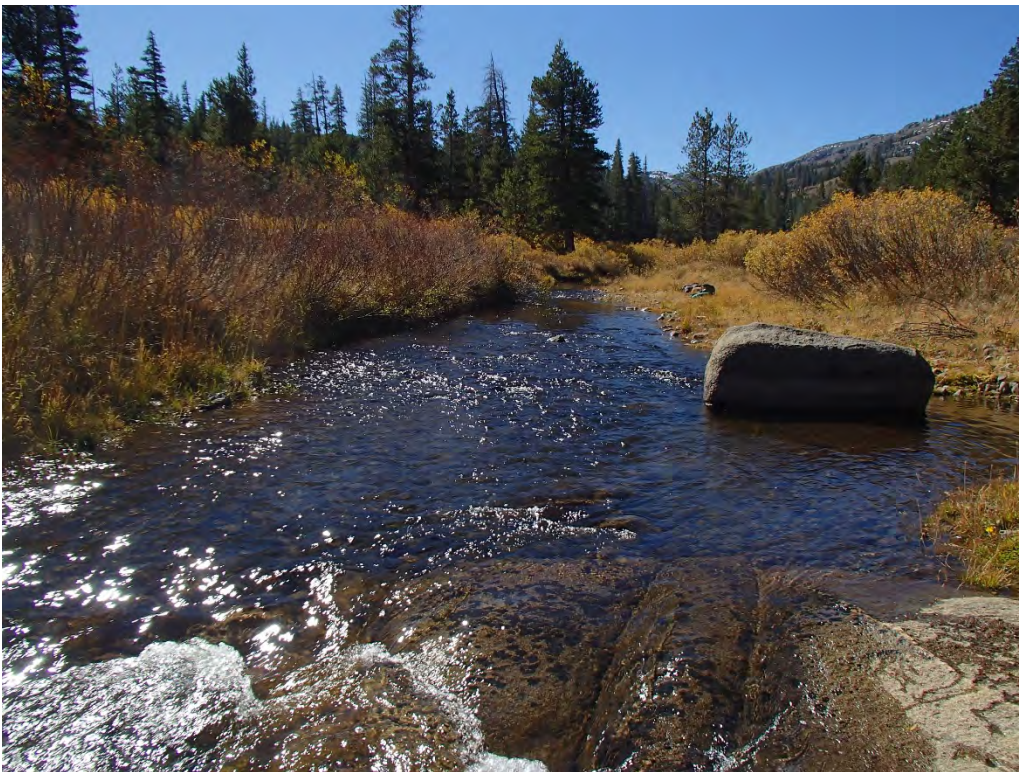
Figure 42. Near the top of FM7, bedrock emerges from the stream bed. The forest is closer to the stream margins on both sides of the channel. Entrenchment is minimal and the floodplain is easily accessed by the stream. Immediately upstream from here there is a series of open willow shrubfields punctuated by close forest zones.
