# Faith Valley Meadow

Post-Restoration Treatment Stream Condition Inventory 2024

Prepared by: Sabra Purdy and Trout Unlimited on Behalf of American Rivers

February 15<sup>th</sup>, 2025

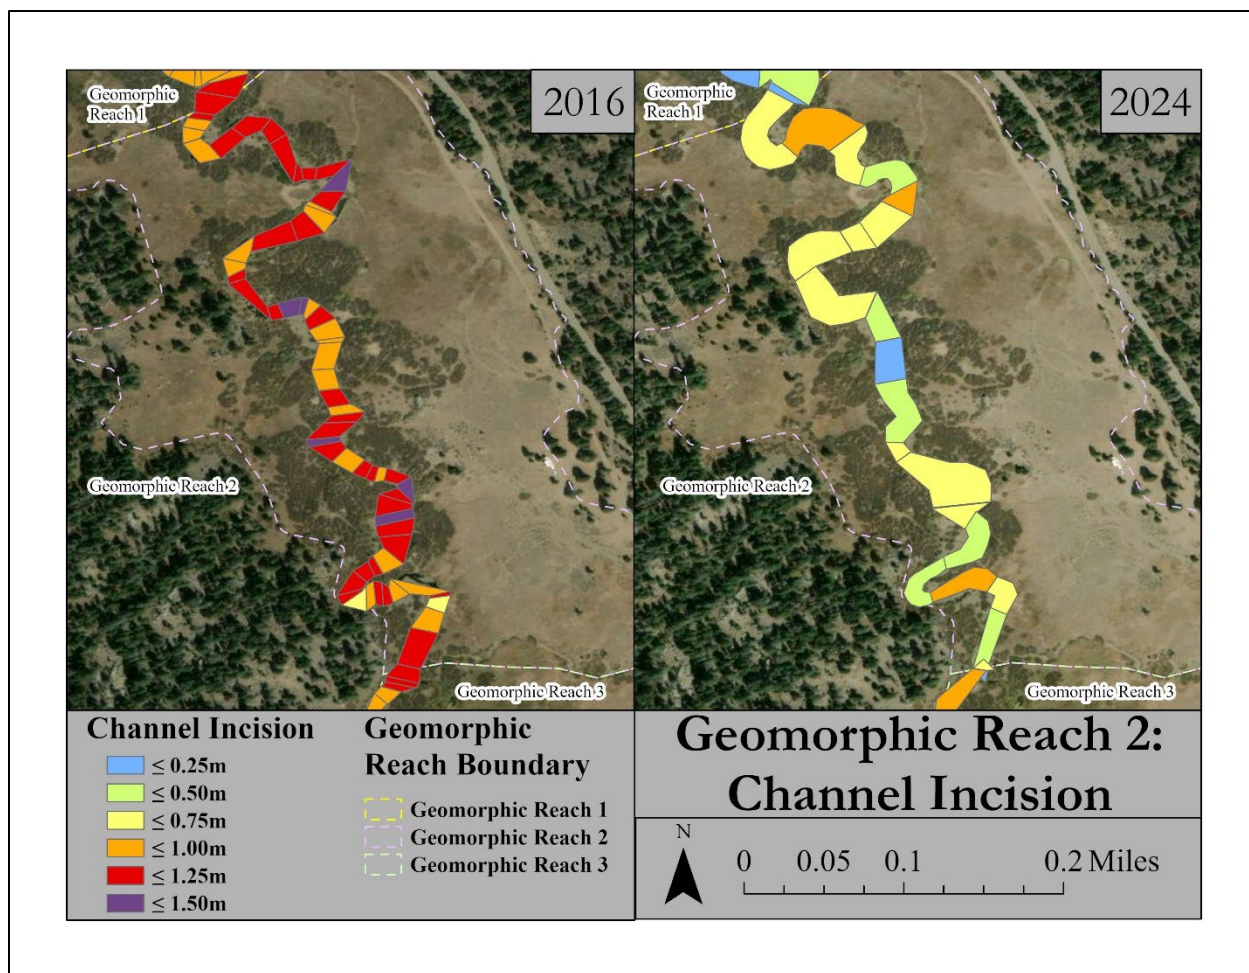
Figure 7. Detail of Channel Incision changes in Geomorphic Reach 2 pre-and post-restoration treatment. The decreases in entrenchment below the historic floodplain are significant throughout the treatment area. The channel widened and wetted area also expanded in this reach post-treatment. Detail maps for the entire project area and other geomorphic reaches are in the appendix.

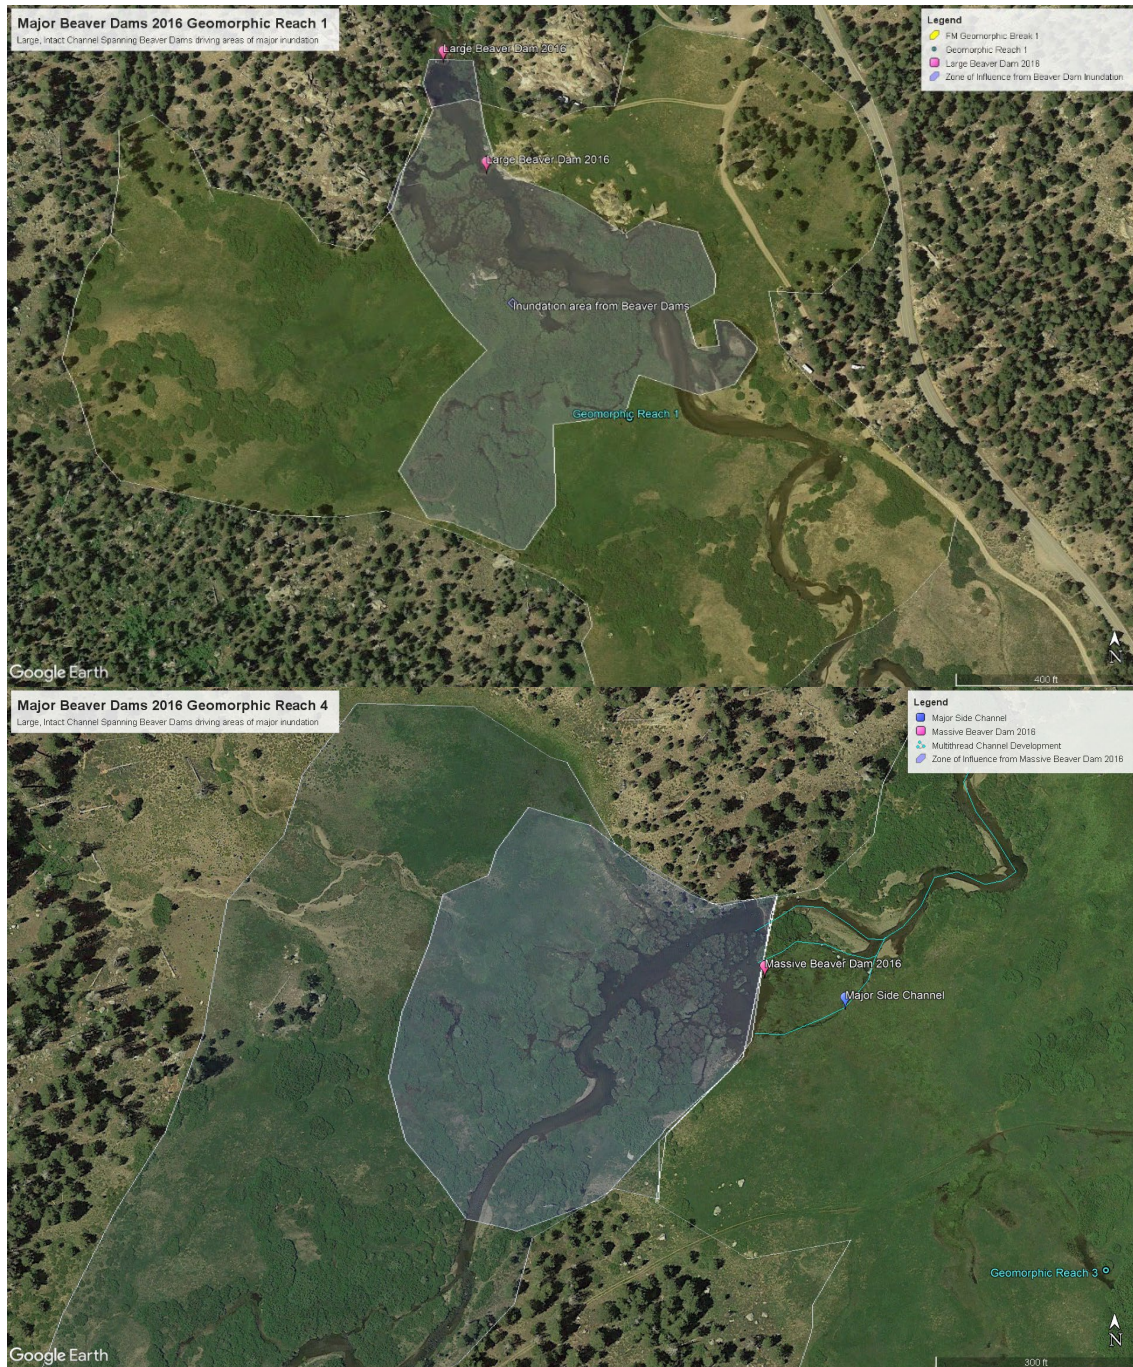
Figure 10. Major beaver dams present in 2016 that breached in the following winter dramatically altering the habitat and areas of inundation. The lower 2 beaver dams in Geomorphic Reach 1 inundated an area of ~ 9.75 acres with the large dam at Geomorphic Reach 4 inundating ~ 5.5 acres. The impacts to groundwater tables extended even further. These inundated areas were significantly reduced after the breaches and the channel became confined again. This is the reference condition for full floodplain connectivity in Faith Valley and represents Stage 0 conditions in the Stream Evolution Model.

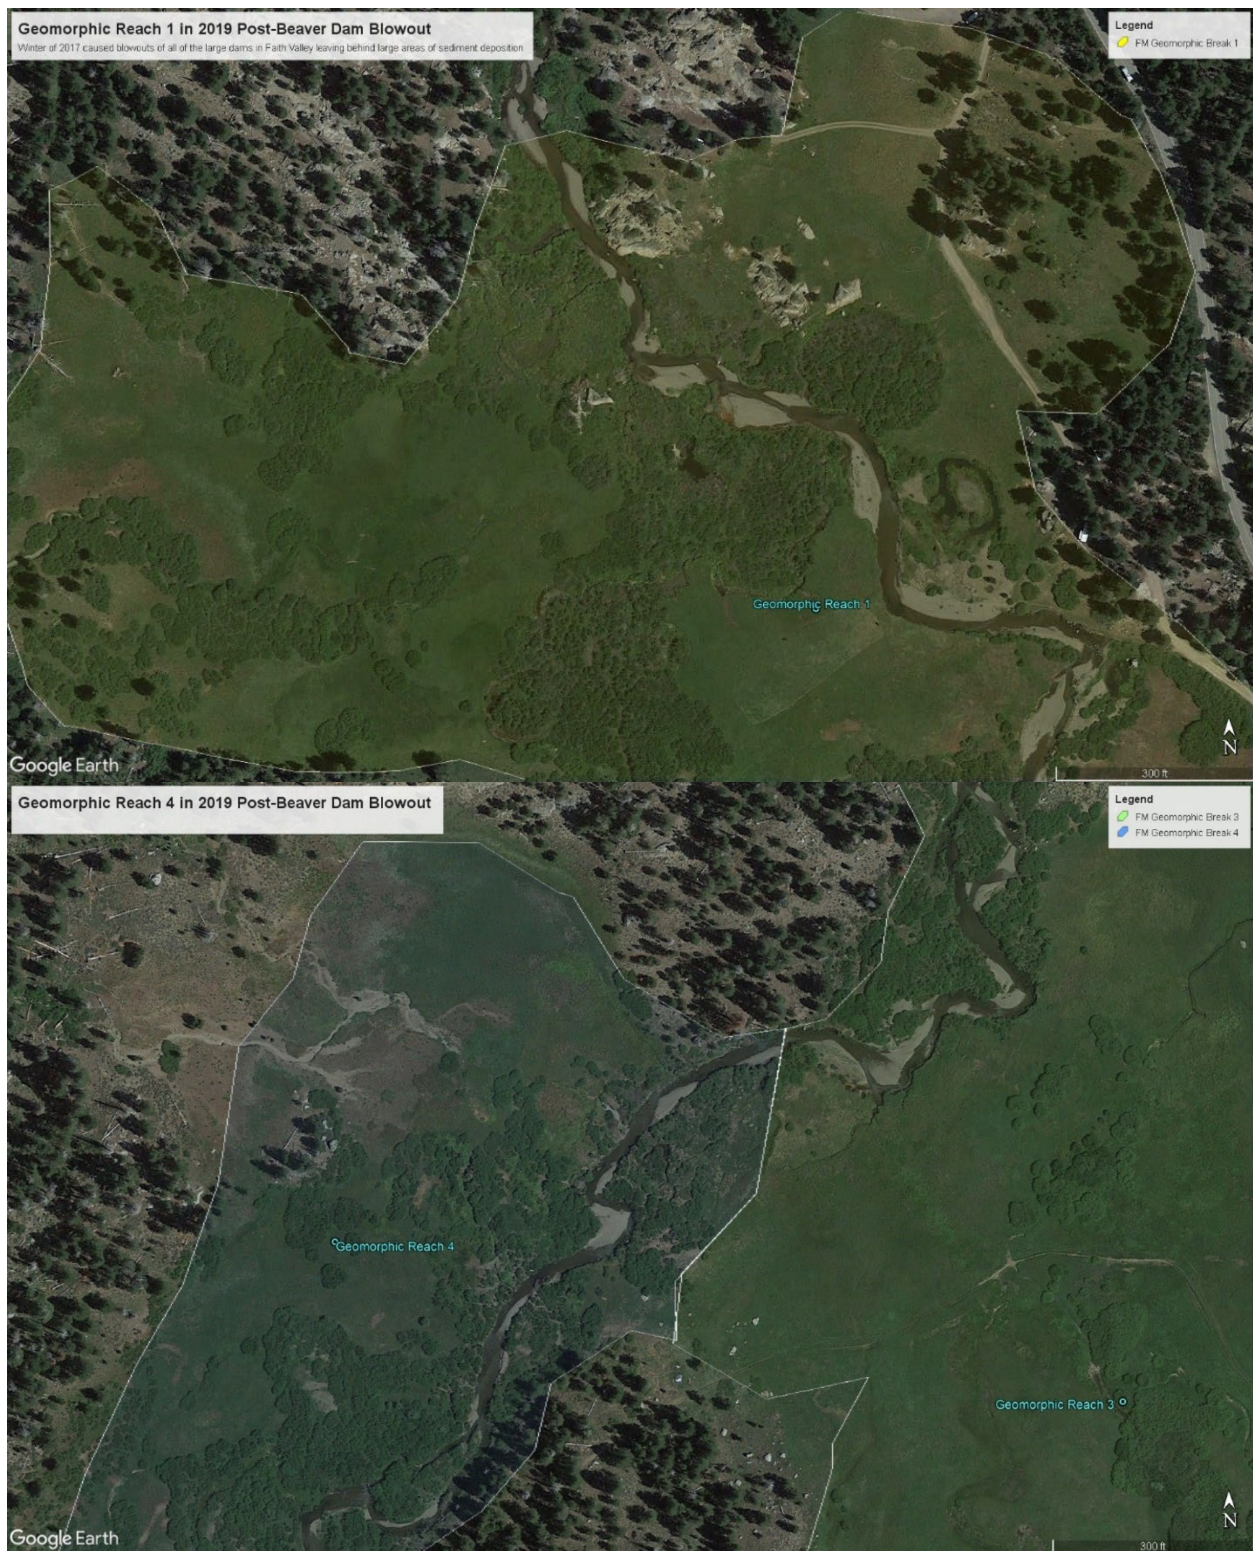
Figure 11. The same reaches as depicted in figure 10 after the heavy flows in 2017 completely breached all of the large beaver dams in Faith Valley. Note the reduction of inundated areas and large areas of fresh sediment deposition exposed and redeposited by the blowout. This is a return to Stage 5-7 in the Stream Evolution Model.

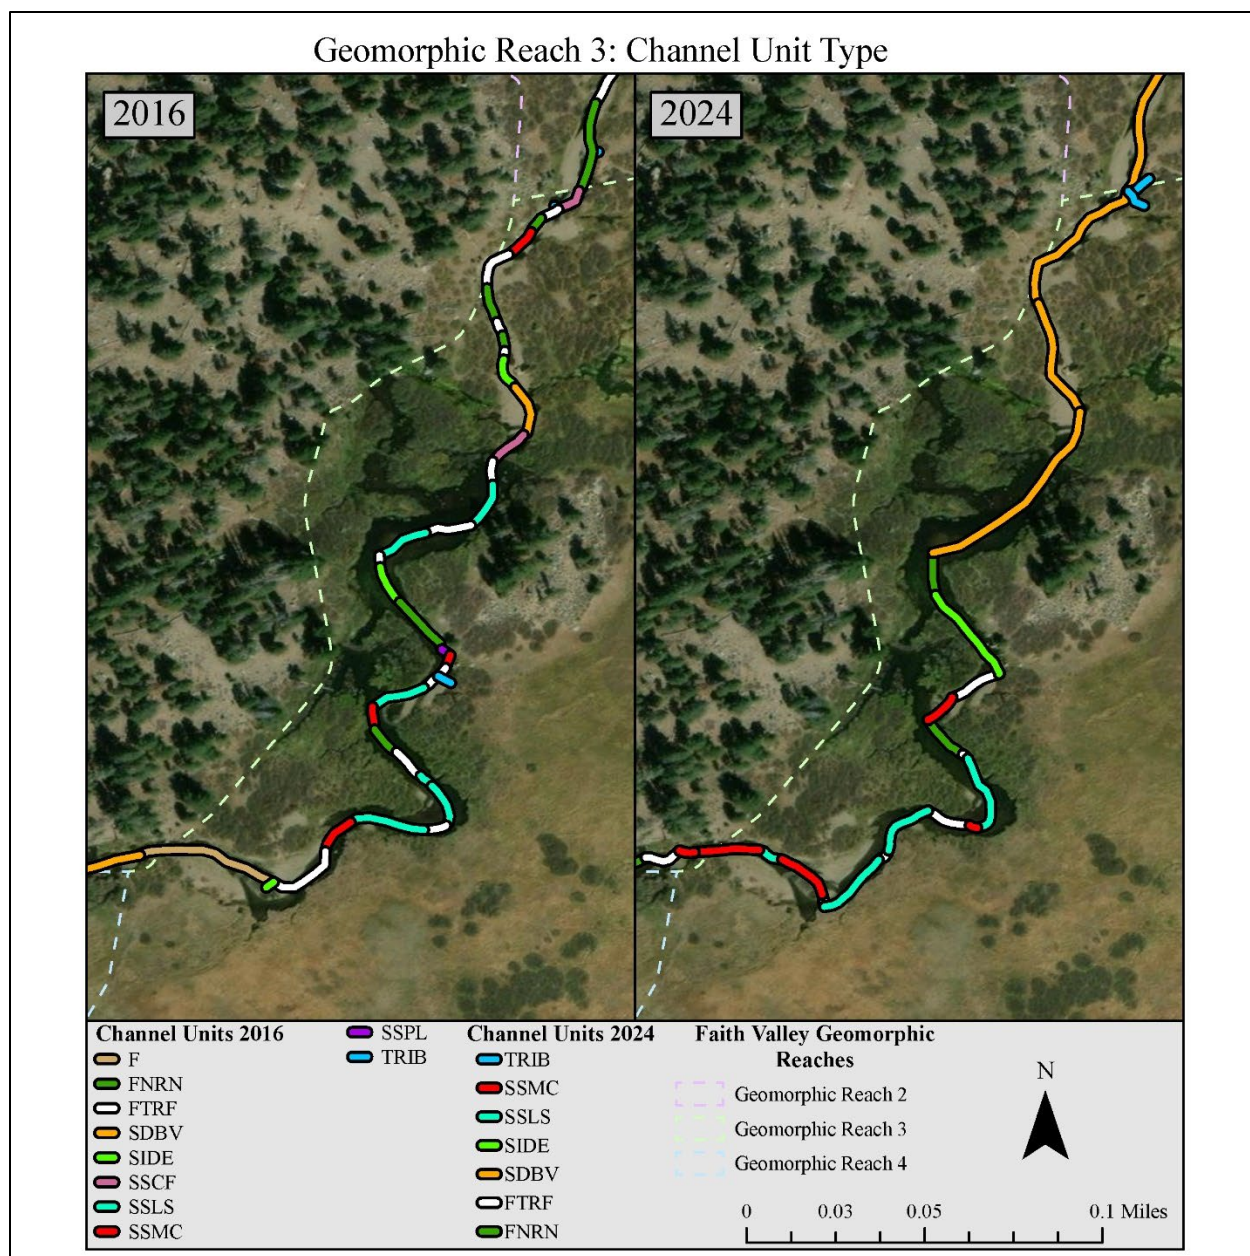
Figure 14. Detail of Geomorphic Reach 3 Channel Units in 2016 vs. 2024. The lower end of GM3 contained several BDA structures whereas the natural beaver dams present in 2016 at the upstream end were breached leaving behind scour pools in 2024. Sediment rearrangement and scour following a beaver dam breach completely reworks the instream channel habitats.

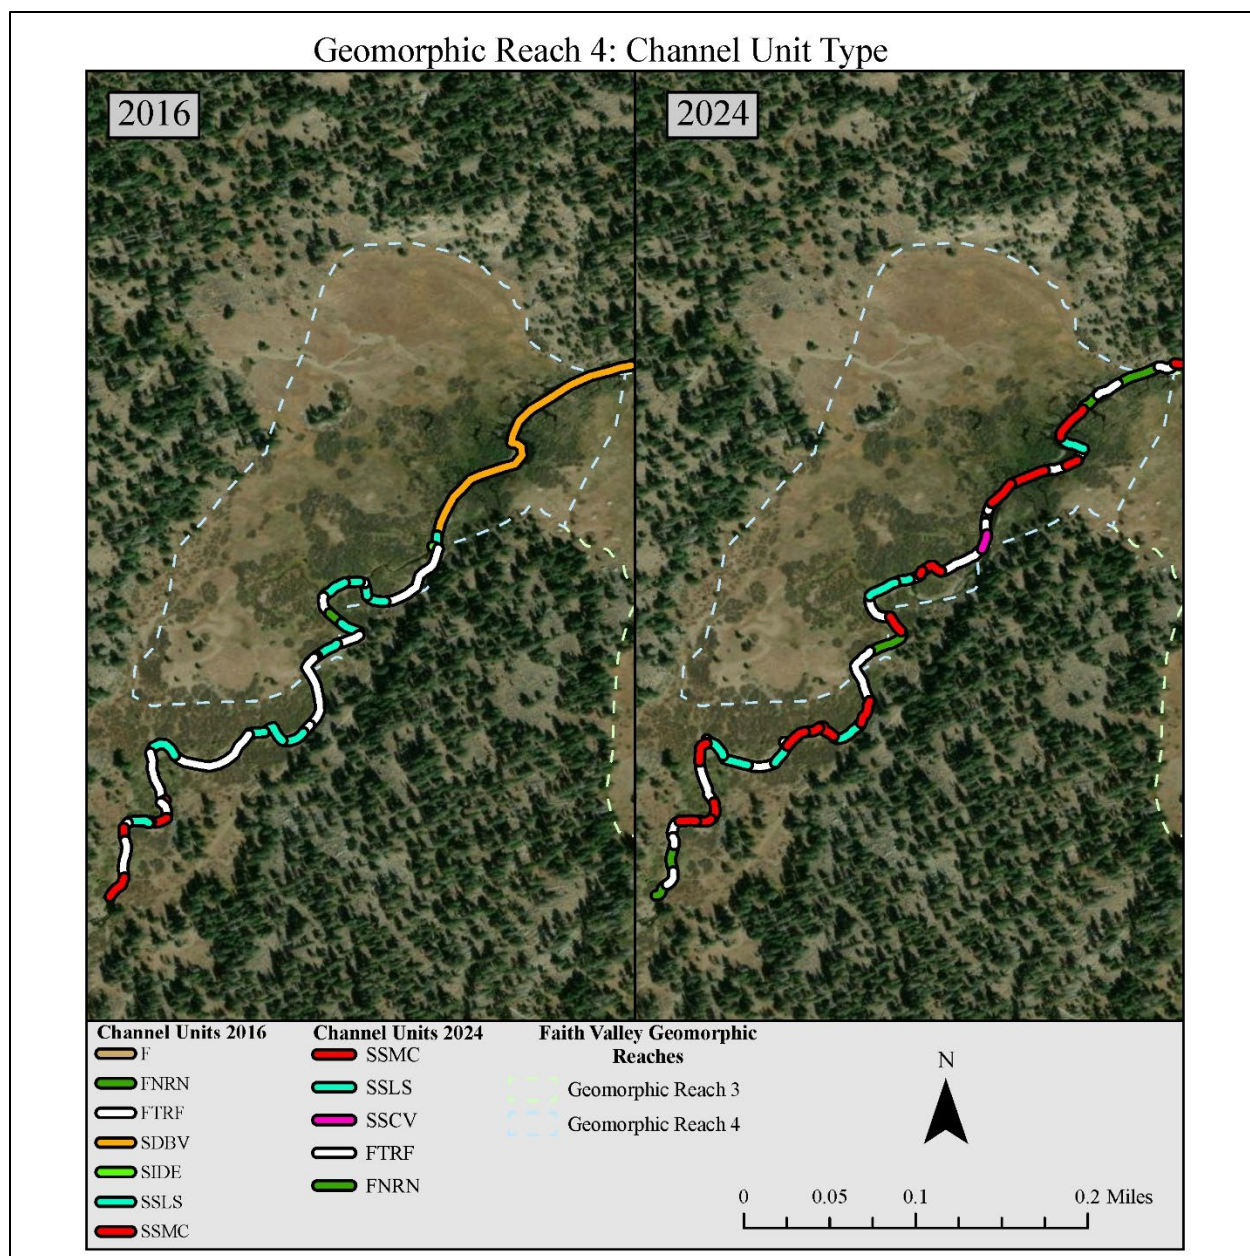
Figure 15. Detail of Geomorphic Reach 4 Channel Units in 2016 vs. 2024. Note the large beaver dam pool present at the downstream end of GM4 in 2016 that breached in 2017 and became many smaller habitat units following the loss of the dam.

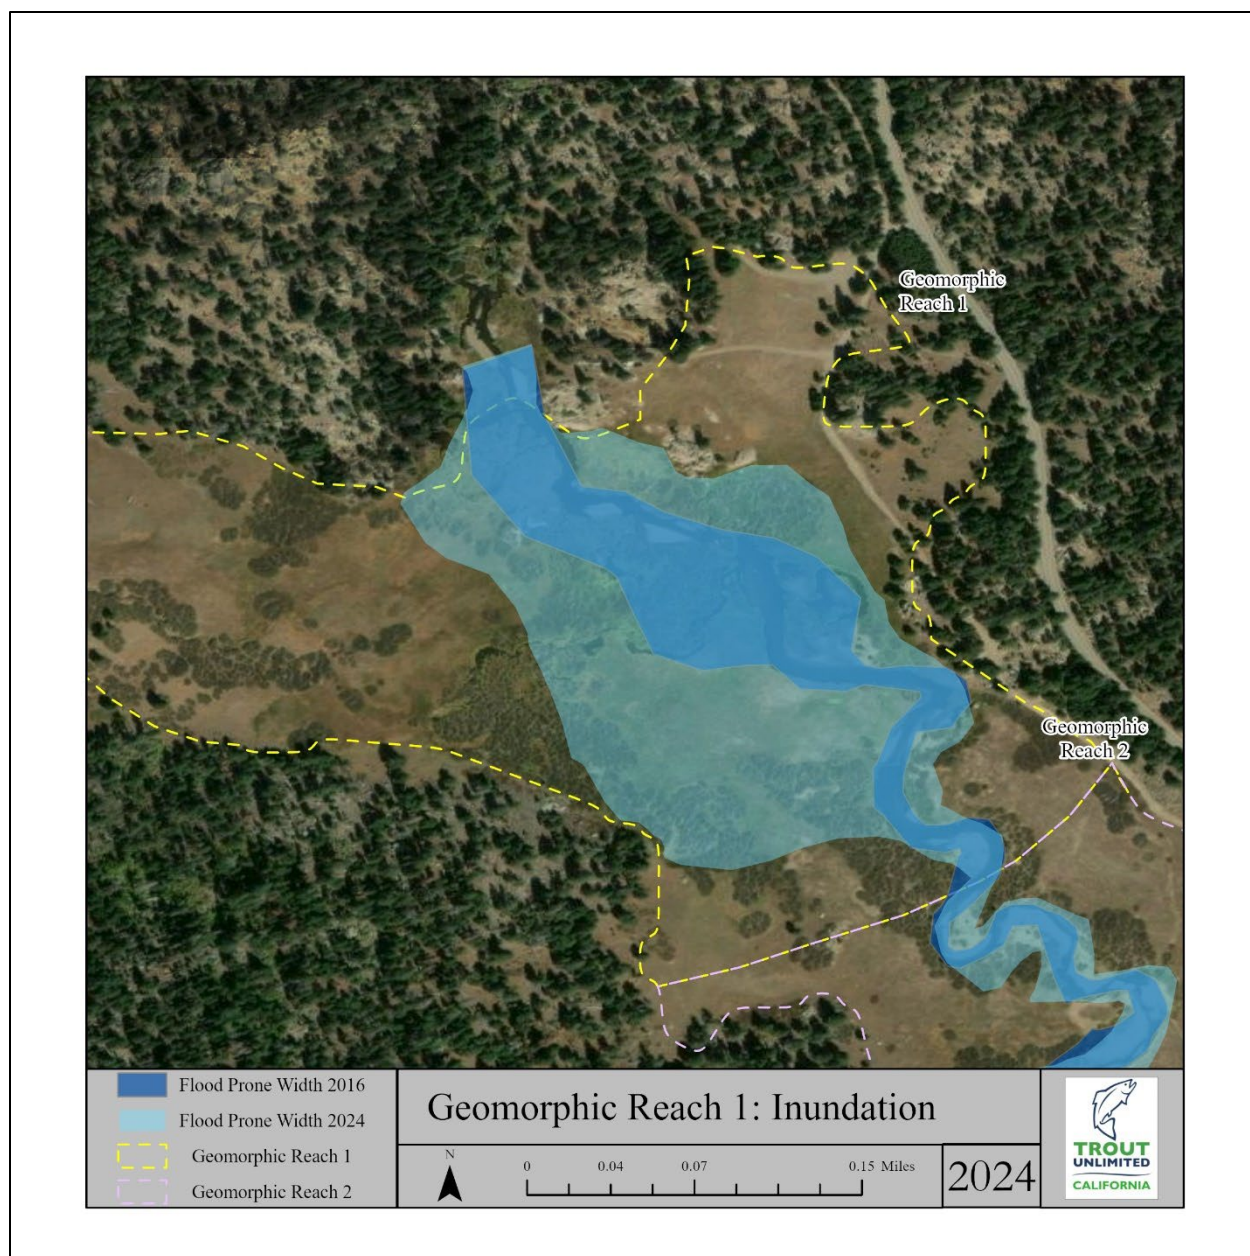
Figure 17. Detail of Geomorphic Reach 1 Inundation Areas and Flood Prone Widths in 2016 vs. 2024. Note the increase in inundation potential in 2024. This was due to increased floodplain connectivity from the structures near the top of GM1 that allowed water to spill into the valley bottom at lower flows than in 2016.

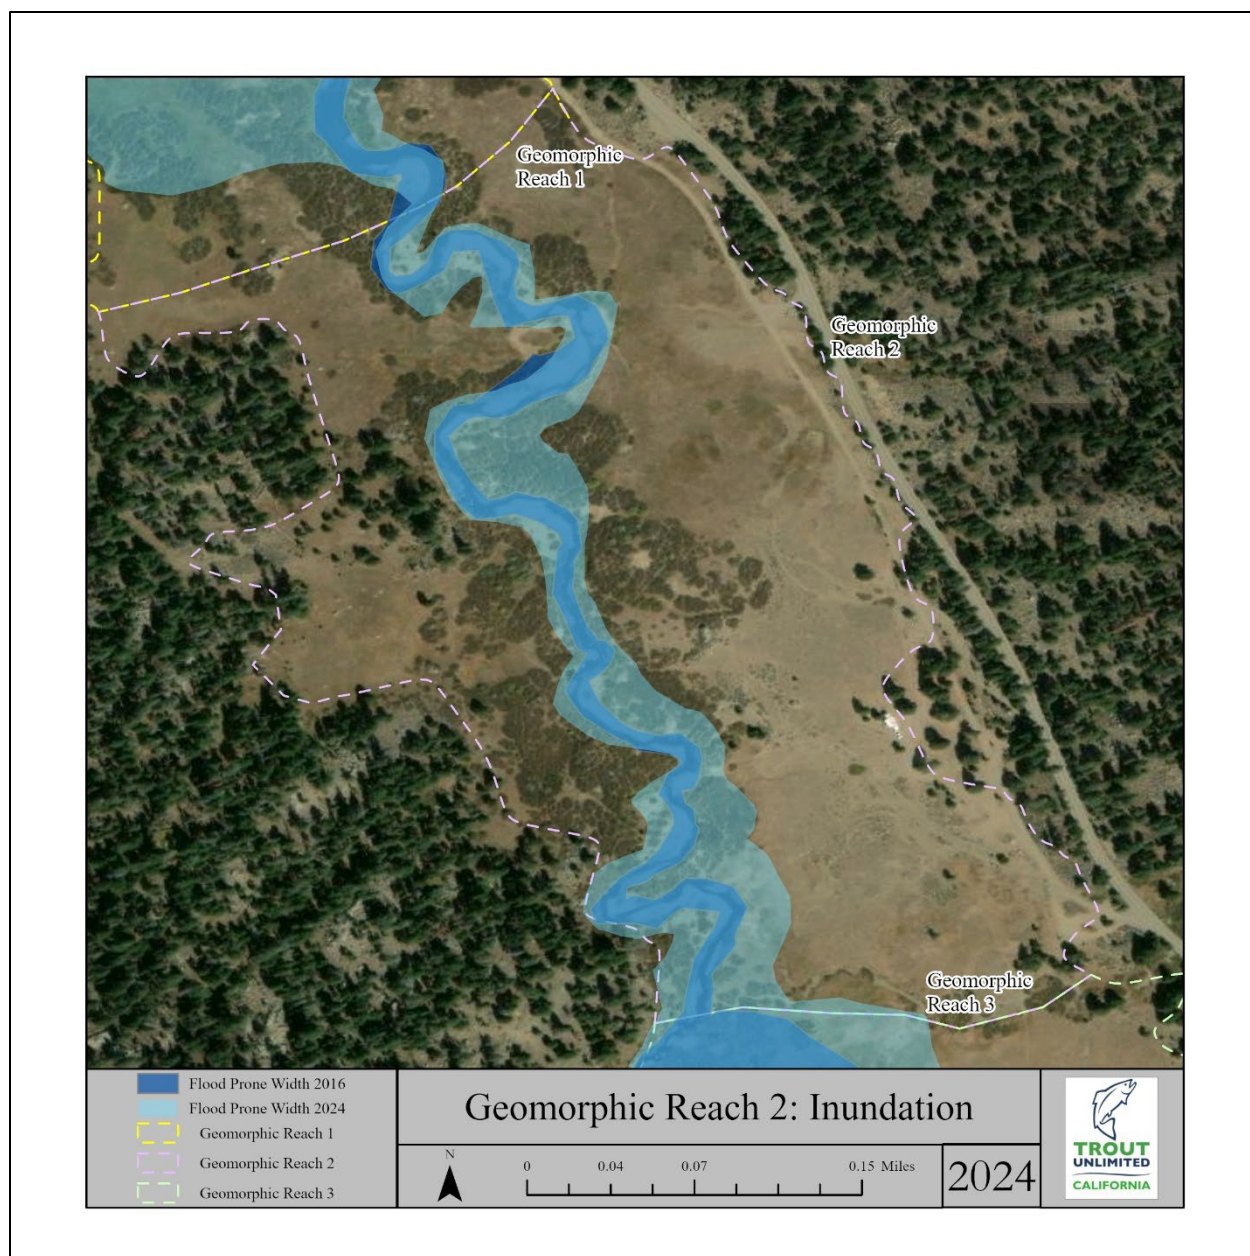
Figure 18. Detail of Geomorphic Reach 2 Inundation Areas and Flood Prone Widths in 2016 vs. 2024. Floodplain connectivity was improved by the implementation of Beaver Dam Analogs in what was the most entrenched portion of the channel in Faith Valley. While it remains entrenched, the treatment set the reach on a trajectory of aggradation and better floodplain connectivity. Subsequent treatments over time coupled with beaver activity on top of BDAs could allow this reach to fully re-aggrade to the historic floodplain.

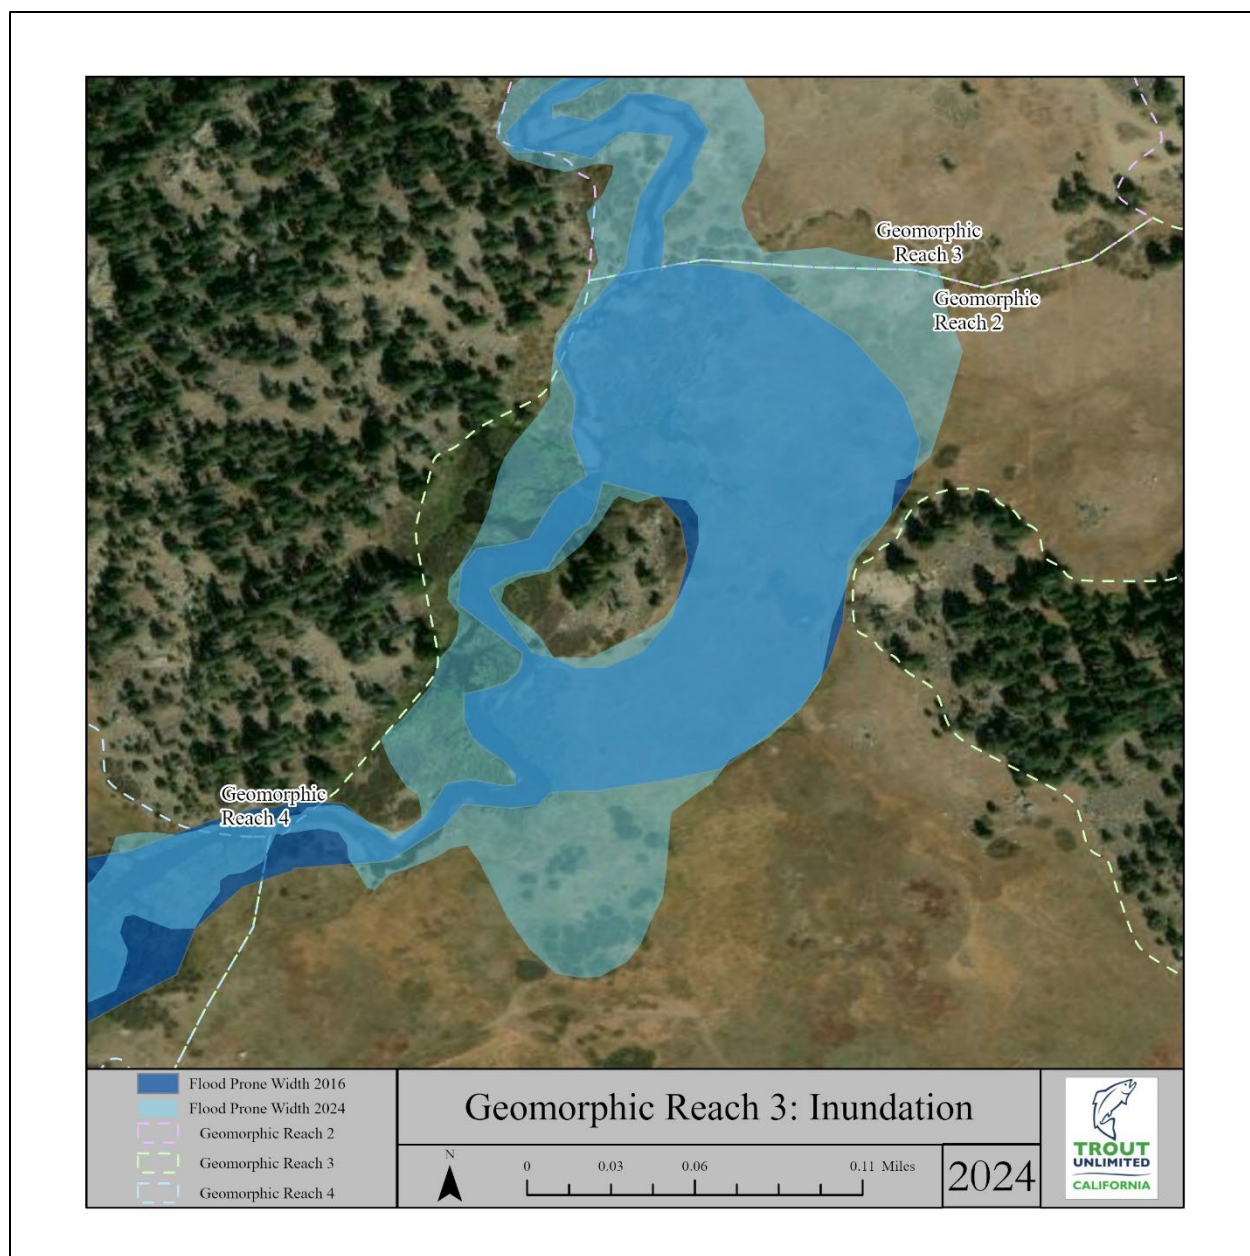
Figure 19. Detail of Geomorphic Reach 3 Inundation Areas and Flood Prone Widths in 2016 vs. 2024. Tributary channels and floodplains throughout this area are well connected and flood frequently. The mainstem has historically been very dynamic as beaver dams are built and are subsequently breached in high flow events. The upstream end of GM3 has not received any restoration treatment.

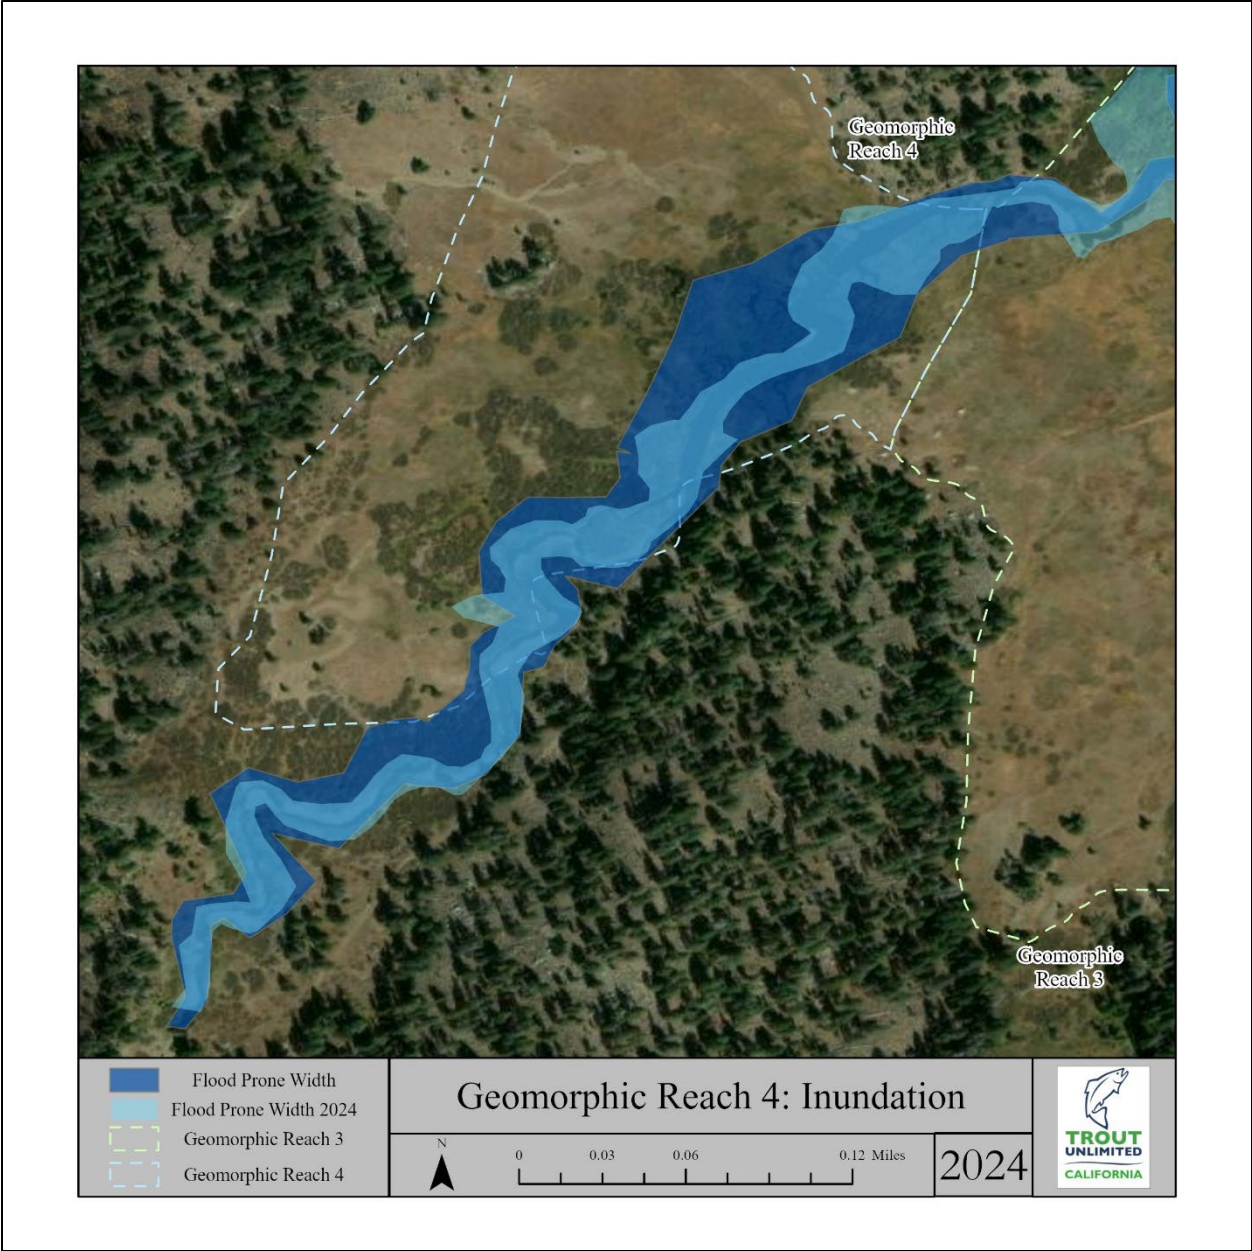
Figure 20. Detail of Geomorphic Reach 4 Inundation Areas and Flood Prone Widths in 2016 vs. 2024. Note that the flood prone width decreased in this reach following the breach of the large dam that was present in 2016.

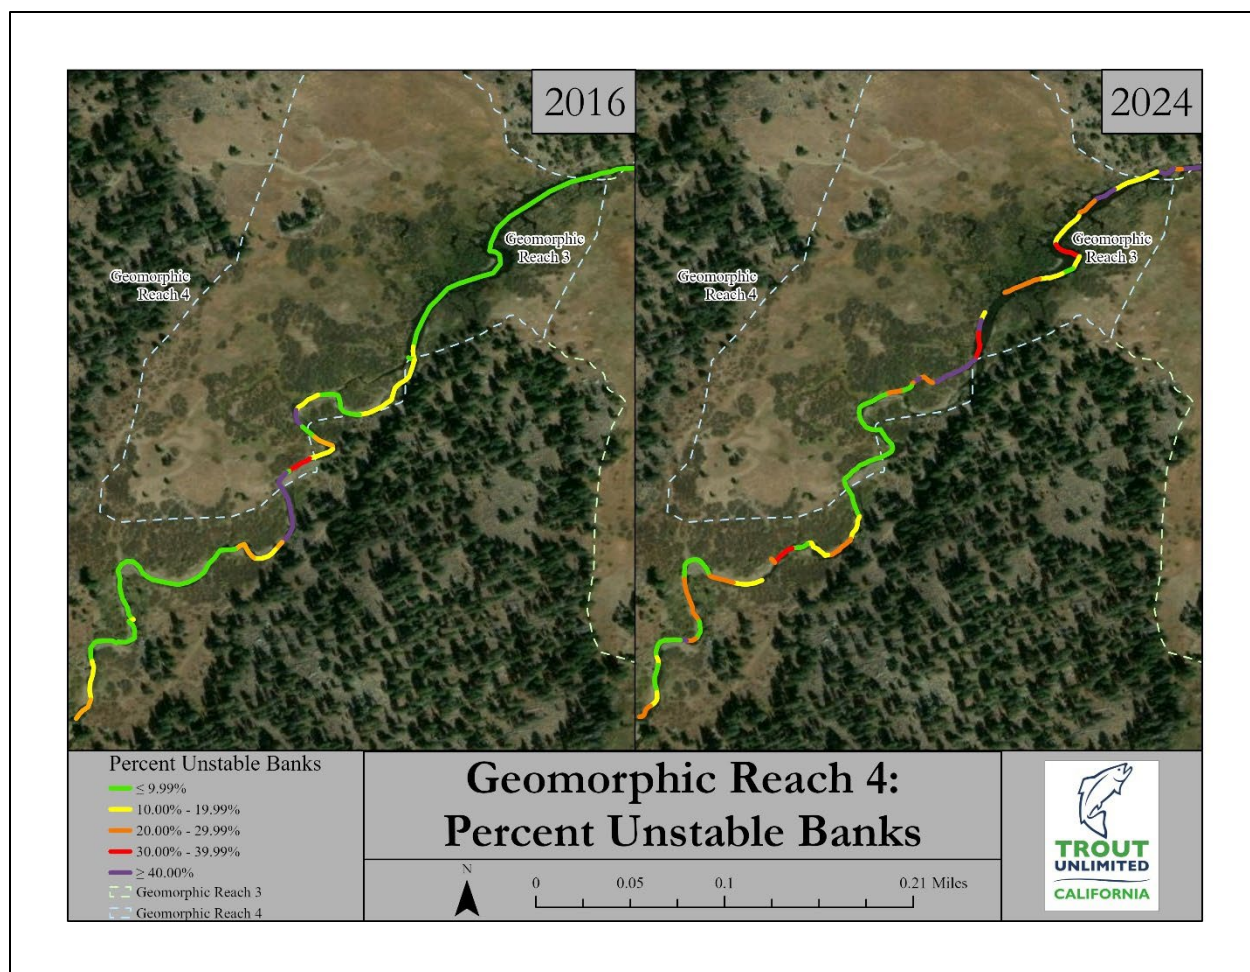
Figure 25. Detail of Bank Stability in GM4 in 2016 vs. 2024 by channel unit. Blue indicates <10% unstable banks in the unit, green indicates between 10% and 19.99% unstable banks in the unit, yellow indicates between 20% and 29.99% unstable banks in the unit, red indicates between 30 and 39.99% unstable banks in the unit, and purple indicates >40% unstable banks in the unit. Note the increased bank instability in this reach due to the loss of the large beaver dam that was present in 2016 as well as the altered flow path.

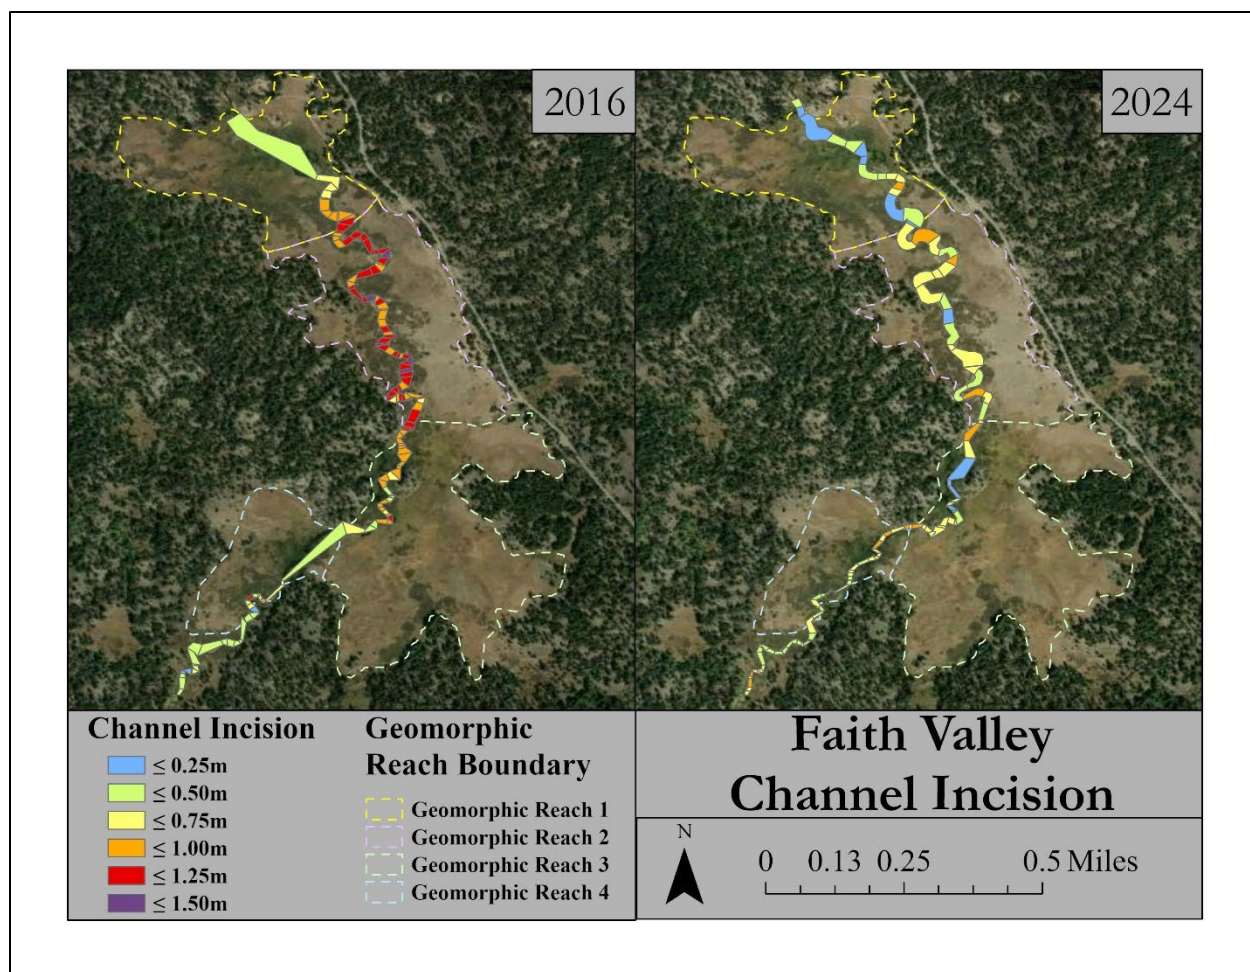
Figure 26. Overview of Channel Incision/entrenchment changes in Faith Valley pre-and post-restoration treatment. The decreases in entrenchment below the historic floodplain are significant throughout the treatment area.

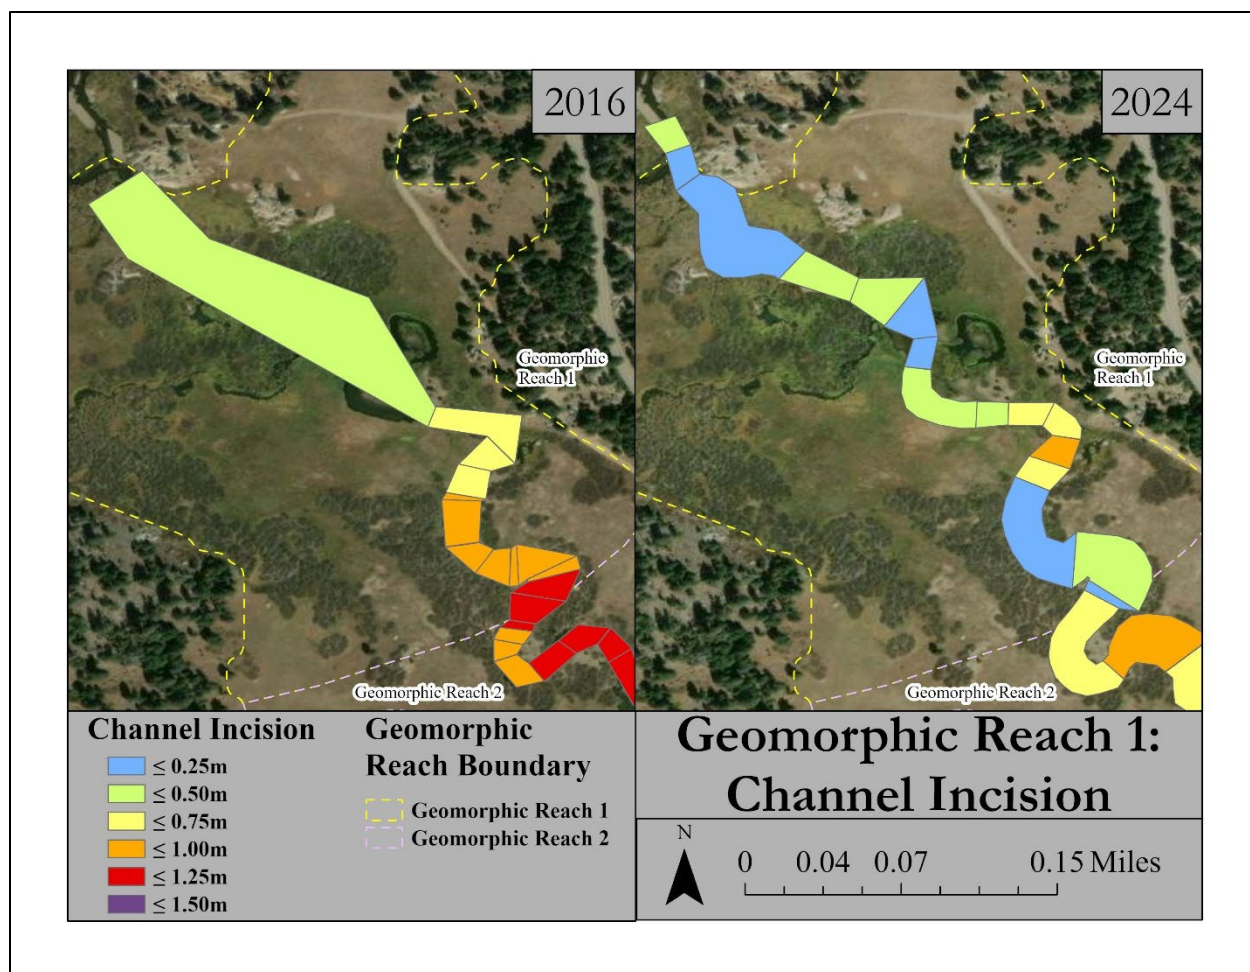
Figure 27. Detail of GM1 changes to channel incision and width pre-treatment (2016) and post-treatment (2024). The overall trajectory is for decreased distance to the historical floodplain surface, i.e., decreased entrenchment.

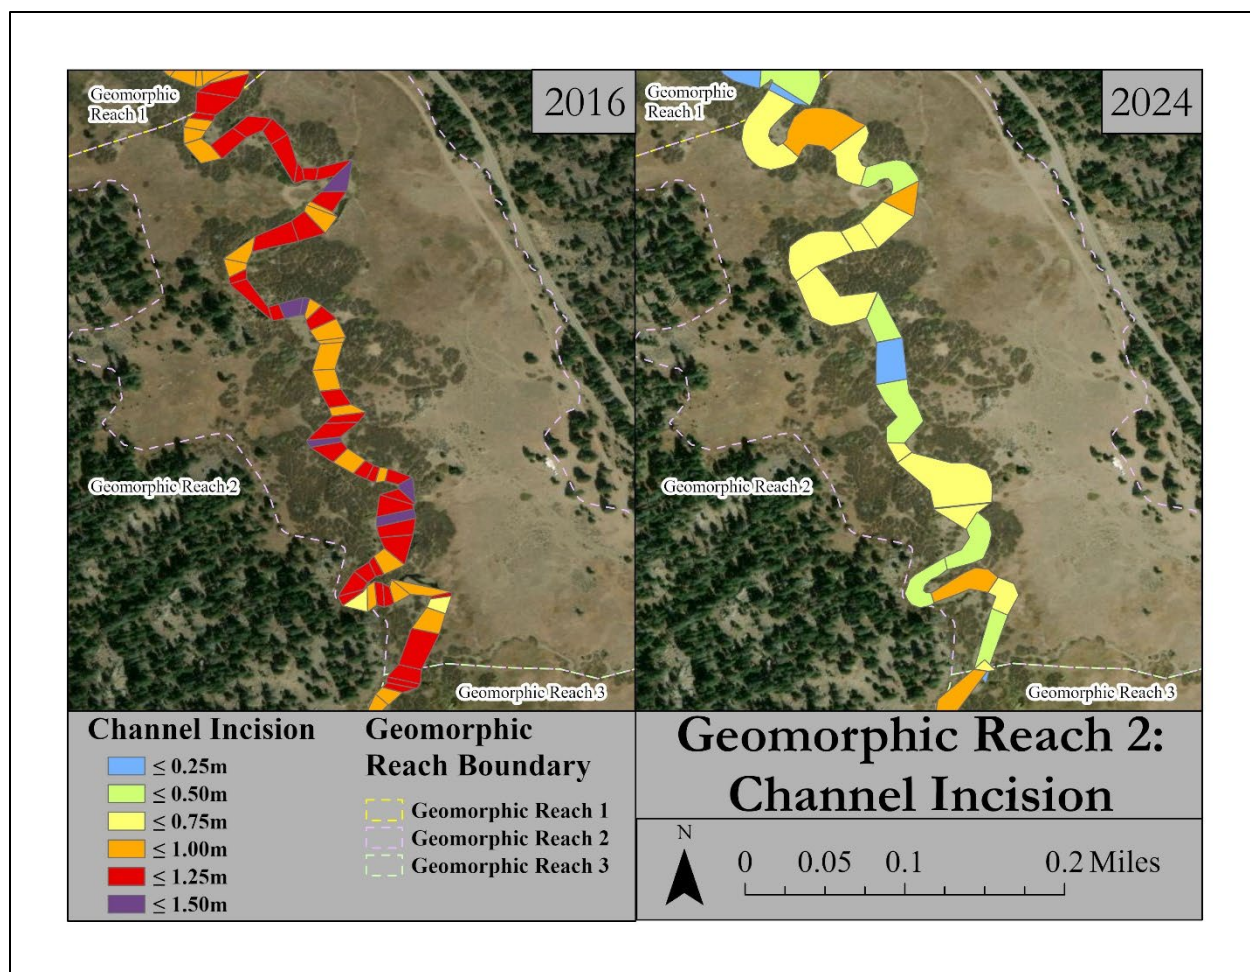
Figure 28. Detail of changes to channel incision and width pre-treatment (2016) and post-treatment (2024). This reach contained the highest number of structures and demonstrated a positive response.

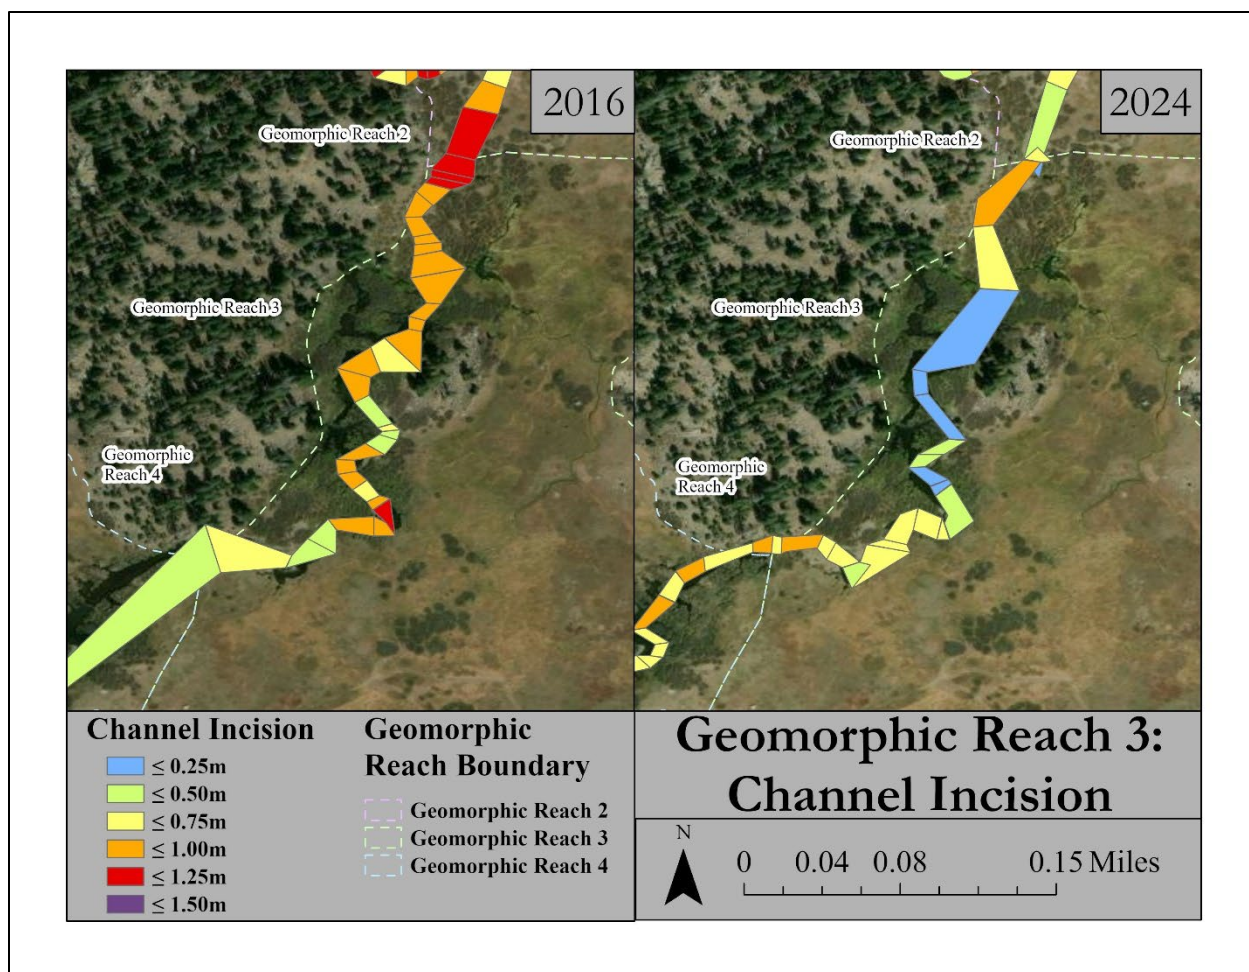
Figure 29. Detail of Channel incision and width in Reach GM3. Structures were built in the downstream section only in this reach (stream flows north). Channel aggradation also occurred from a redistribution of sediments from upstream beaver dam breaches but decreased in the areas around the former dams. This is a great example of the dynamics associated with the build and breach cycles at Faith Valley.

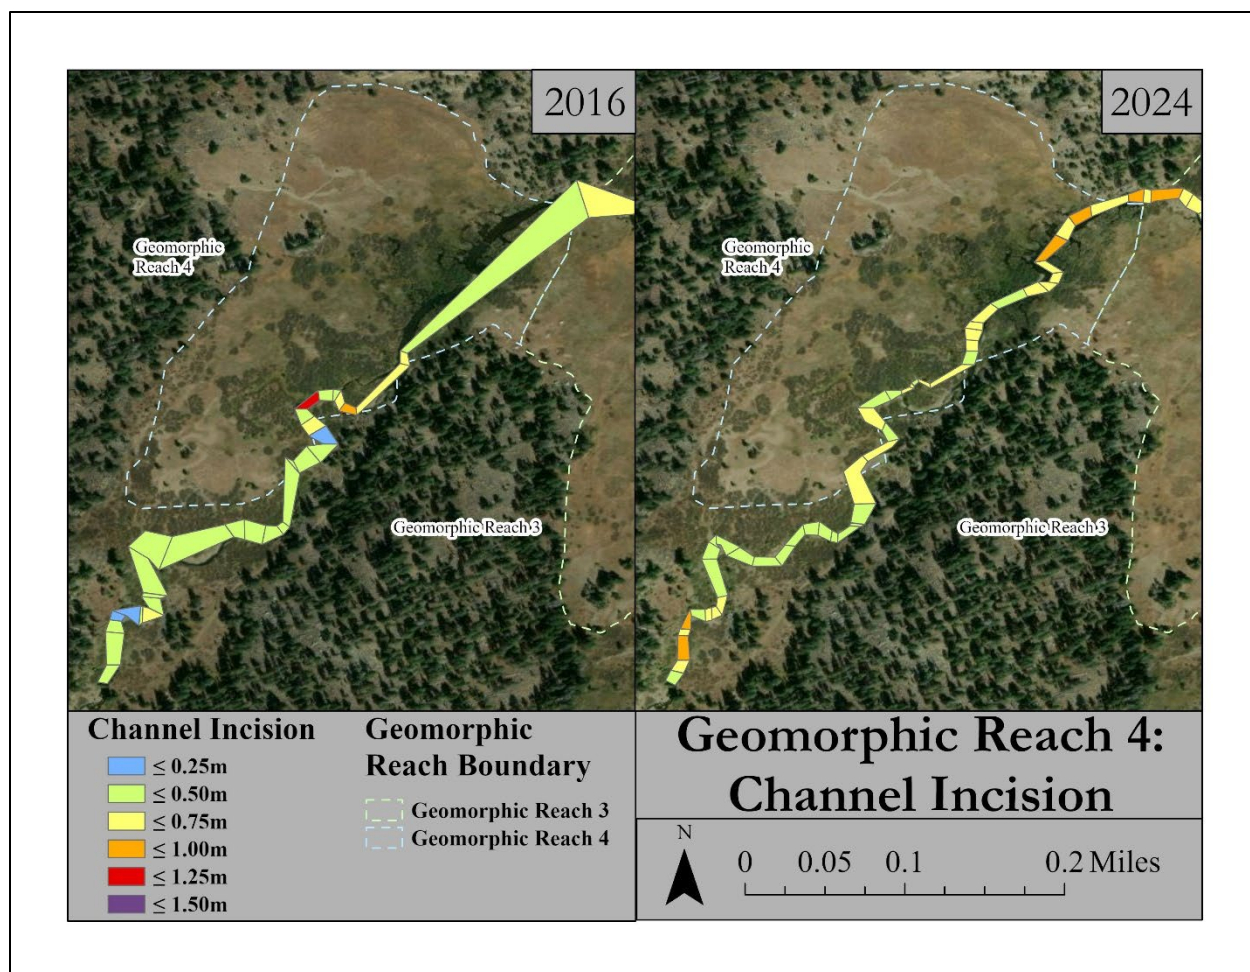
Figure 30. Detail of Channel Incision and width in GM4. The loss of the primary dam at the downstream end of the reach drove the shift of the channel back to a more narrow and more incised state.
