# Faith Valley Meadow

Post-Restoration Treatment Stream Condition Inventory 2024

Prepared by: Sabra Purdy and Trout Unlimited on Behalf of American Rivers

February 15<sup>th</sup>, 2025

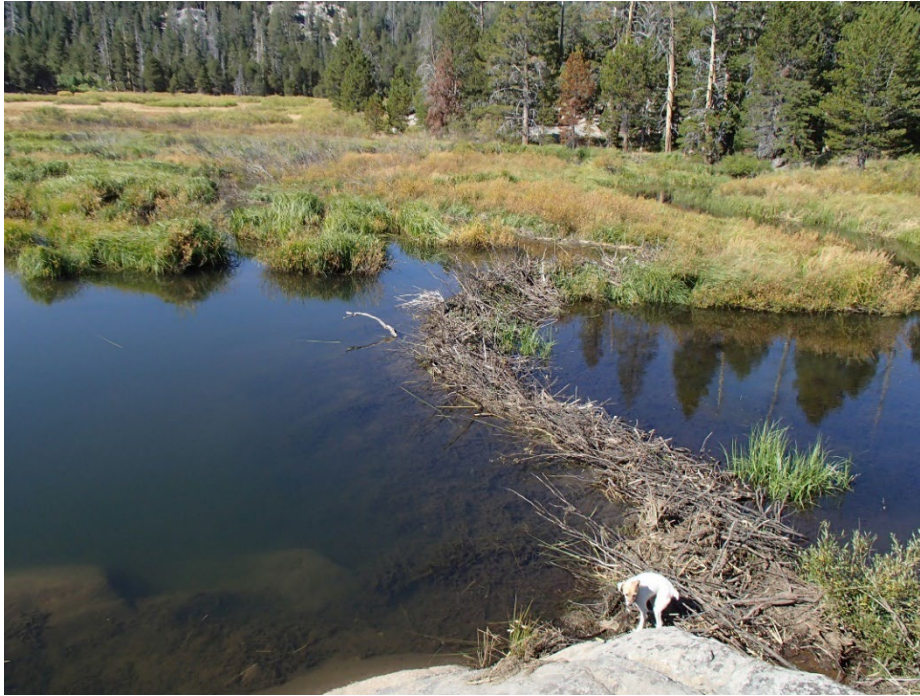
*Figure 31. Beaver Dam at the base of GM1 in 2016. This dam backed water up for hundreds of meters and created a large area of inundation laterally that resulted in a tremendous vegetation response throughout the valley bottom. This dam did not survive the winter of 2016/2017 GM1\_2016, SDBV1.*

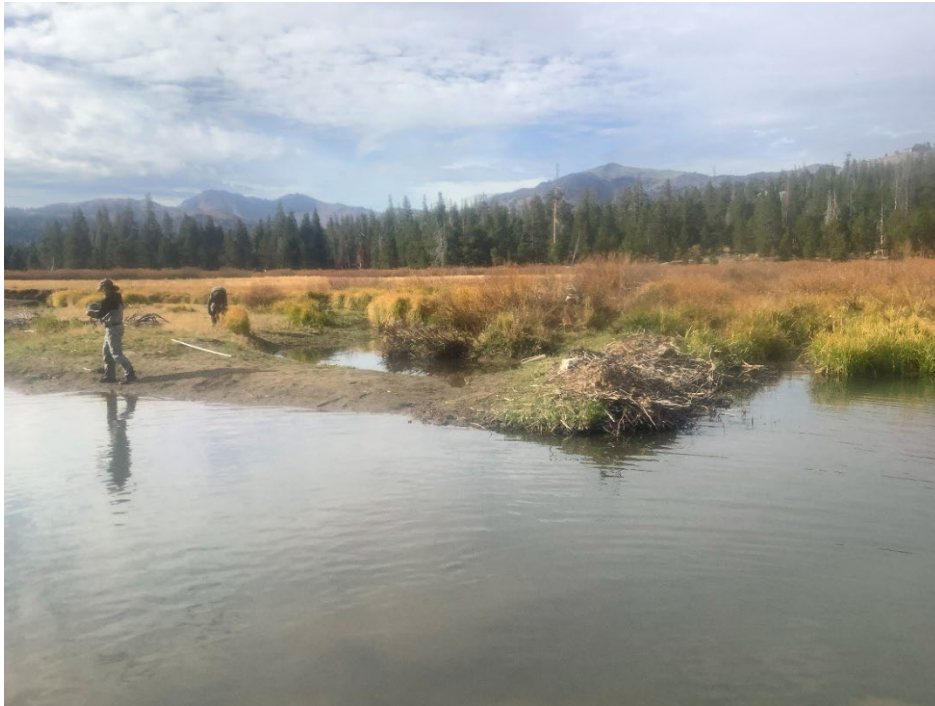
*Figure 32. This area in GM1 was more fully inundated in 2016 from the large beaver dam at the base, now elevation is controlled by the downstream Grade control structure. While water table is still high, there is less inundated habitat but full floodplain connectivity. Note the dam remnant perched above current water surface on the point. GM1\_2024, SSL52.*

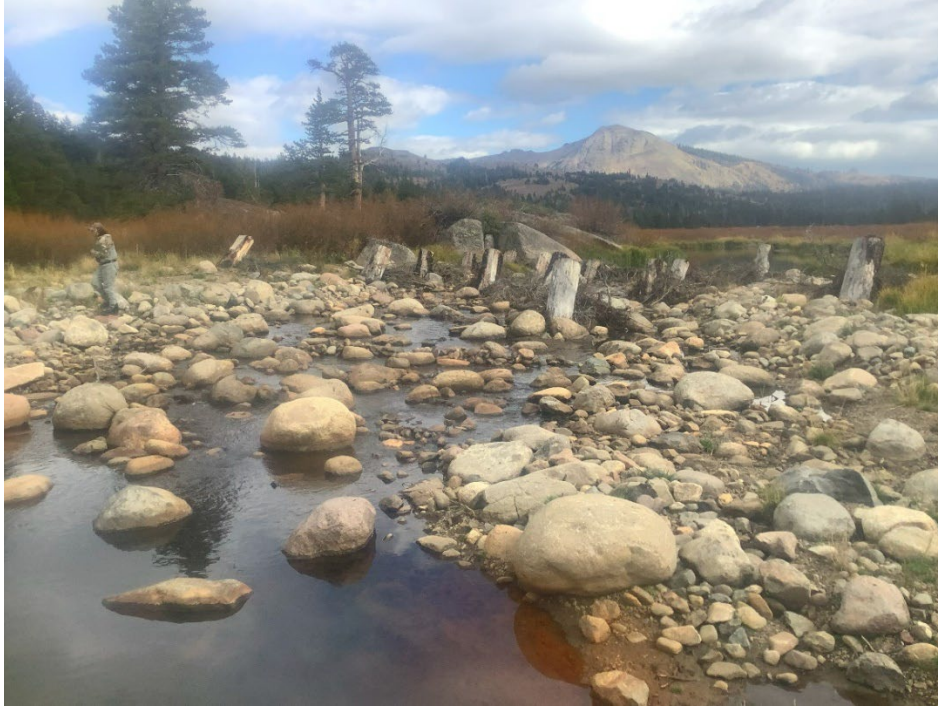
*Figure 33. The grade control structure built at the downstream end of Faith Valley. The vertical logs coming out of the structure are intended to facilitate future beaver dams or beaver dam analogs by creating a sturdy anchor point. GM1\_2024, FTRF1*

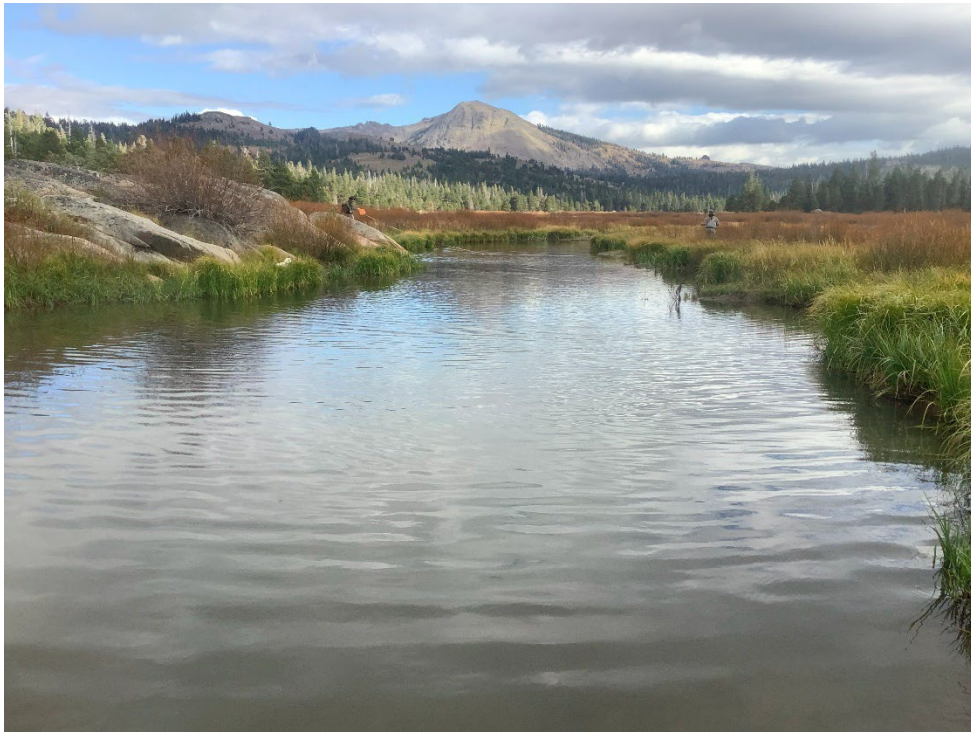
*Figure 34. The area of inundation created by the grade control structure at GM1\_2024, FTRF1. While less than the natural dam in 2016, it is unlikely to blow out and will allow for greater aggradation in this reach over time.*

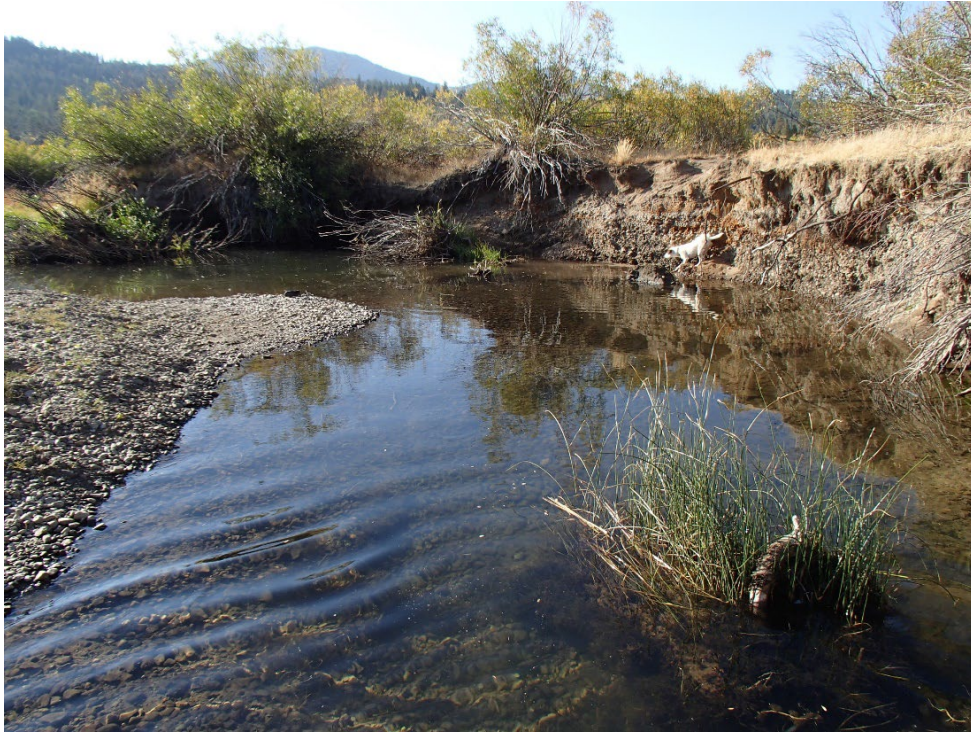
*Figure 35. Area of incision and bank instability. Note the chunk of sod that has fractured off the bank. There is a beaver dam remnant immediately downstream that contributed to bank erosion when it flanked and eroded laterally. GM1\_2016, SSL8.*

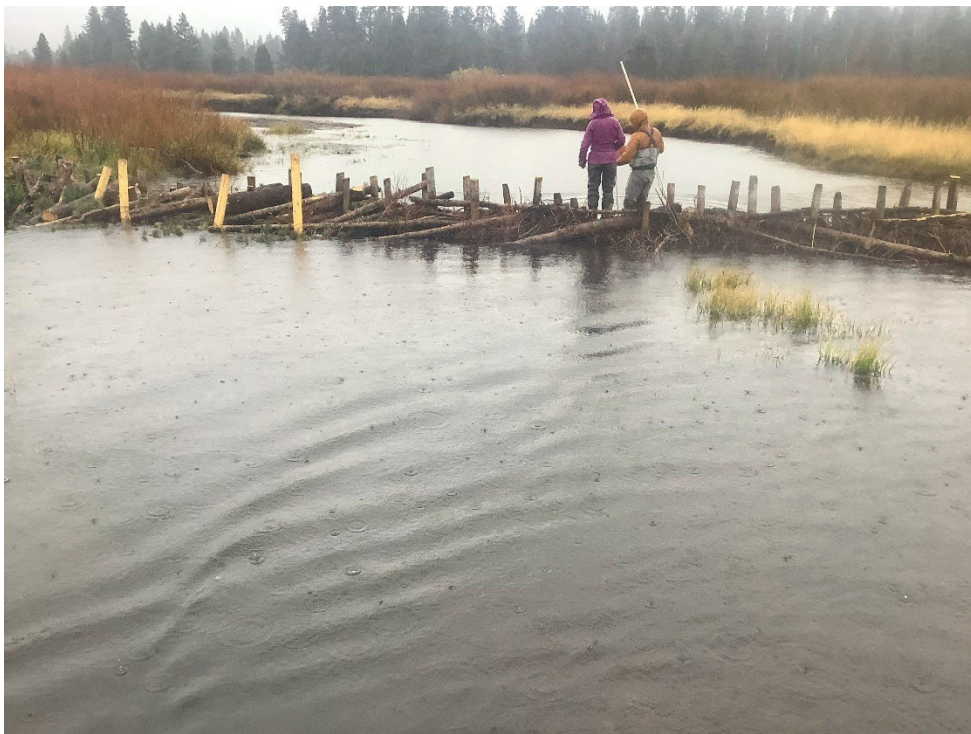
*Figure 36. Just downstream of the previous photo in 2024 a BDA has been placed to aggrade the channel. The cutbank in figure 35 is visible in this image in the distance. GM1\_2024 SDBV7*

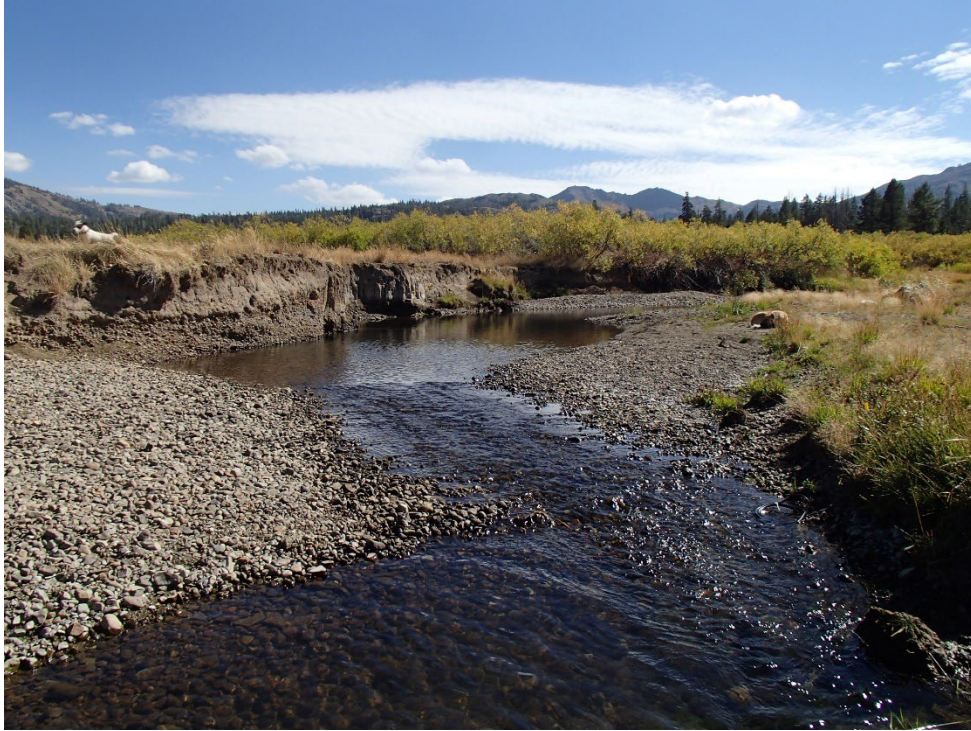
*Figure 37. A cutbank still actively eroding. The historic floodplain is still largely disconnected from the stream GM2\_2016. Near SSLS17.*

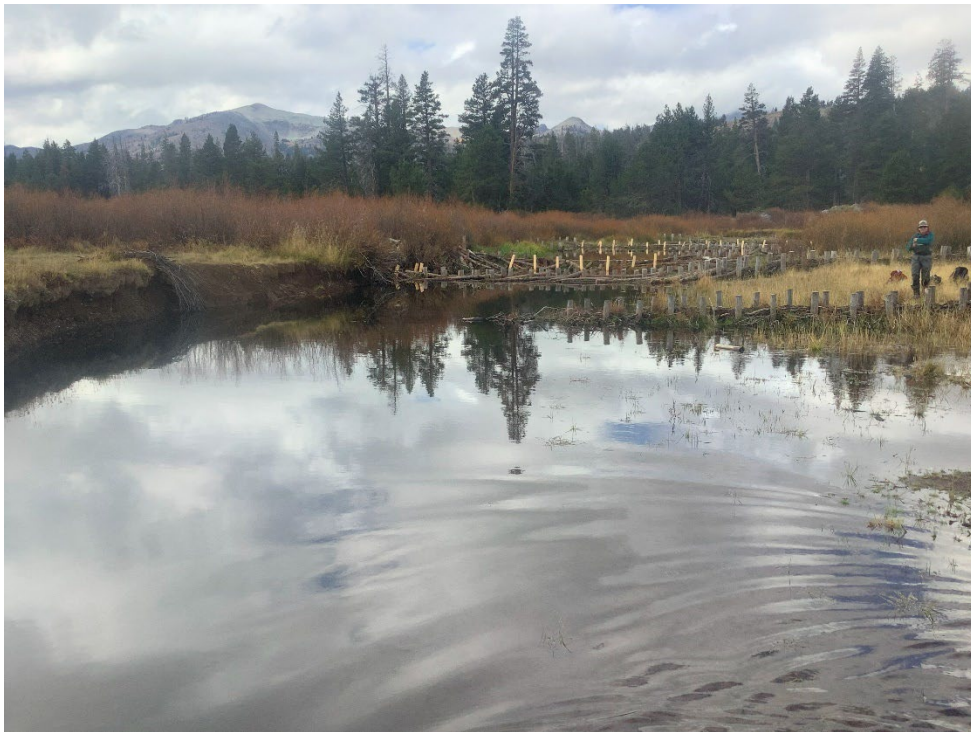
*Figure 38. The same area in 2024 post-treatment. There is still some exposed unstable bank, but it is shorter than pre-treatment. The numerous BDAs in this section trap sediment, increase pool depth and inundated area. The flows were approximately the same in both photos. GM2\_2024, SDBV17*

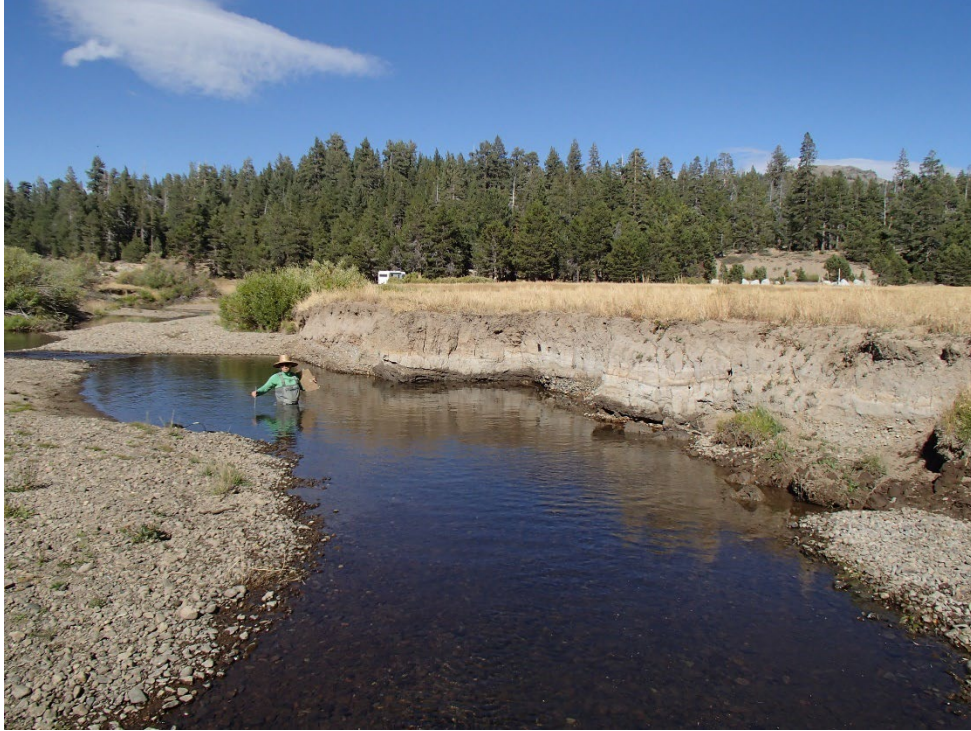
*Figure 39. Looking downstream at the steep high right cutbank and dry vegetation. This section is the most disconnected in Faith Valley Meadow. GM2-2016, SSL518*

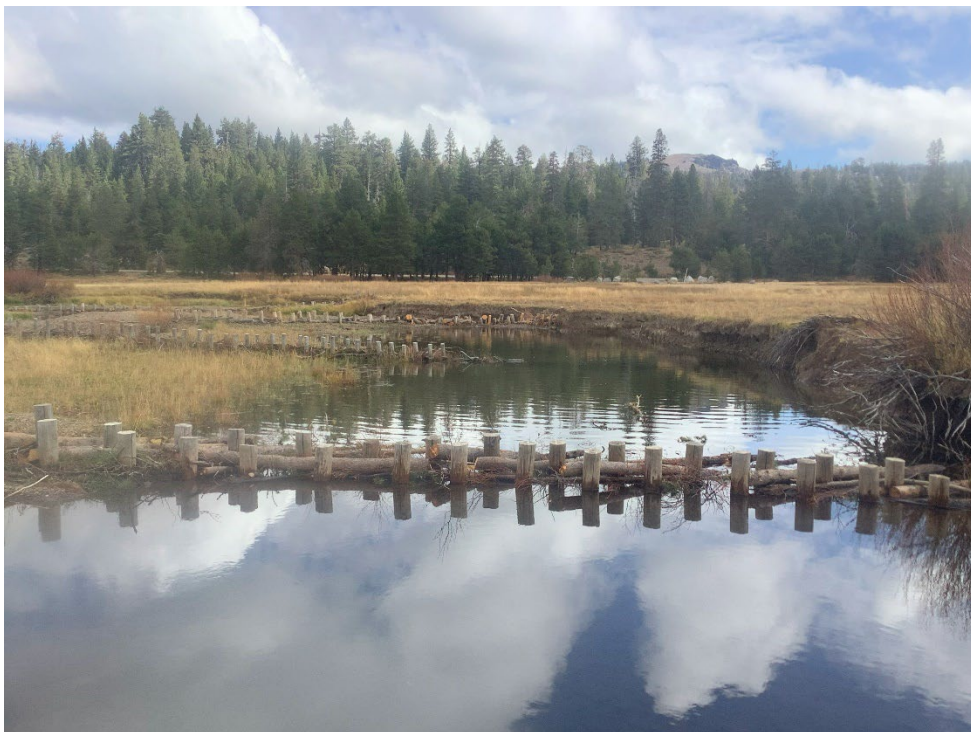
*Figure 40. The same section of channel as in Figure 35 post-treatment. A complex of structures drives sediment deposition, a higher water table, deeper pools, and slower velocities. Emergent vegetation is beginning to take hold on the left bank gravel bar. Note the partial span of the middle structure which was breached in 2023. It continues to do work in the channel despite being breached. GM\_2024, SDBV17*

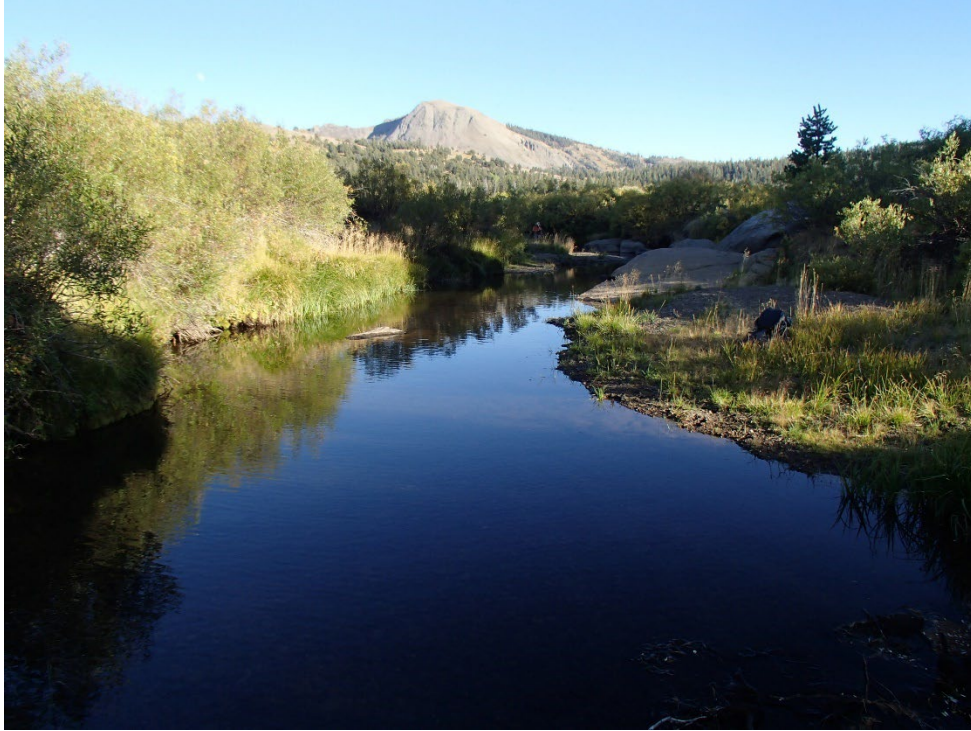
*Figure 41. A deep scour pool in 2016 where the channel touches the edge of the moraine and large boulders appear. Note stable well-vegetated banks from earlier beaver dam, now breached. GM2\_2016, SSMC22*

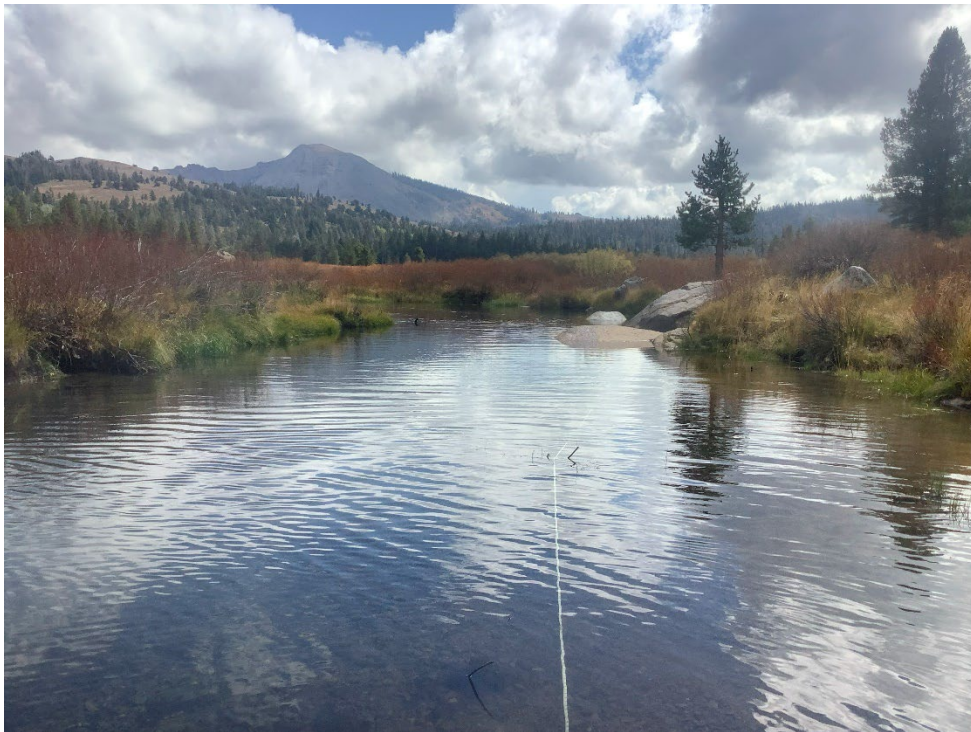
*Figure 42. The same scour pool in 2024. Note the boulder visible in the picture above is now nearly submerged by the effects of a downstream BDA structure. Wetted width and pool depth have increased. Distance from the channel to the historical floodplain is reduced, bringing groundwater closer to the rooting zone of floodplain vegetation. GM2\_2024, SDBV20.*

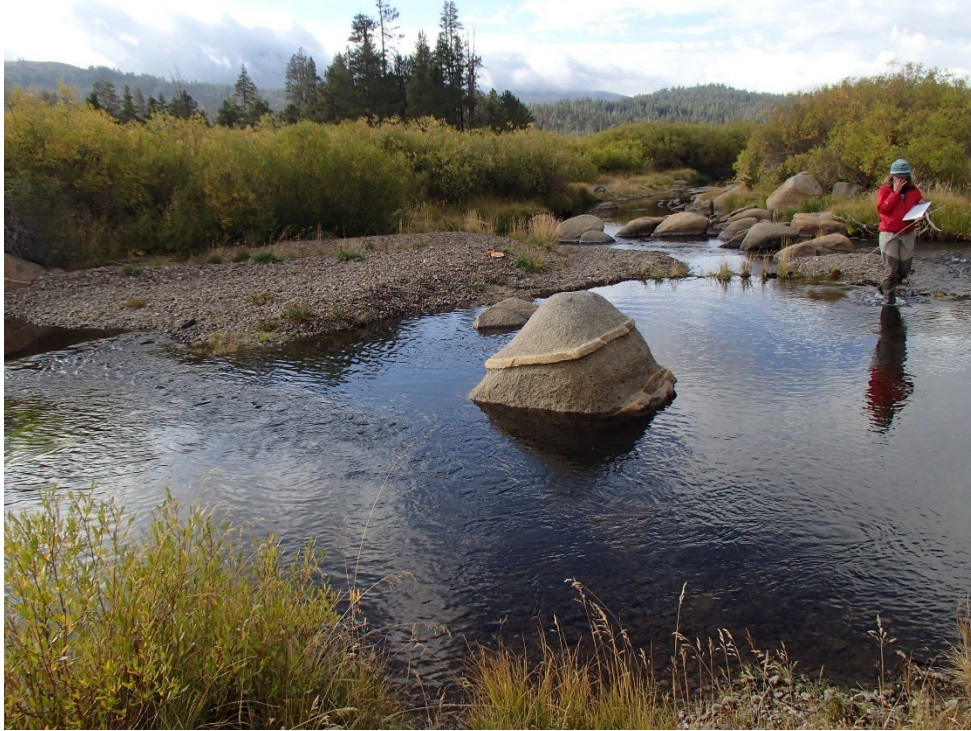
*Figure 43. A highly distinctive boulder in the channel in 2016 looking downstream with the remnants of a beaver dam creating a riffle crest. Note the other boulders in the background and exposed gravel bar. GM2\_2016, SSMC28*

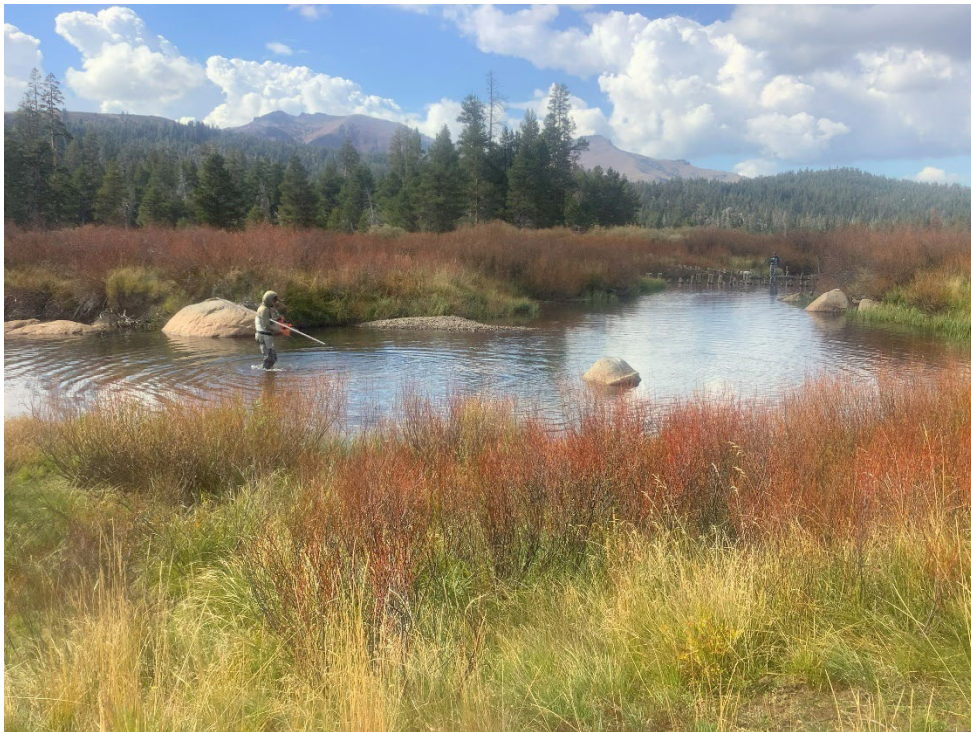
*Figure 44. The same unit as Figure 43 in 2024 looking downstream at a BDA that has covered the boulders and gravel bar with water. GM2\_2024, SDBV23*

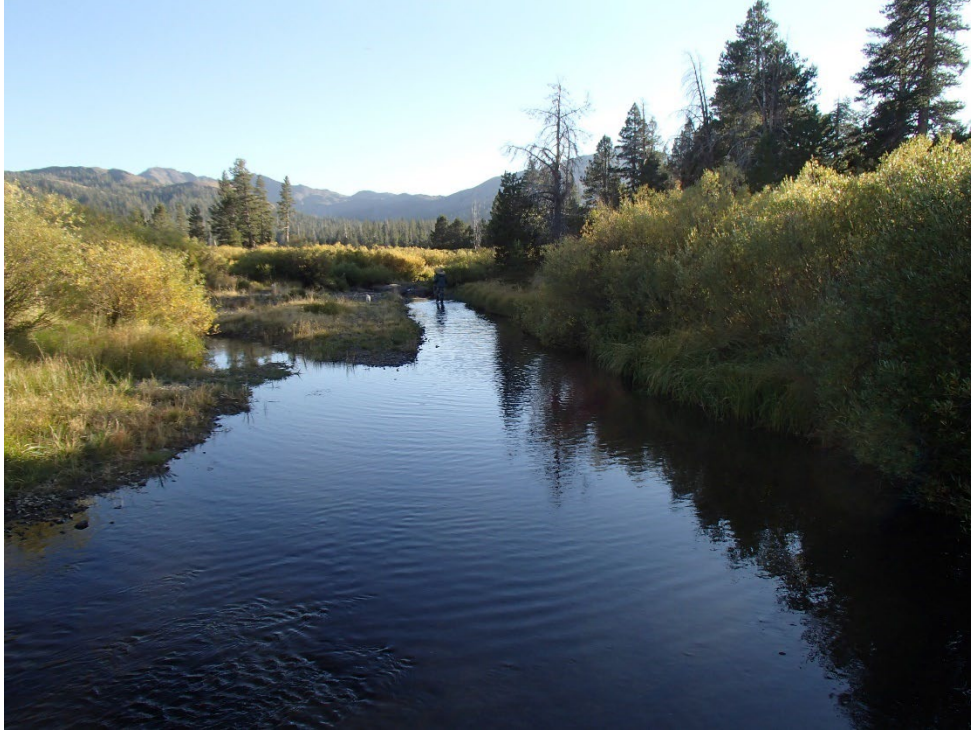
*Figure 45. Looking upstream at a narrow wetted area with gravel deposits in channel. Note the standing dead tree on the bank on the right. GM2\_2016, FTRF36*

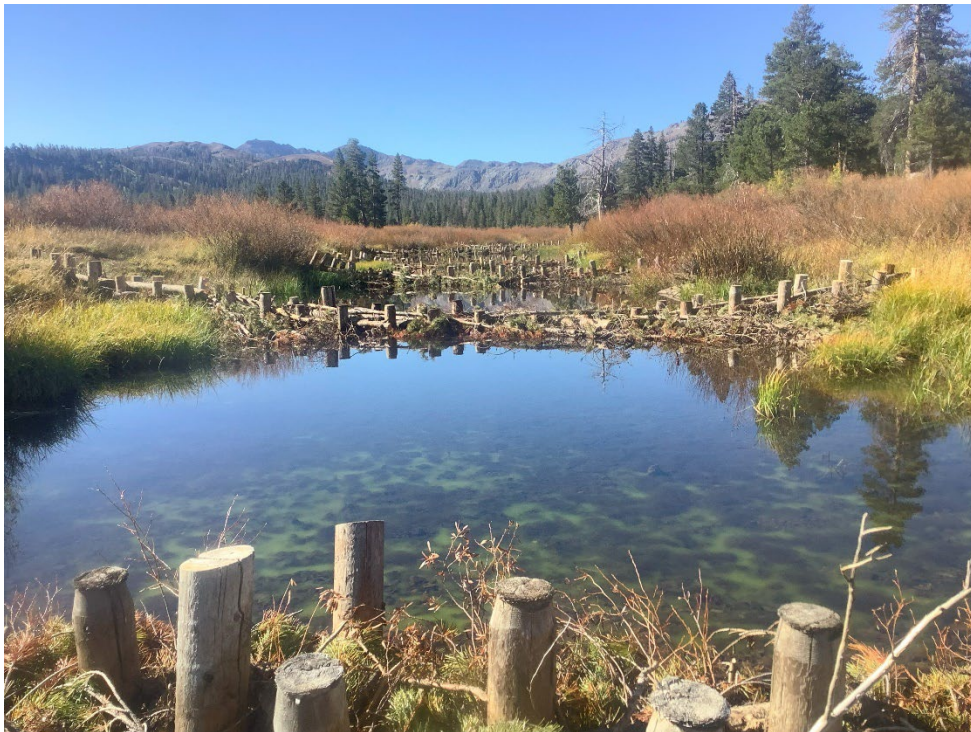
*Figure 46. The same area post-treatment. There is now a complex of 5 BDAs in this section working together as a complex to provide redundancy. Note that the material on the dam in the fore is beginning to sprout, this is becoming a living biogenic structure. Emergent vegetation at the margins is colonizing the fine sediments behind the dam. The dead tree on the bank remains standing but we hope that it eventually falls into the channel to add some large woody debris. GM2\_2024, SDBV31*

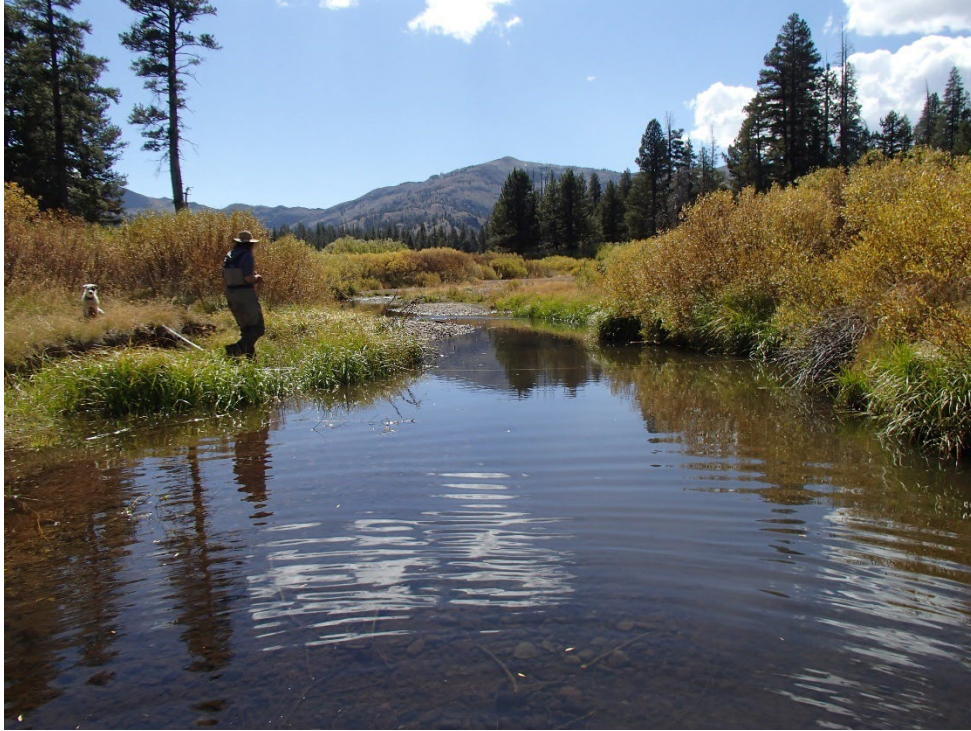
*Figure 47. A natural pool made from a remnant beaver dam in 2016. The area shows lots of indications of earlier dams and beaver associated geomorphology. GM3\_2016, SDBV43*

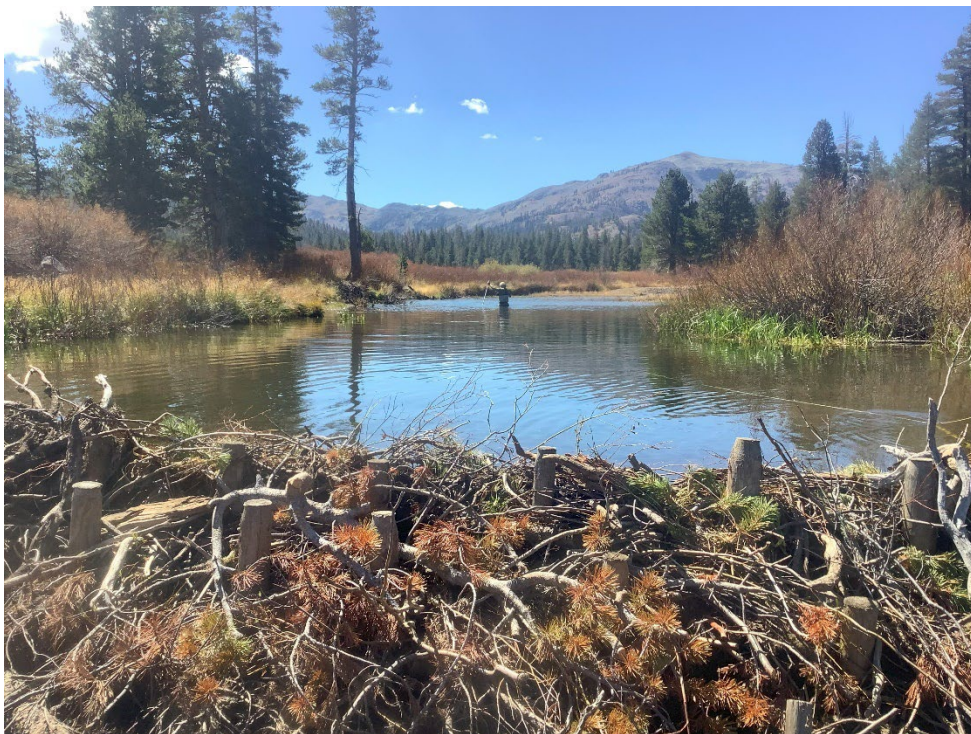
*Figure 48. The same area post-treatment in 2024 with a large BDA creating a lot of inundated area upstream. There are active beavers in this area that have been adding onto the BDA and creating additional dams in the side channel created by the BDA. GM3\_2024, SDBV34*

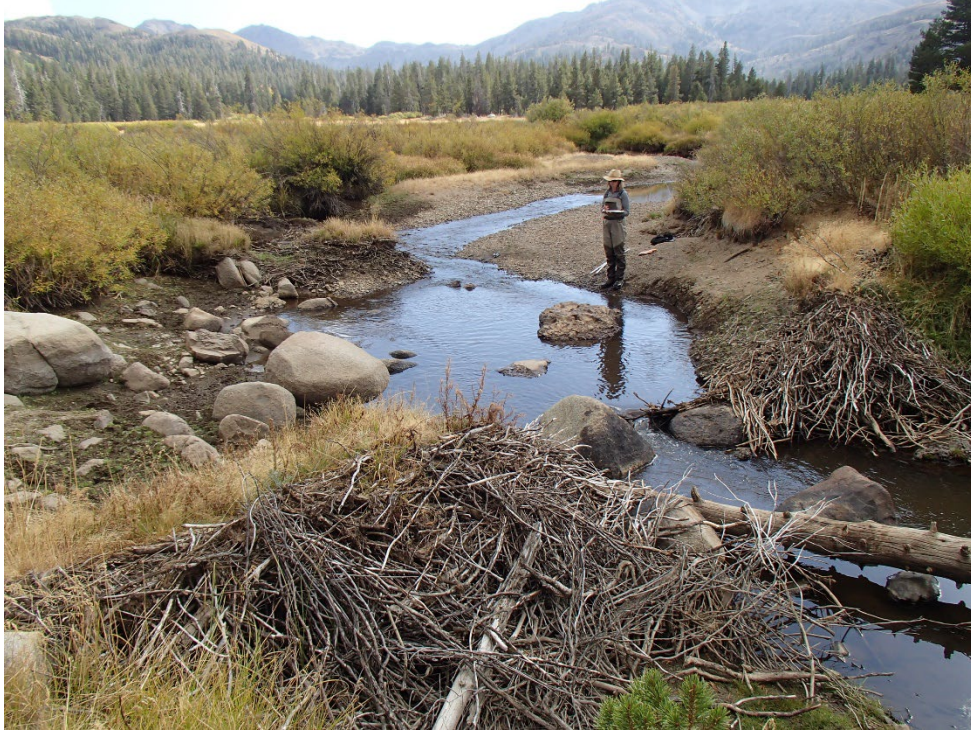
*Figure 49. Breached Remnant beaver dam in 2016. The highwater mark from when the dam was intact is clearly visible. Even remnant dams provide structure and habitat complexity. GM3\_2016, SSMC 48*

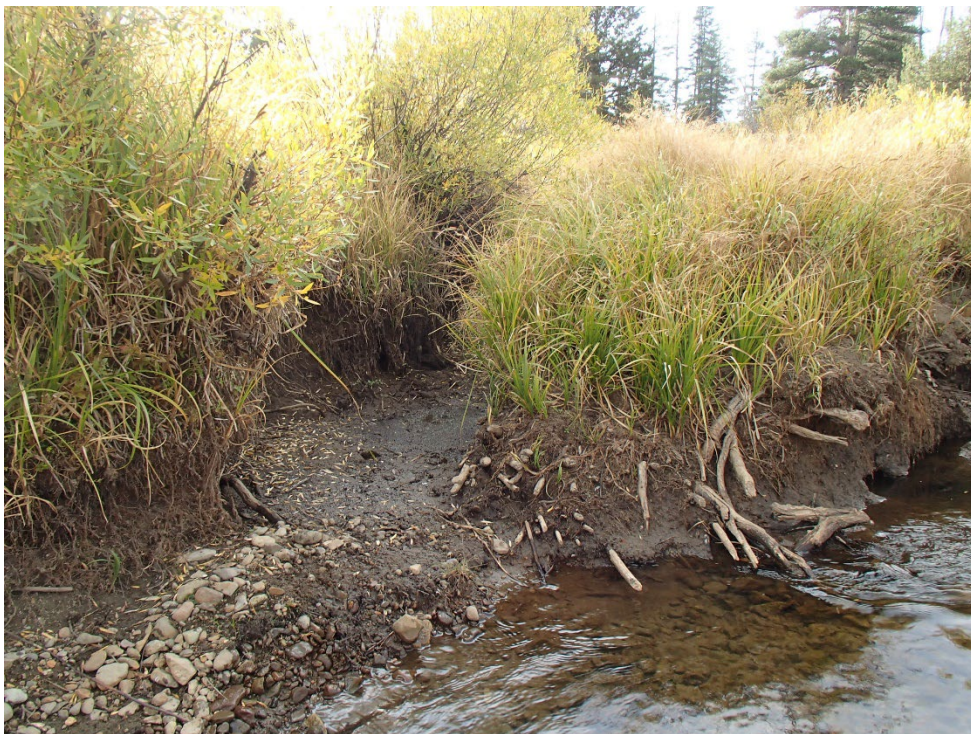
*Figure 50. Beaver dam remnants and old beaver channels revealed by the loss of the large dam pictured in Figure 49. Remnants cover this entire reach indicating that beavers continuously build dams in this area. GM4\_2016, FNRN50*

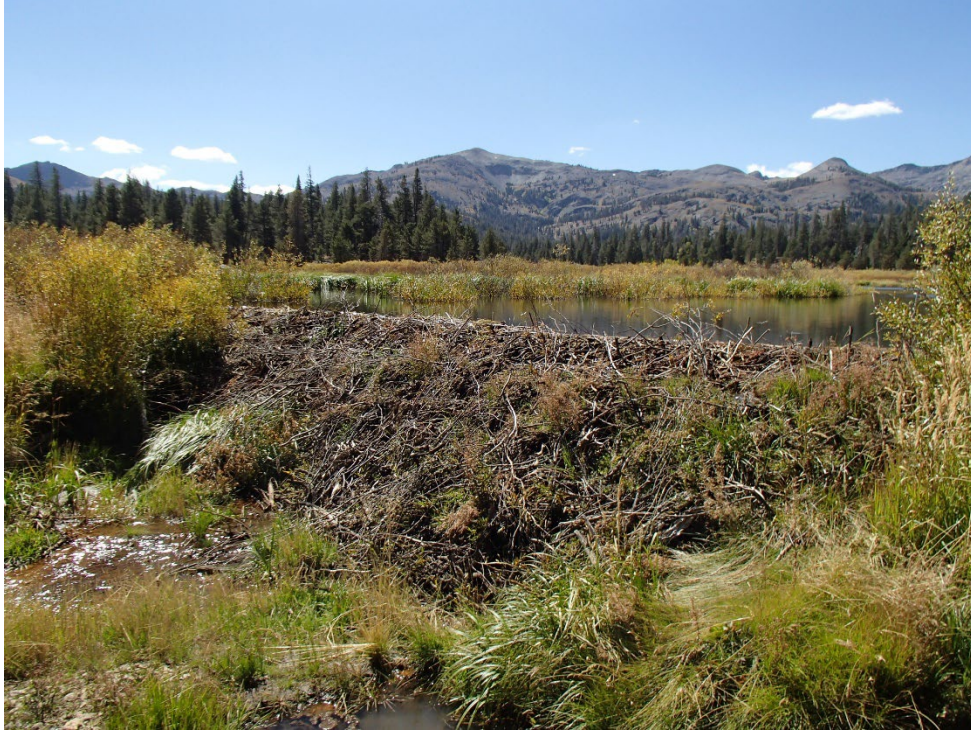
*Figure 51. Massive beaver dam at the split between GM3 and GM4 in 2016 creating more than 5 acres of Stage 0 inundated habitat. This dam blew out in 2017. GM4\_2016, SDBV55*

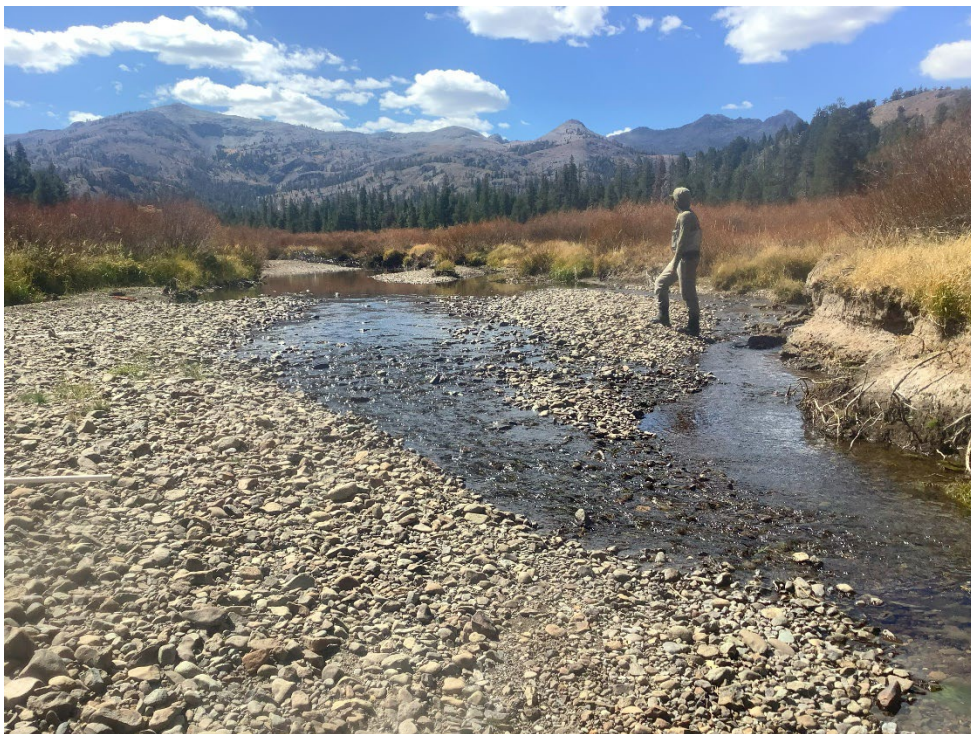
*Figure 52. The former beaver pond (SDBV55) in 2024 after the dam breached revealing a complex of dam remnants and exposed beaver tunnels and lodges. The stream went back to Stage 5-7 with an entrenched channel and exposed unstable banks. GM4\_2024, FTRF15*

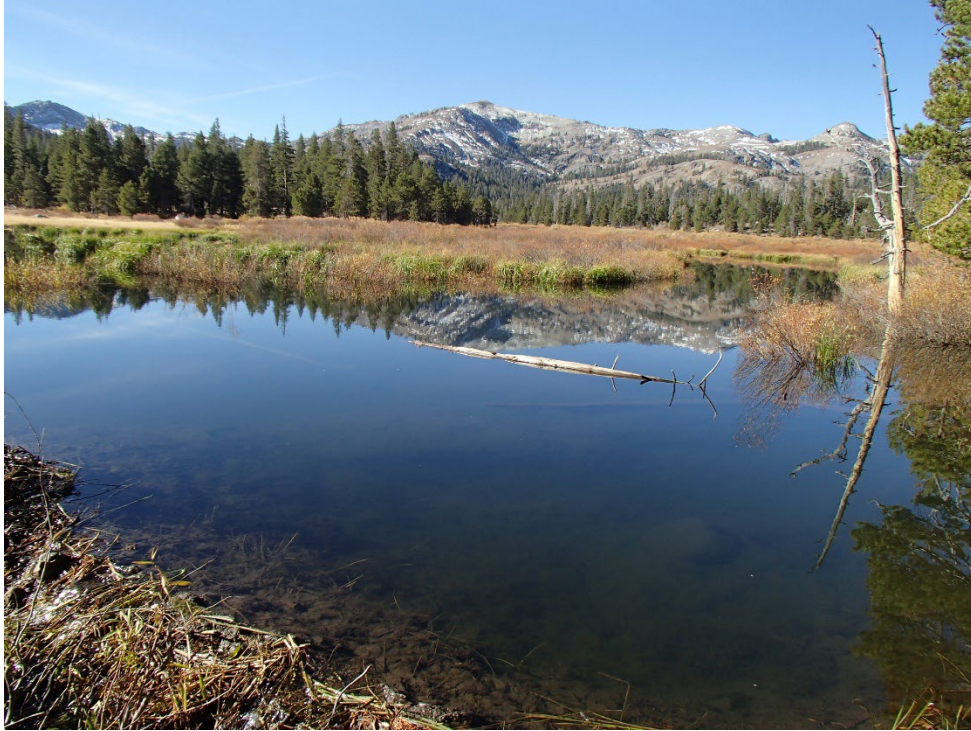
Figure 53. Drowned trees and a fully connected floodplain in the large beaver dam pond. GM4\_2016, SDBV55

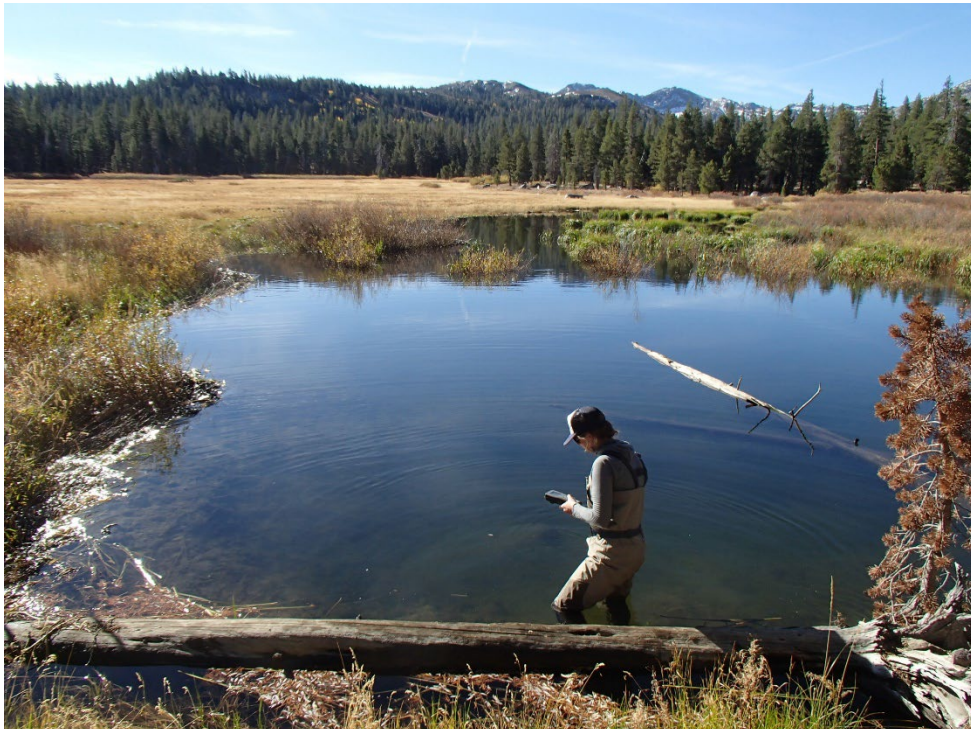
Figure 54. Beavers extended this large dam for 90m across the floodplain, inundating the entire valley bottom. Multiple flow paths from the dam worked across the valley. However, headcuts were forming on the side channels when they returned to the mainstem below due to dam breaches downstream. GM4\_2016, SDBV55

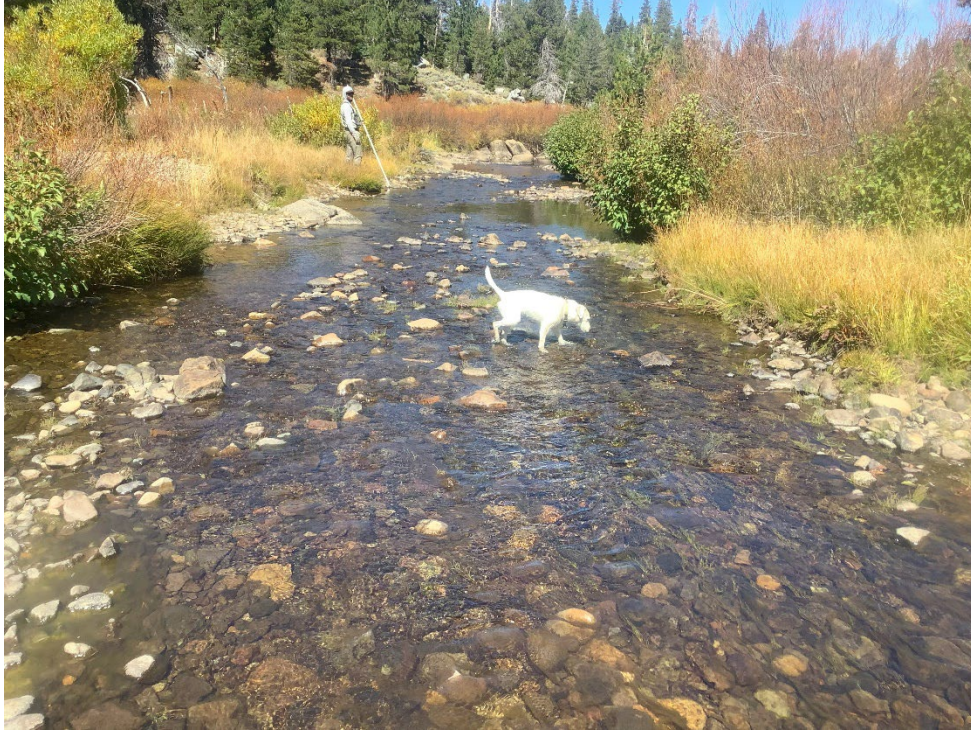
*Figure 55. Upstream of the large beaver pond area the stream becomes increasingly steeper and more confined with larger average substrate size and a narrower valley bottom. More alders are found in this reach due to the coarser sediment. There were also more fish present in this zone than in the lower reaches of Faith Valley. GM4\_2024, FTRF33*

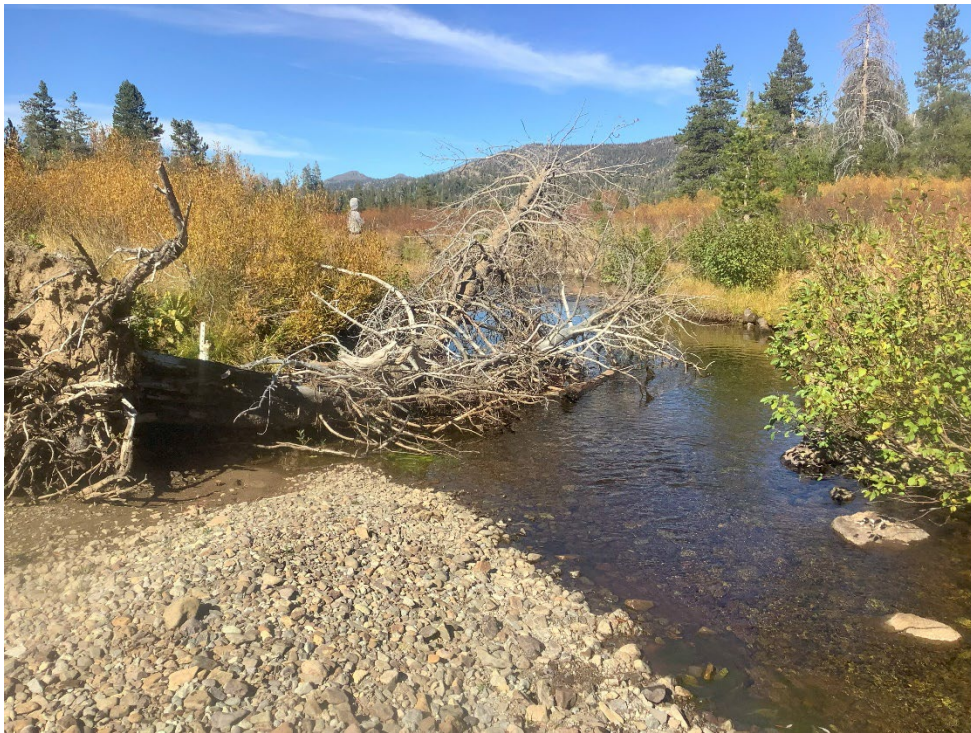
*Figure 56. The final unit of GM4 where large wood recruitment drives sediment sorting, scour, and deposition. The End. GM4\_2024, FNRN39*
