## **Appendix F: Beaver Inventory 2016-2024**

### ***Overview and Survey Methods***

This Appendix reports the results of beaver monitoring in Faith Valley from 2016 to 2024. The purpose of this monitoring effort was to evaluate the persistence and geomorphic impacts of natural beaver structures in Faith Valley and estimate the effects of the project on these metrics post-implementation. Beaver surveys were conducted from a confined reach just upstream of the project boundary to the steep boulder cascade just below the downstream end of the project area (Figure 1). We collected data once in 2016 and 2017 and then began to collect data twice per year. Surveys were conducted in spring (June/July) and fall (September/October) of each year to evaluate dam persistence through high-flow spring runoff and new dam construction during the summer and fall months. During each survey, we systematically surveyed the area described above and collected GPS points for all complete (channel-spanning) beaver dams (Photo 1), partial beaver dams (Photo 2), and lodges (Photo 3). We recorded whether each structure was complete – defined as channel-spanning, or partial (either partially blown out or par

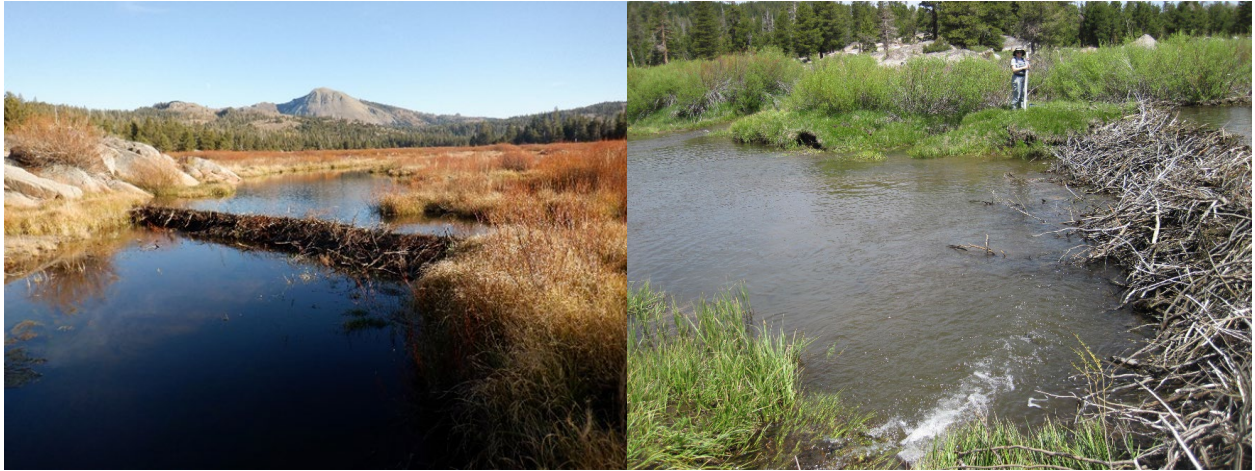
**Photo 1.** Example of complete/channel-spanning dams in Fall 2021 (left) and Spring 2022 (right).

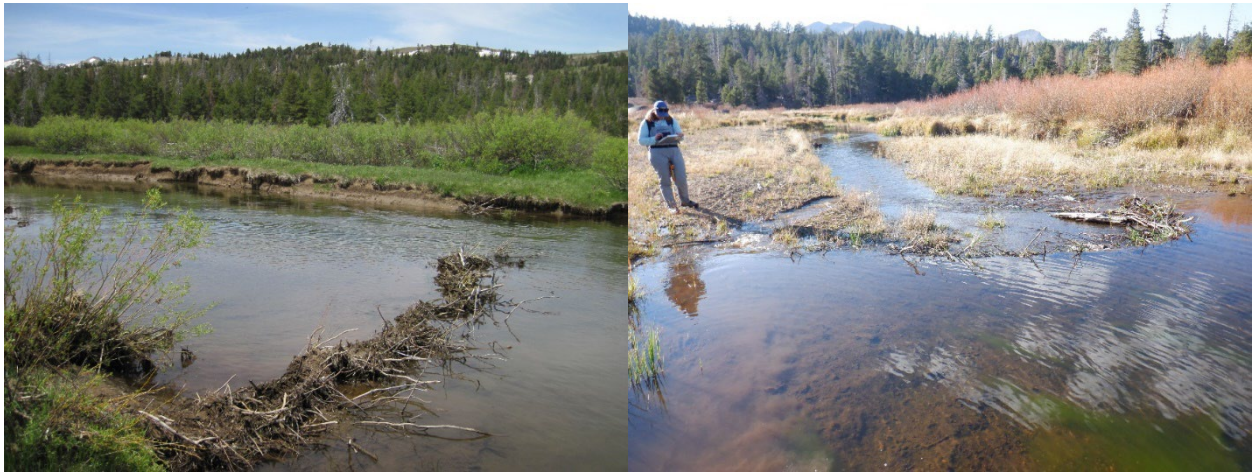
**Photo 2.** Example of a blown out partial dam in spring 2022 (left) and partially constructed dam in fall 2022 (right).

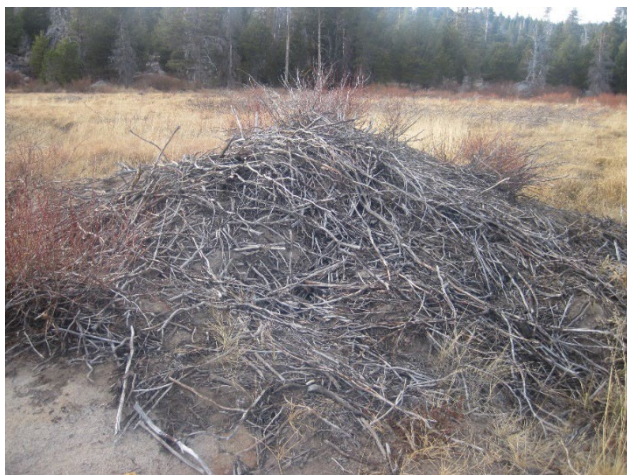
**Photo 3.** Example of a beaver lodge in fall 2019.

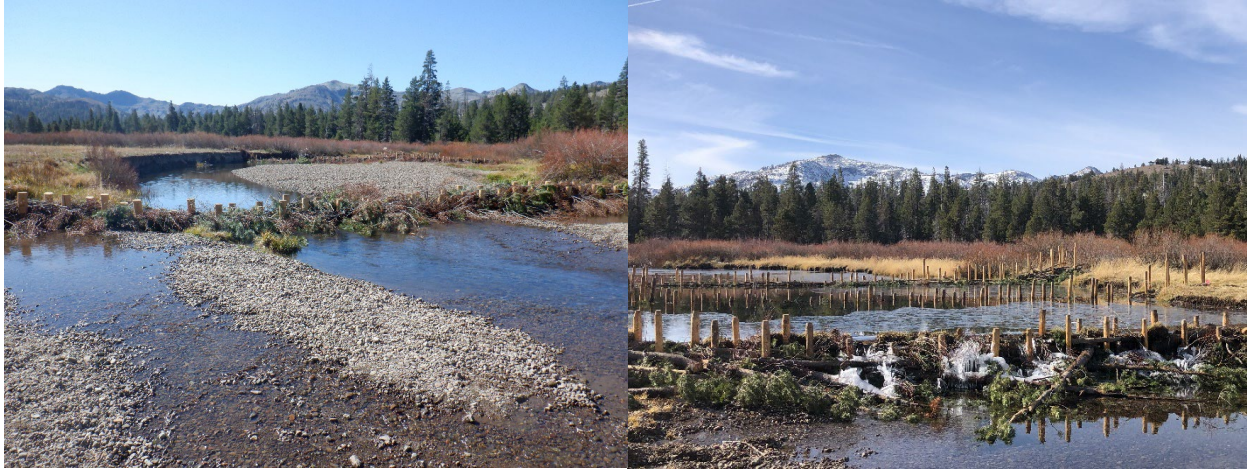
**Photo 4.** Examples of BDAs without beaver activity in fall 2022 (left) and fall 2023 (right)

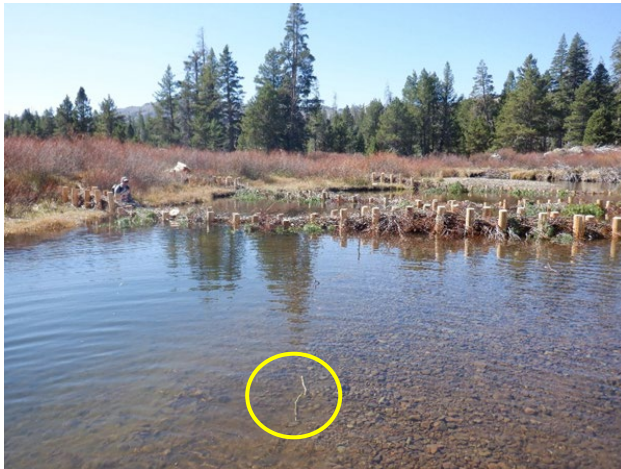
**Photo 5.** Example of BDA with evidence of beaver in fall 2022— not easily visible in photo, but note chew stick in foreground

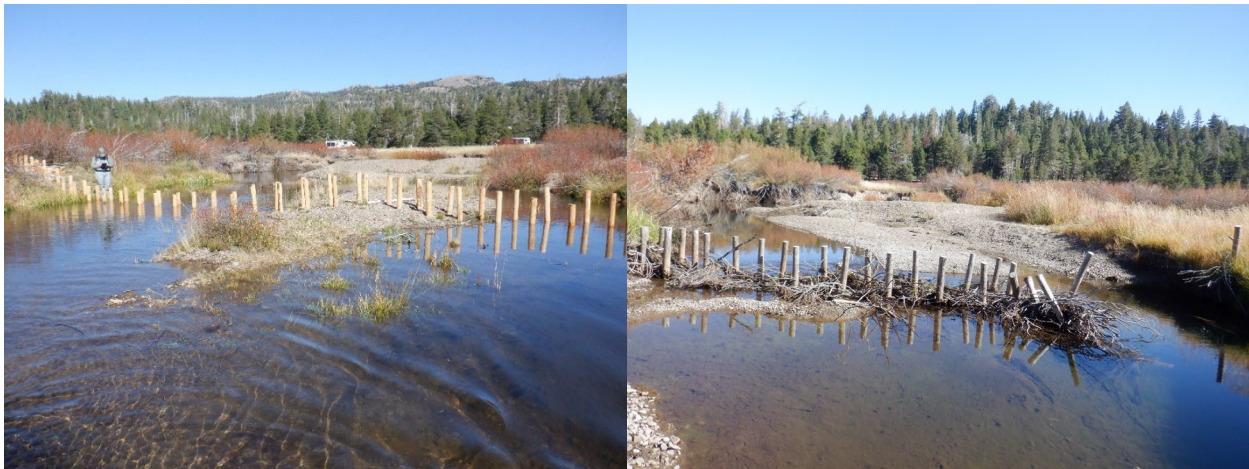
**Photo 6.** Examples of a partially built BDA (left) where willow weave was not completed (fall 2022) and a blown out BDA (right) in fall 2023.

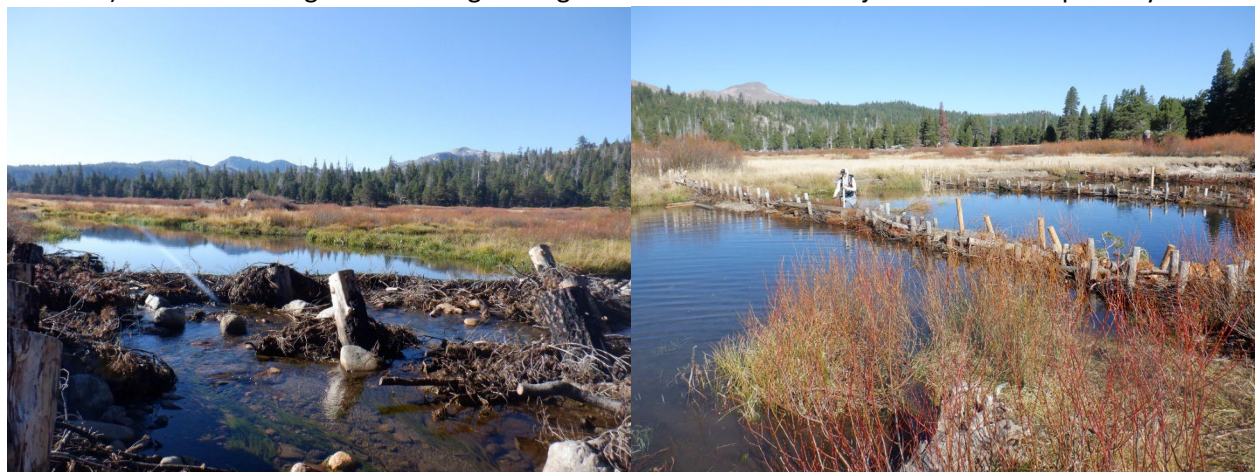
**Photo 7.** New beaver dam built on the upstream end of the grade control constructed in 2022 (left) and persistent BDAs providing grade control. Photos from October 2023 (left) and September 2024 (right).

achieved by installing the grade control structure at the downstream end of the meadow. The grade control structure has persisted since construction in fall 2022 and has been colonized by beaver since fall 2023 (Photo 7). Beyond the grade control, monitoring is demonstrating a trend toward increasing the number and persistence of channel-spanning dams throughout the meadow. As previously discussed, all BDAs installed during phase 2 included in the fall 2023 survey persisted through winter 2023/2024, and the overall number of channel-spanning structures that provide grade control has drastically increased post-project (Figure 3). Additional seasons of data would be needed to evaluate persistence of phase 2 structures over the longer term and with more substantial flow. Additionally, the project may have

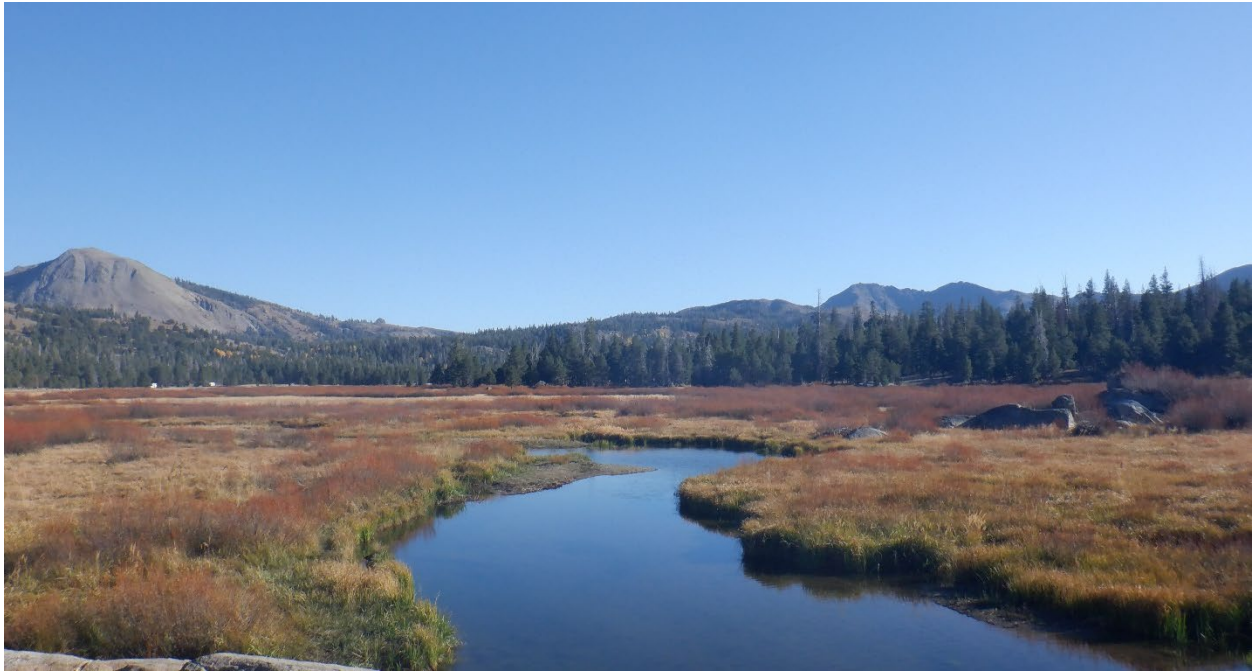
**Photo 8.** Photo of ponded area associated with large beaver dam built on the grade control, October 2024.
