# Faith Valley Meadow

Post-Restoration Treatment Stream Condition Inventory 2024

Prepared by: Sabra Purdy and Trout Unlimited on Behalf of American Rivers

February 15<sup>th</sup>, 2025

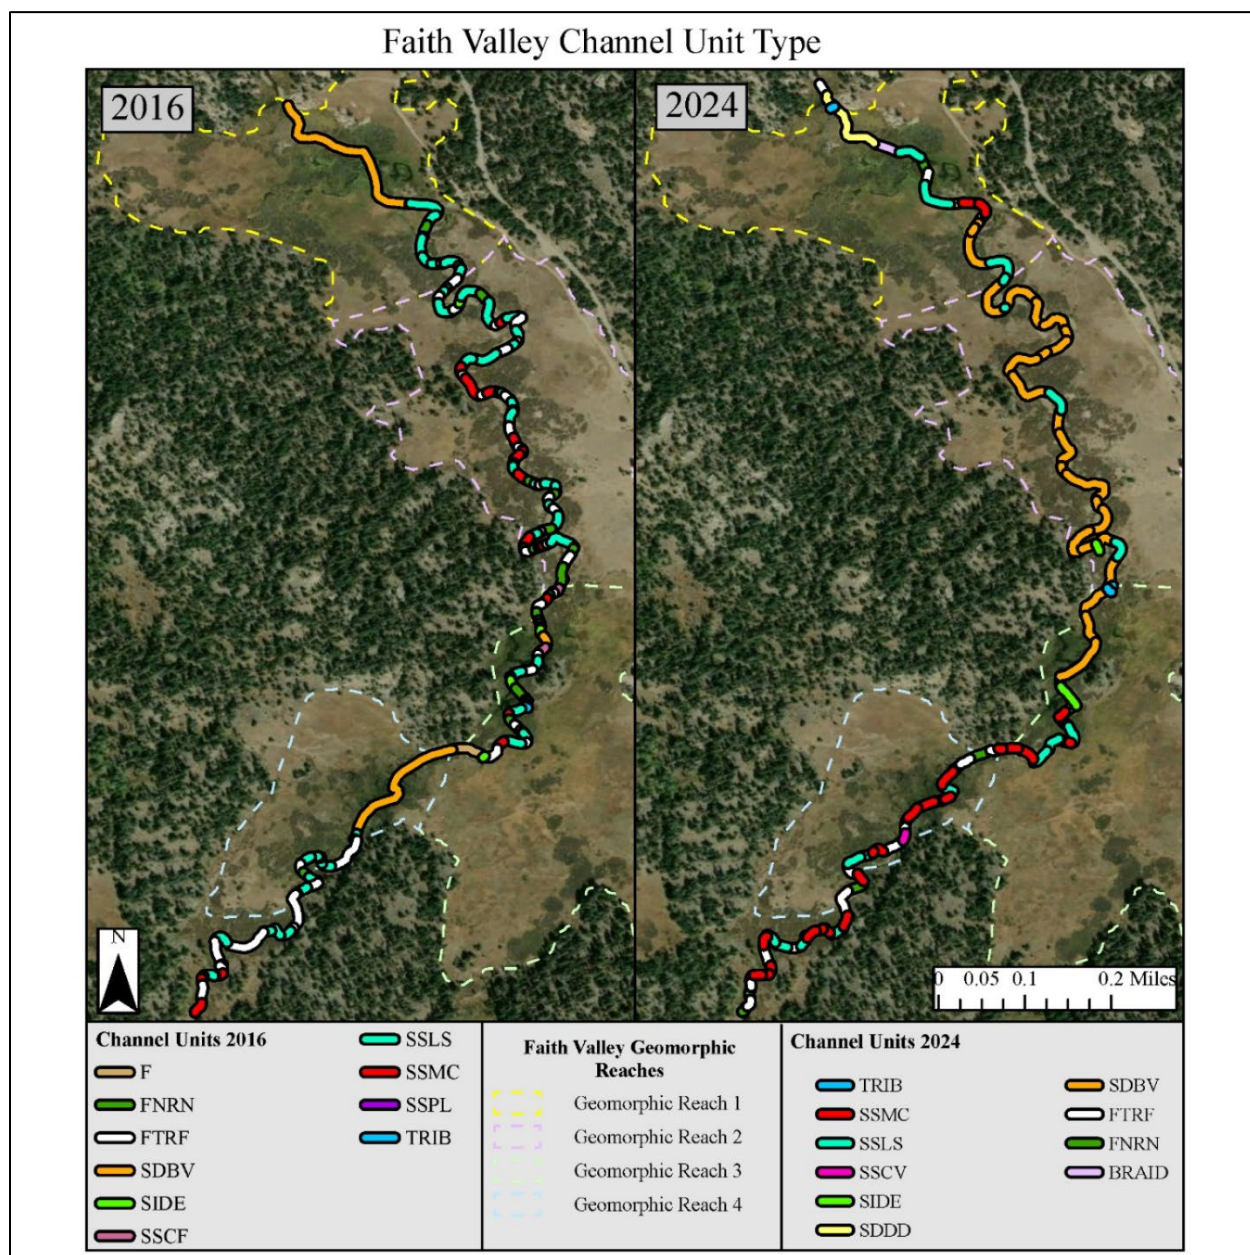
Figure 5. Overview of Channel Habitat Units in 2016 and 2024 in Faith Valley. For more detailed reach level images, see Appendix 1.

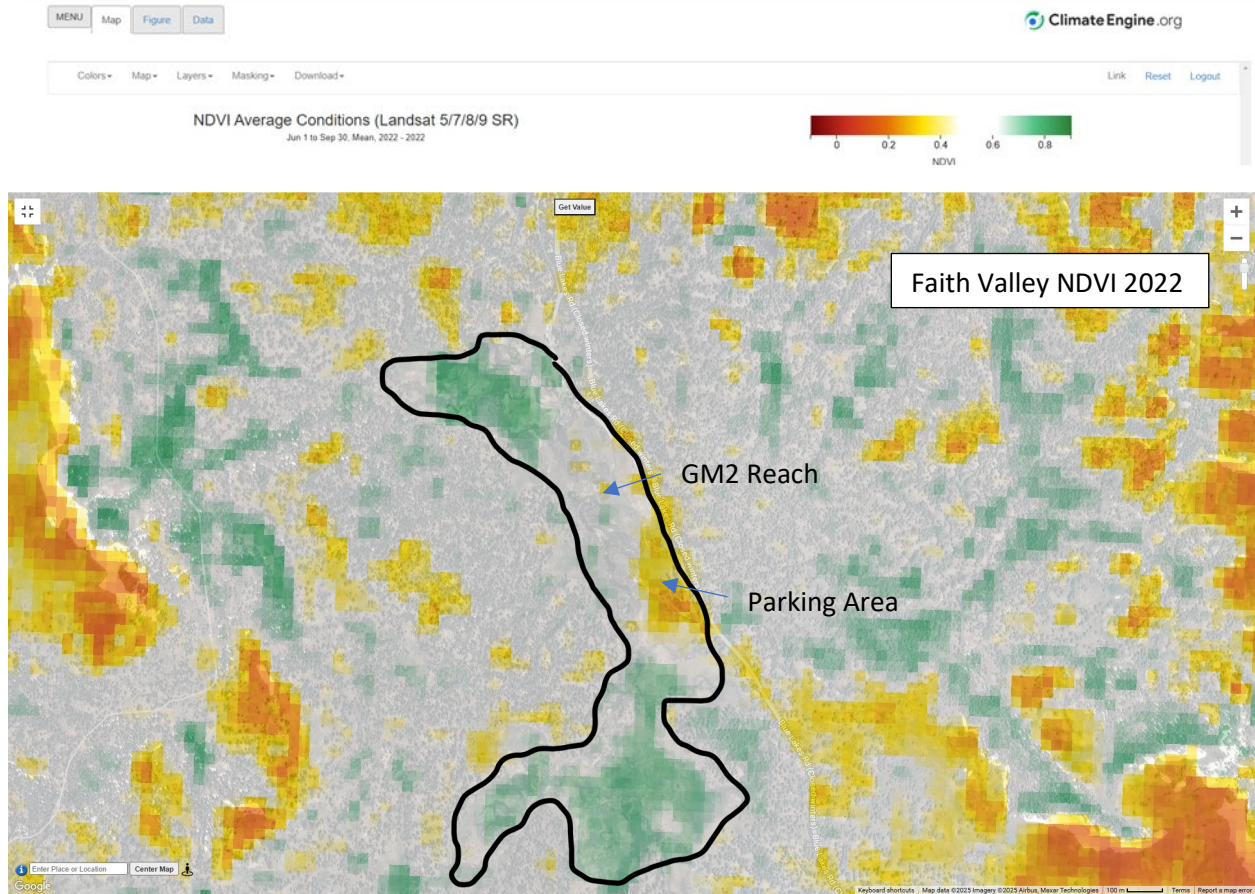
Figure 9. NDVI map for Faith Valley in 2022 (last year available). Comparing this to future results will help demonstrate project impacts on vegetation, particularly in the GM2 reach which has the poorest NDVI Values in Faith Valley Meadow and the least hydrologic connectivity to the floodplain. There is great opportunity for improvement in this section. (Generated by ClimateEngine.org)

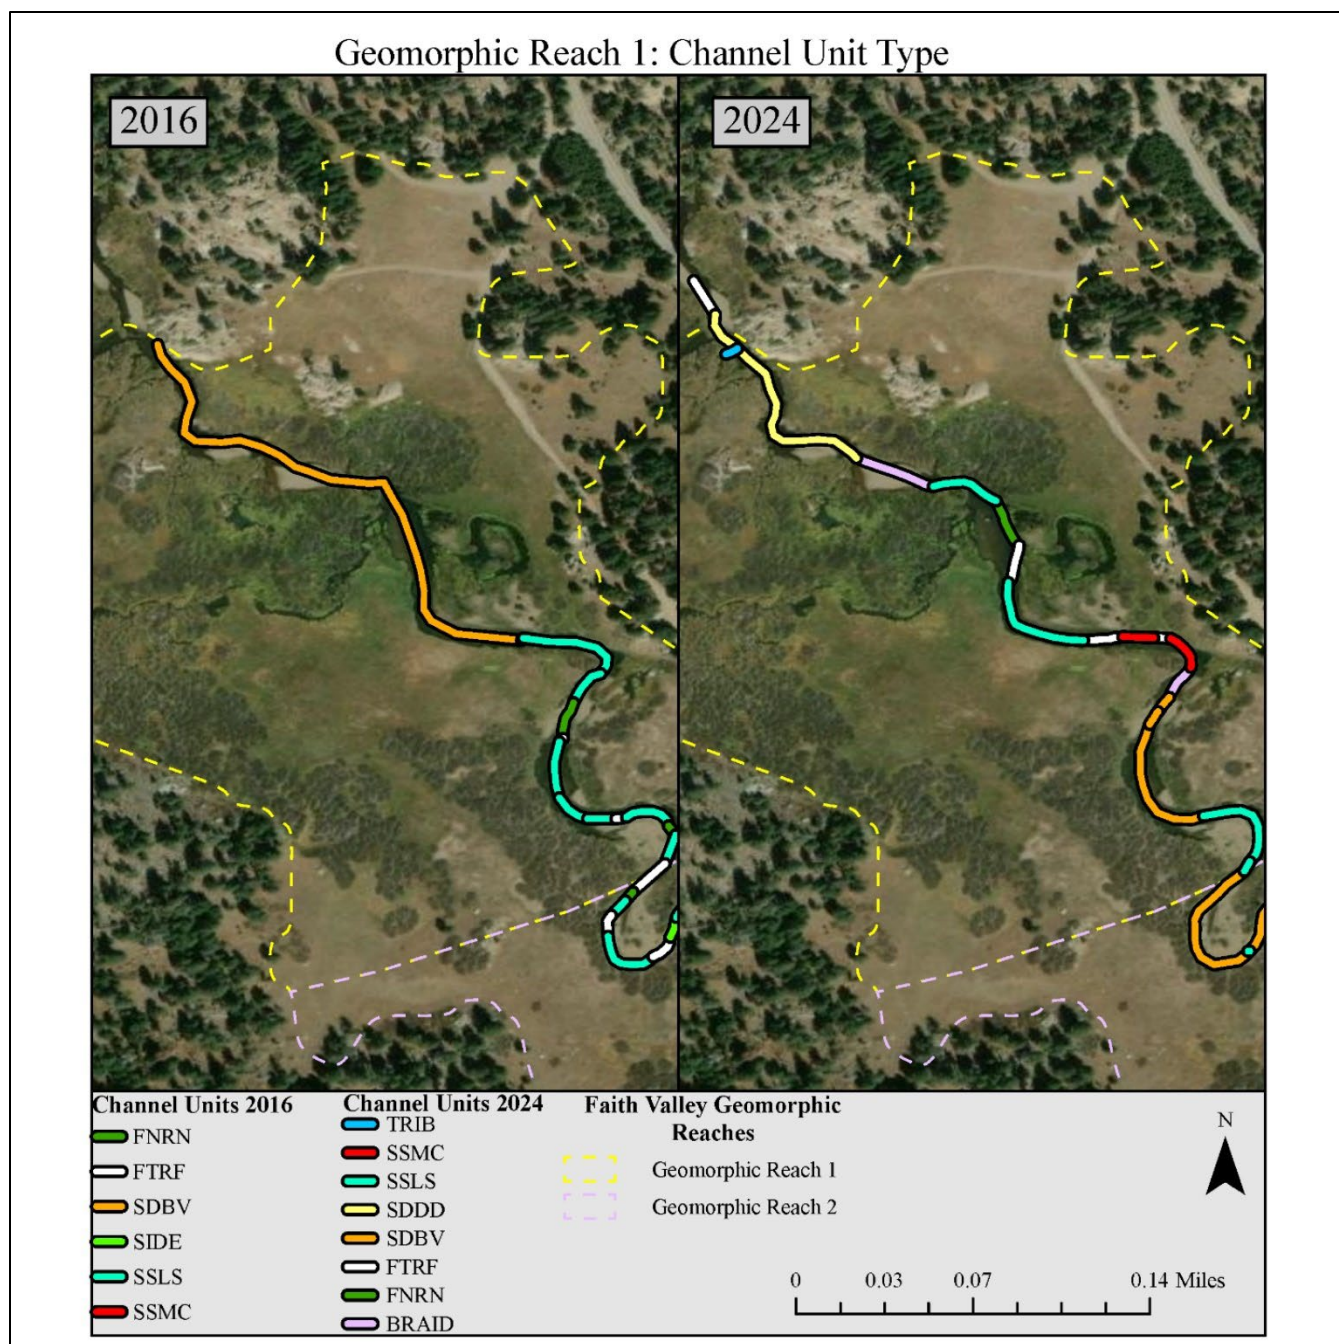
Figure 12. Detail of Geomorphologic Reach 1 comparing Channel Habitats in 2016 vs. 2024

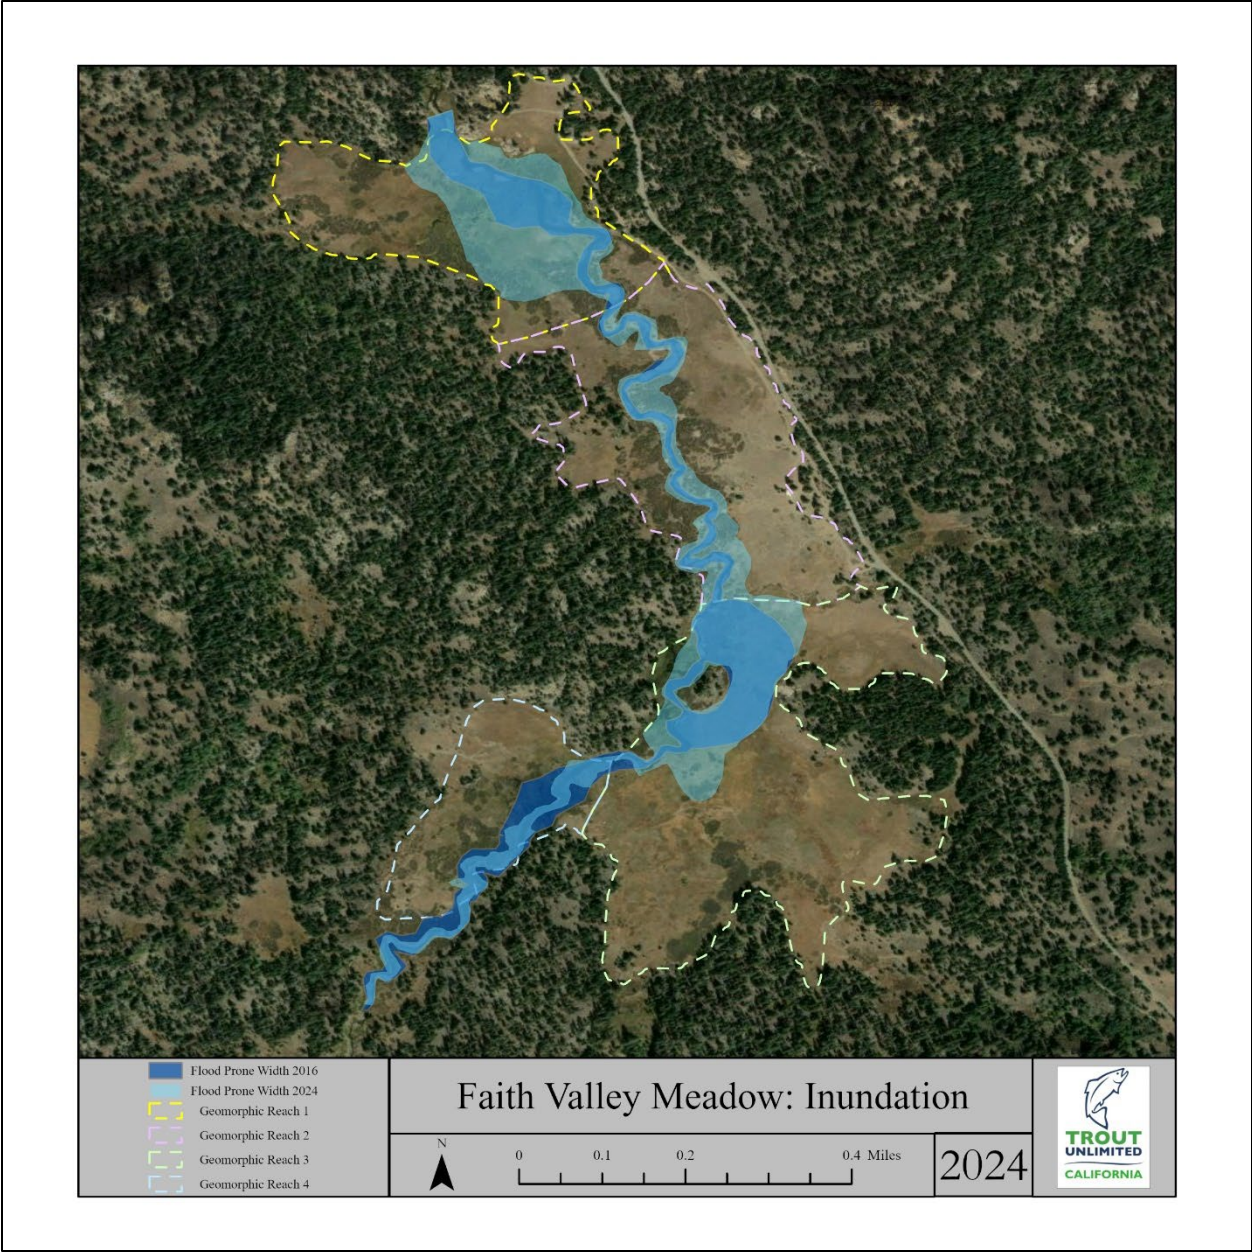
Figure 16. Overview of Inundation areas/Flood Prone widths in 2016 vs. 2024.

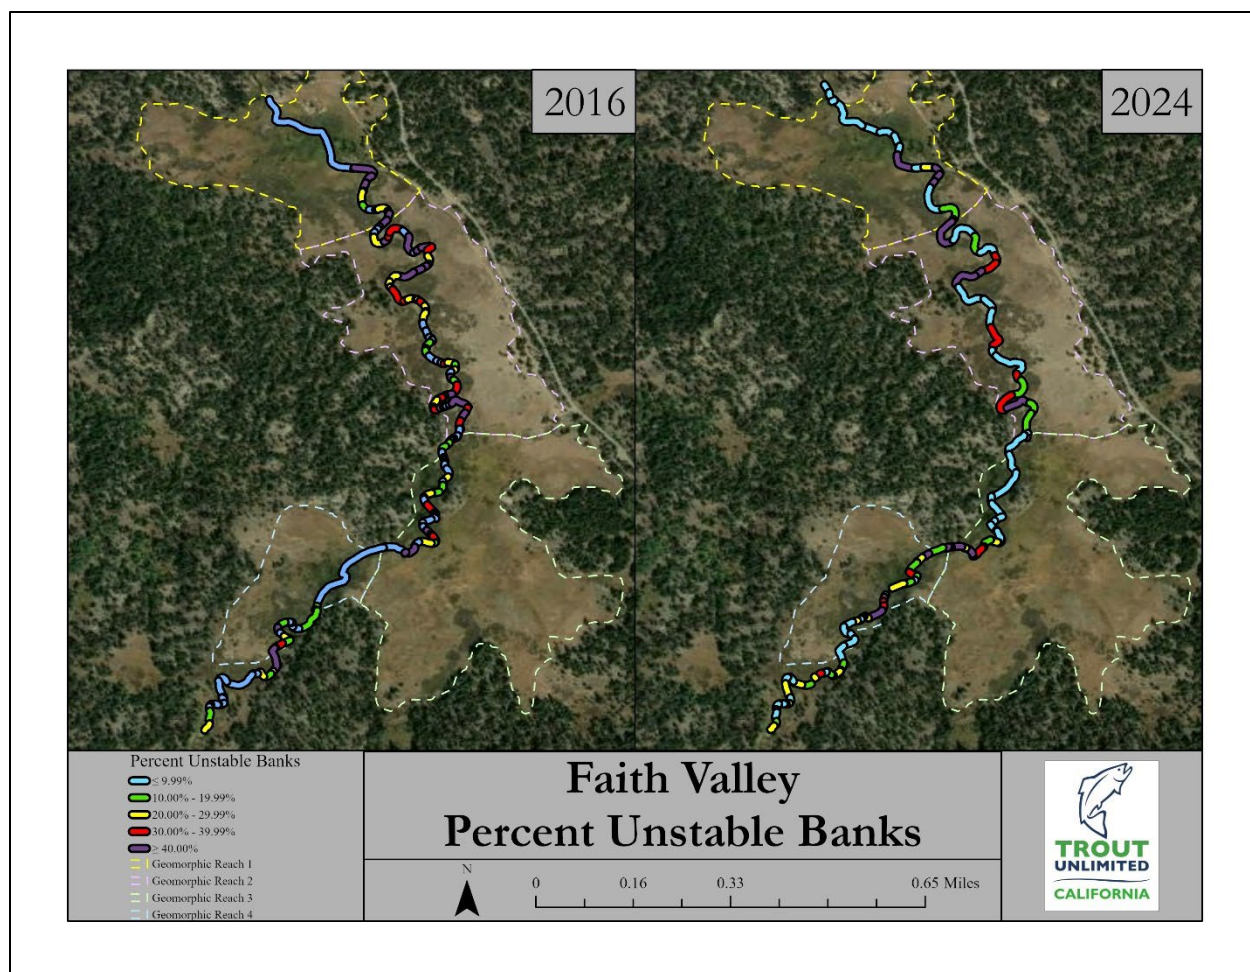
Figure 21. Overview of Bank Stability in Faith Valley in 2016 vs. 2024 by channel unit. Blue indicates <10% unstable banks in the unit, green indicates between 10% and 19.99% unstable banks in the unit, yellow indicates between 20% and 29.99% unstable banks in the unit, red indicates between 30 and 39.99% unstable banks in the unit, and purple indicates >40% unstable banks in the unit.

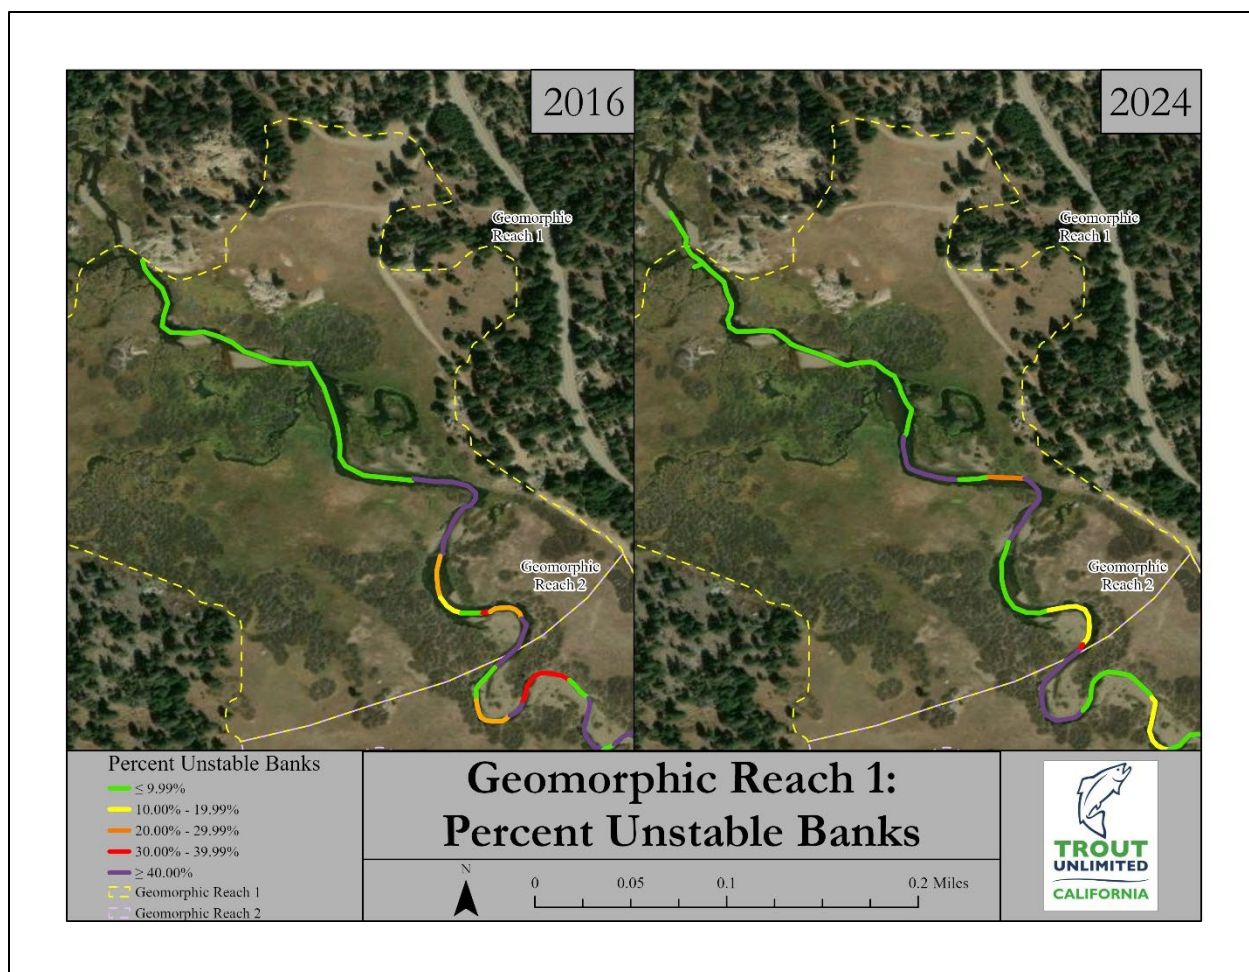
Figure 22. Detail of Bank Stability in GM1 in 2016 vs. 2024 by channel unit. Blue indicates <10% unstable banks in the unit, green indicates between 10% and 19.99% unstable banks in the unit, yellow indicates between 20% and 29.99% unstable banks in the unit, red indicates between 30 and 39.99% unstable banks in the unit, and purple indicates >40% unstable banks in the unit.

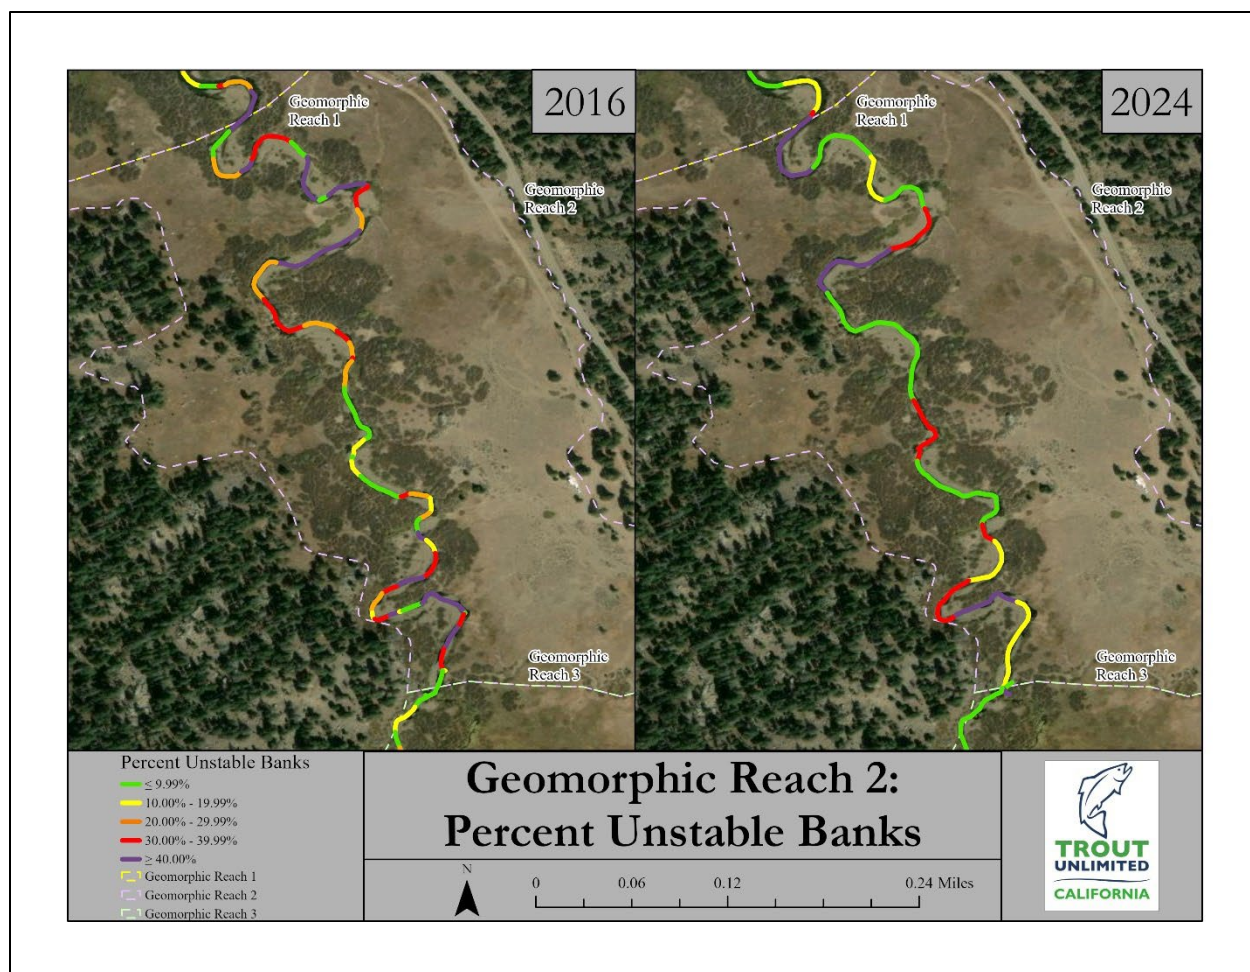
Figure 23. Detail of Bank Stability in GM2 in 2016 vs. 2024 by channel unit. Blue indicates <10% unstable banks in the unit, green indicates between 10% and 19.99% unstable banks in the unit, yellow indicates between 20% and 29.99% unstable banks in the unit, red indicates between 30 and 39.99% unstable banks in the unit, and purple indicates >40% unstable banks in the unit.

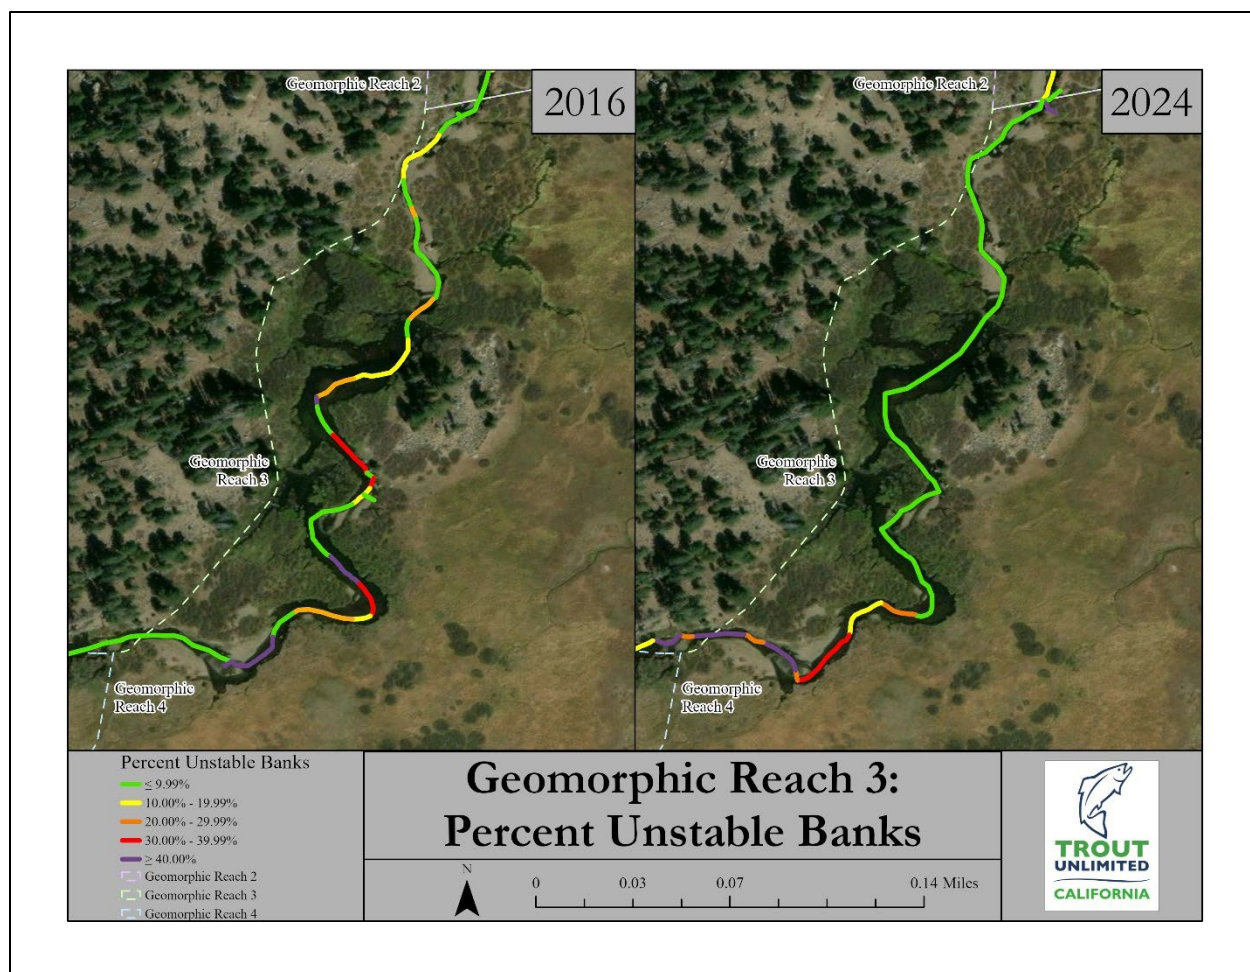
Figure 24. Detail of Bank Stability in GM3 in 2016 vs. 2024 by channel unit. Blue indicates <10% unstable banks in the unit, green indicates between 10% and 19.99% unstable banks in the unit, yellow indicates between 20% and 29.99% unstable banks in the unit, red indicates between 30 and 39.99% unstable banks in the unit, and purple indicates >40% unstable banks in the unit.
