Meadow Name _____	Date : ____ / ____ / ____ MM DD YYYY
GPS Location: _____ N _____ W	
GPS Datum (e.g., WGS 84, NAD 27) _____	
Elevation (ft) _____	Slope (°) _____ County _____
Watershed (HUC8) _____	Landowner _____
USGS Quad Name _____	7.5' or 15' (circle one)
Observers: _____

CONDITION CATEGORY

American Rivers
Rivers Connect Us

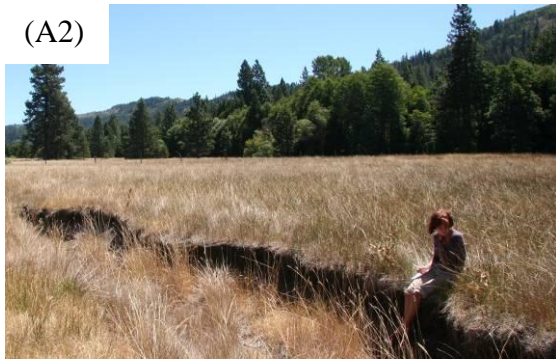
Bank height greater than 4 feet, score=1
(Bear Valley, Bear River Watershed)

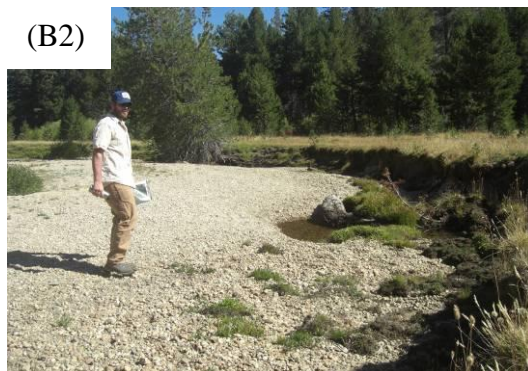
Bank height 2-4 feet, score=2
(Pacific Valley, Mokelumne Watershed)

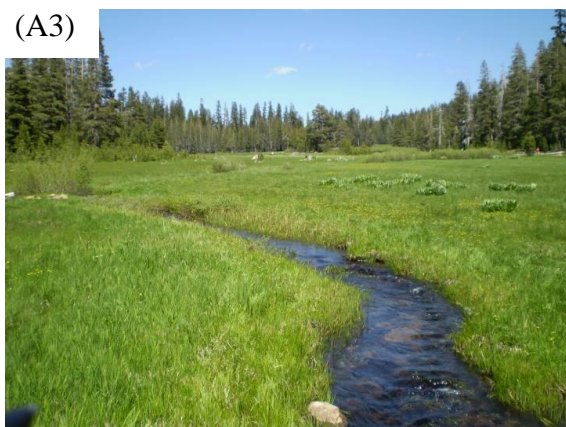
Bank height 0-2 feet, score=4
(Austin Meadow, Yuba River Watershed)

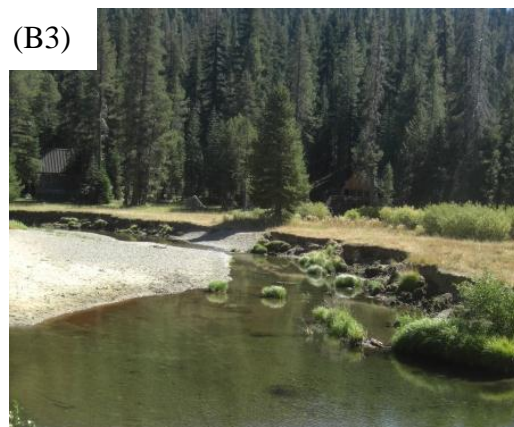
Bank height 2-4 feet, score=2
(Hermit Valley, Mokelumne Watershed)

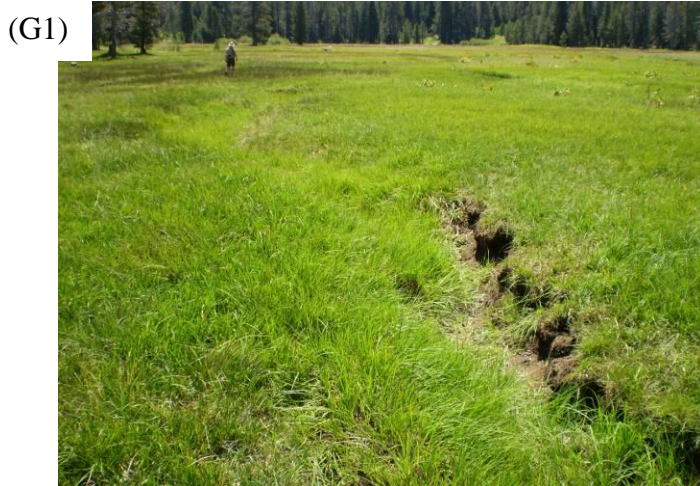
Headcut and gully forming in Freeman Meadow (Yuba Watershed)

Examples of Headcuts (also see G1 above): For headcuts, record the height of the jump, the width and the length.

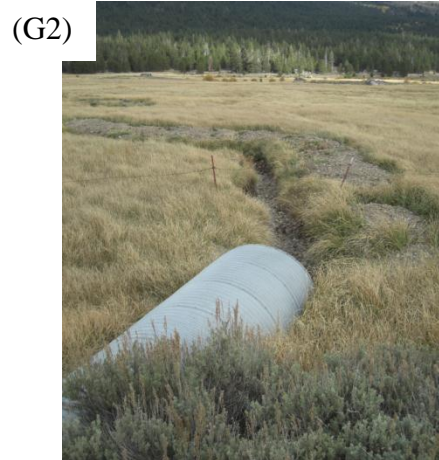
A ditch with vegetated banks in Hope Valley (Carson Watershed).

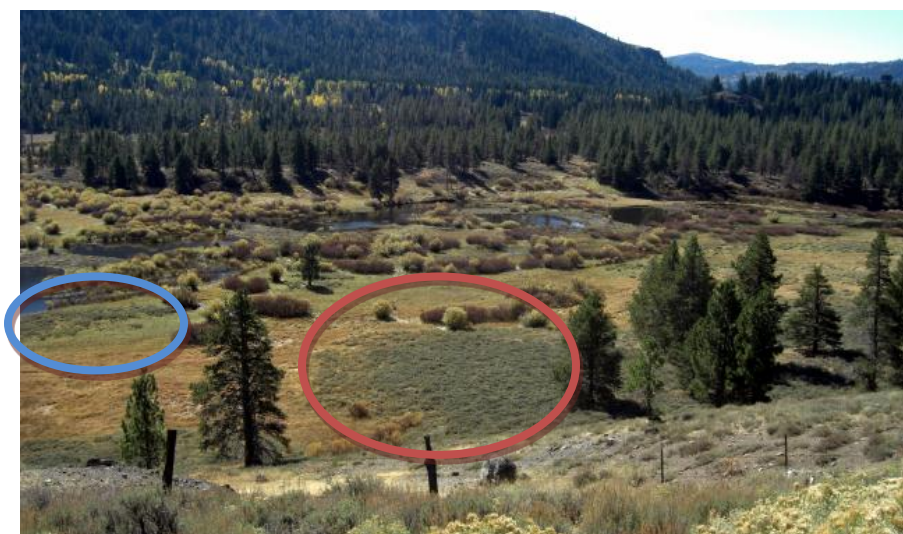
Two areas of sagebrush (greenish) are outlined in the figure. The patch outlined in blue would be included as encroachment because it is low-lying, at the level of the meadow surface –here atop the stream bank. The patch outlined in red is on a higher terrace. Because it is above the meadow surface, this area would not be included in the estimate of encroachment.
